This site is the street from the gate of junior high school to coast. It is gradually declining from north-west to south-east.

Walking down the slope, I found a clear boundary of tsunami damage. In higher area, building has no damage and people can live as usual. On the other hand, in lower area, the most of houses are heavily damaged and they are not available without repair.

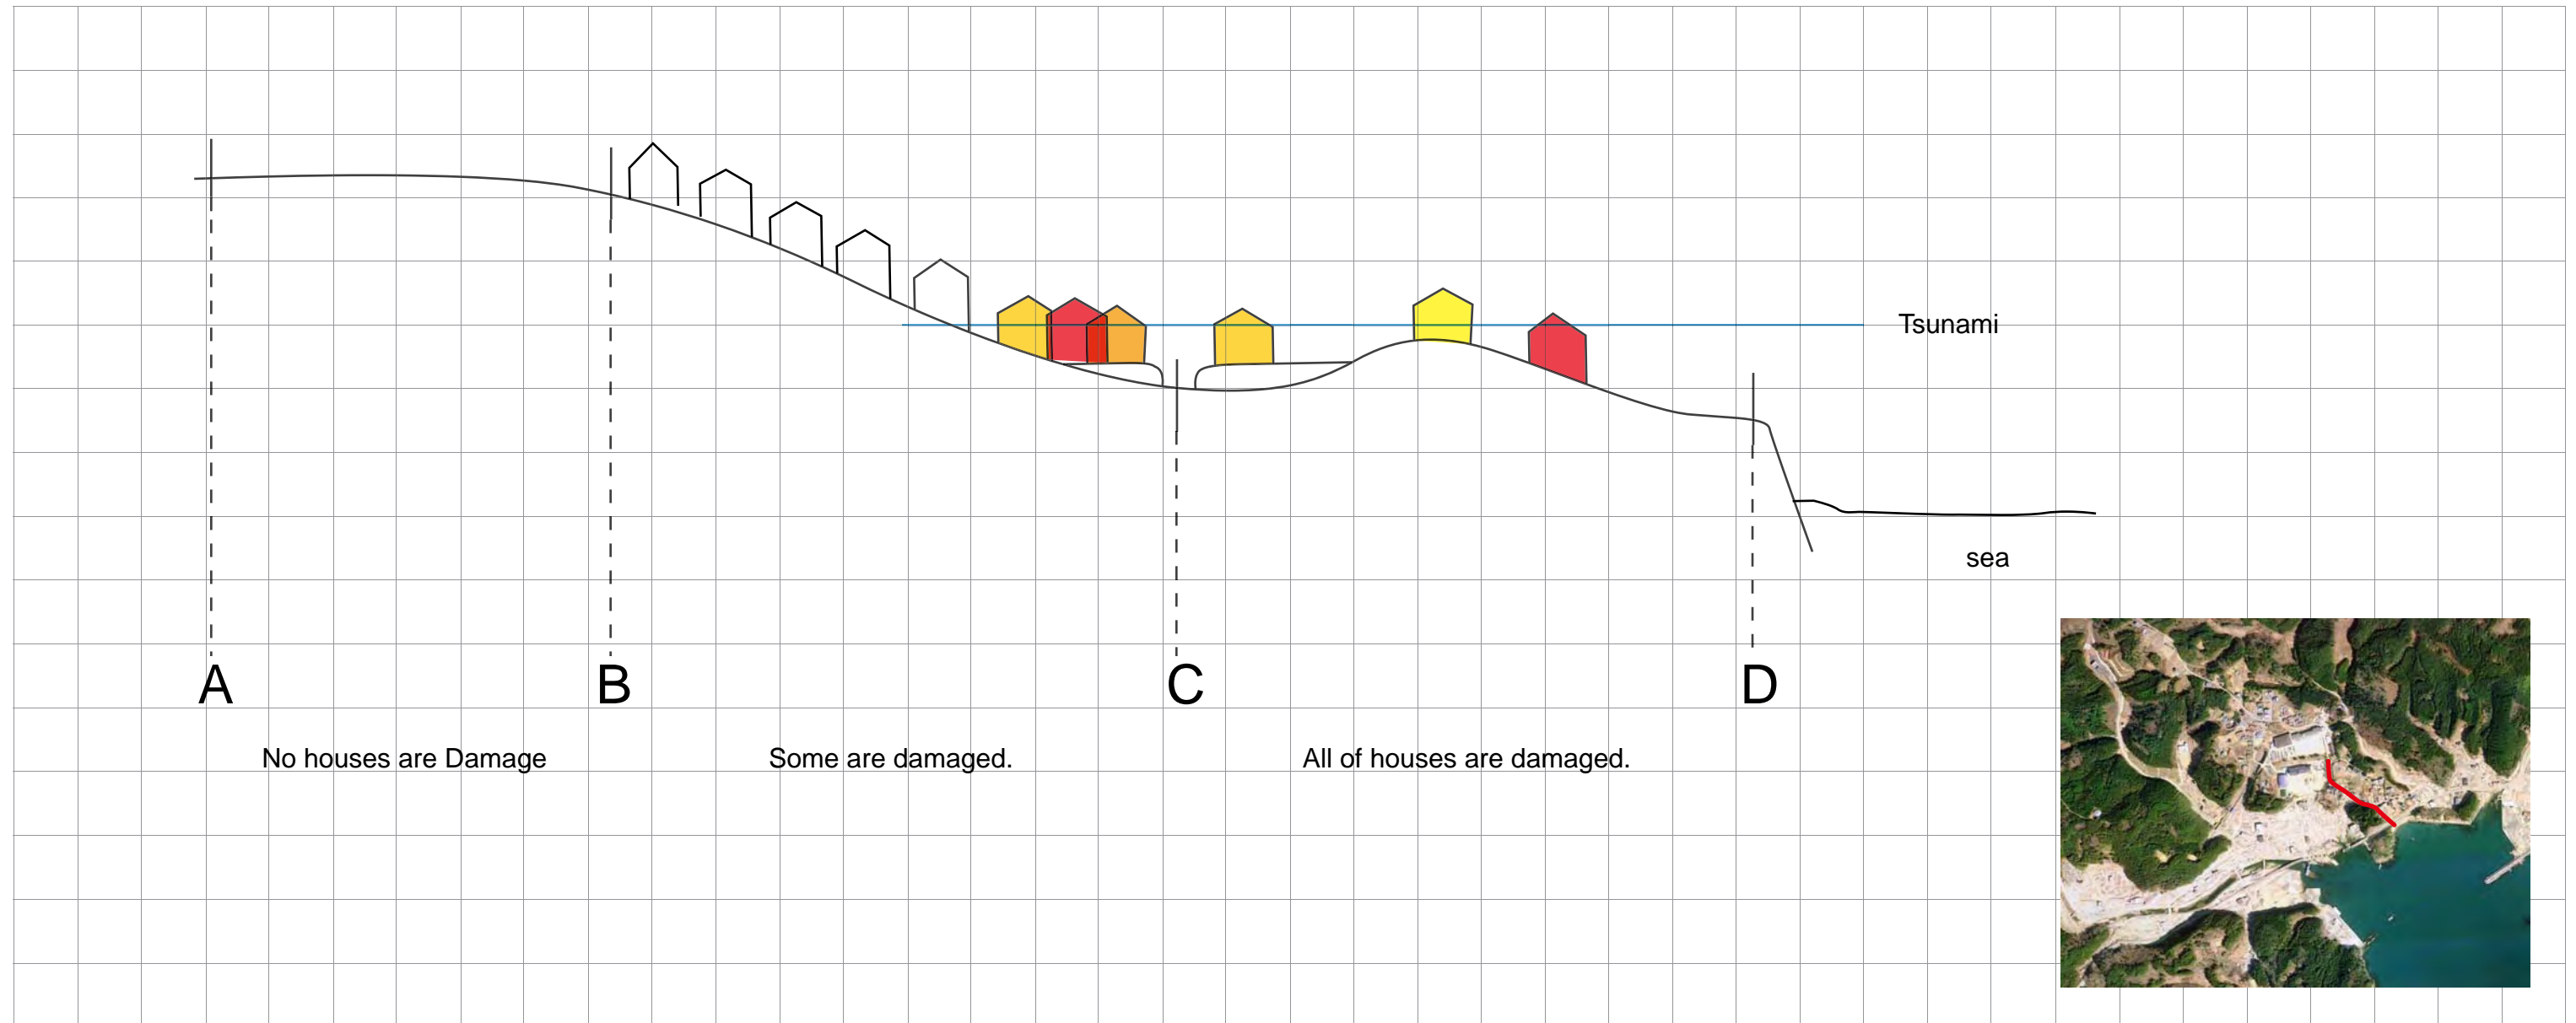
(A to B)
From the gate of junior high school to the entrance of slope. The street is almost flat. Traces of tsunami damages are not found.

(B to C)
From the entrance to the bottom of slope. Ground level is declining. 5 or 6 houses are built along the street. Firstly, traces of tsunami damages are not found and people living here. However, stepping across a line, heavily damaged houses are shown up. The insides of damaged houses are completely destroyed and they are not available anymore.

(C to D)
From the bottom of slope to coast. Ground level is climbing a little and declining again. At the end this street meets coast. There are some houses facing to sea. The 1st floor parts of buildings are heavily damaged. One of them has been already repaired.

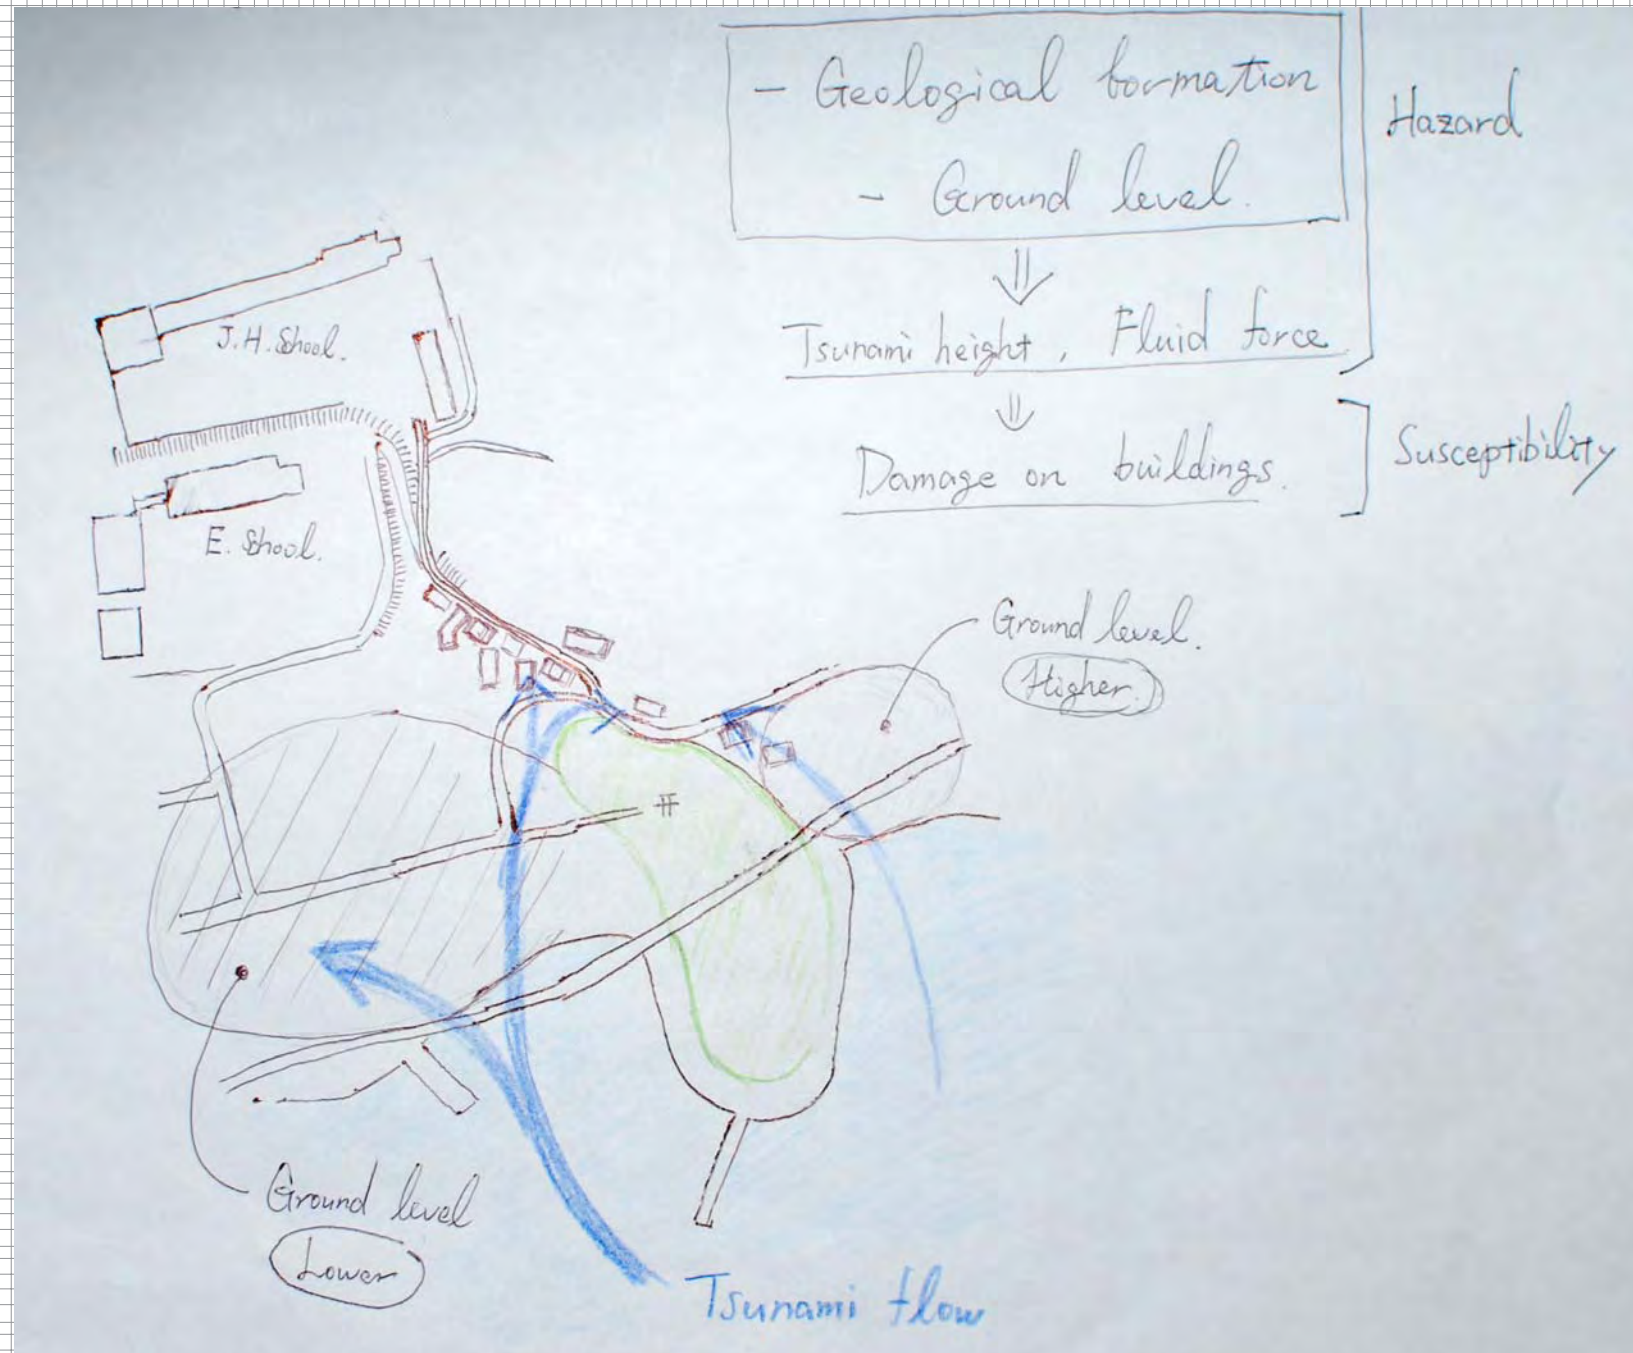
Flow of Tsunami

Ground level is a main factor for influencing damage from tsunami. However, in the lower area, damage degrees are different depending on locations even where the ground level of houses is almost same. Additionally, some houses located in inland got heavier damage than one in coast-line. It might be due to tsunami flows. There are two tsunami flows influencing building damages in this site . One came from the west side of the mountain with shrine, and the other came from east side of the mountain. Ground level of west side is lower than one of east side. Hence, fluid force is stronger in west side. Houses around point C might be damaged by flow from west side, and houses close to coast might be damaged by flow from east side. Thus, geological formation and ground level influence the extent and fluid force of tsunami, which influence damages on buildings.

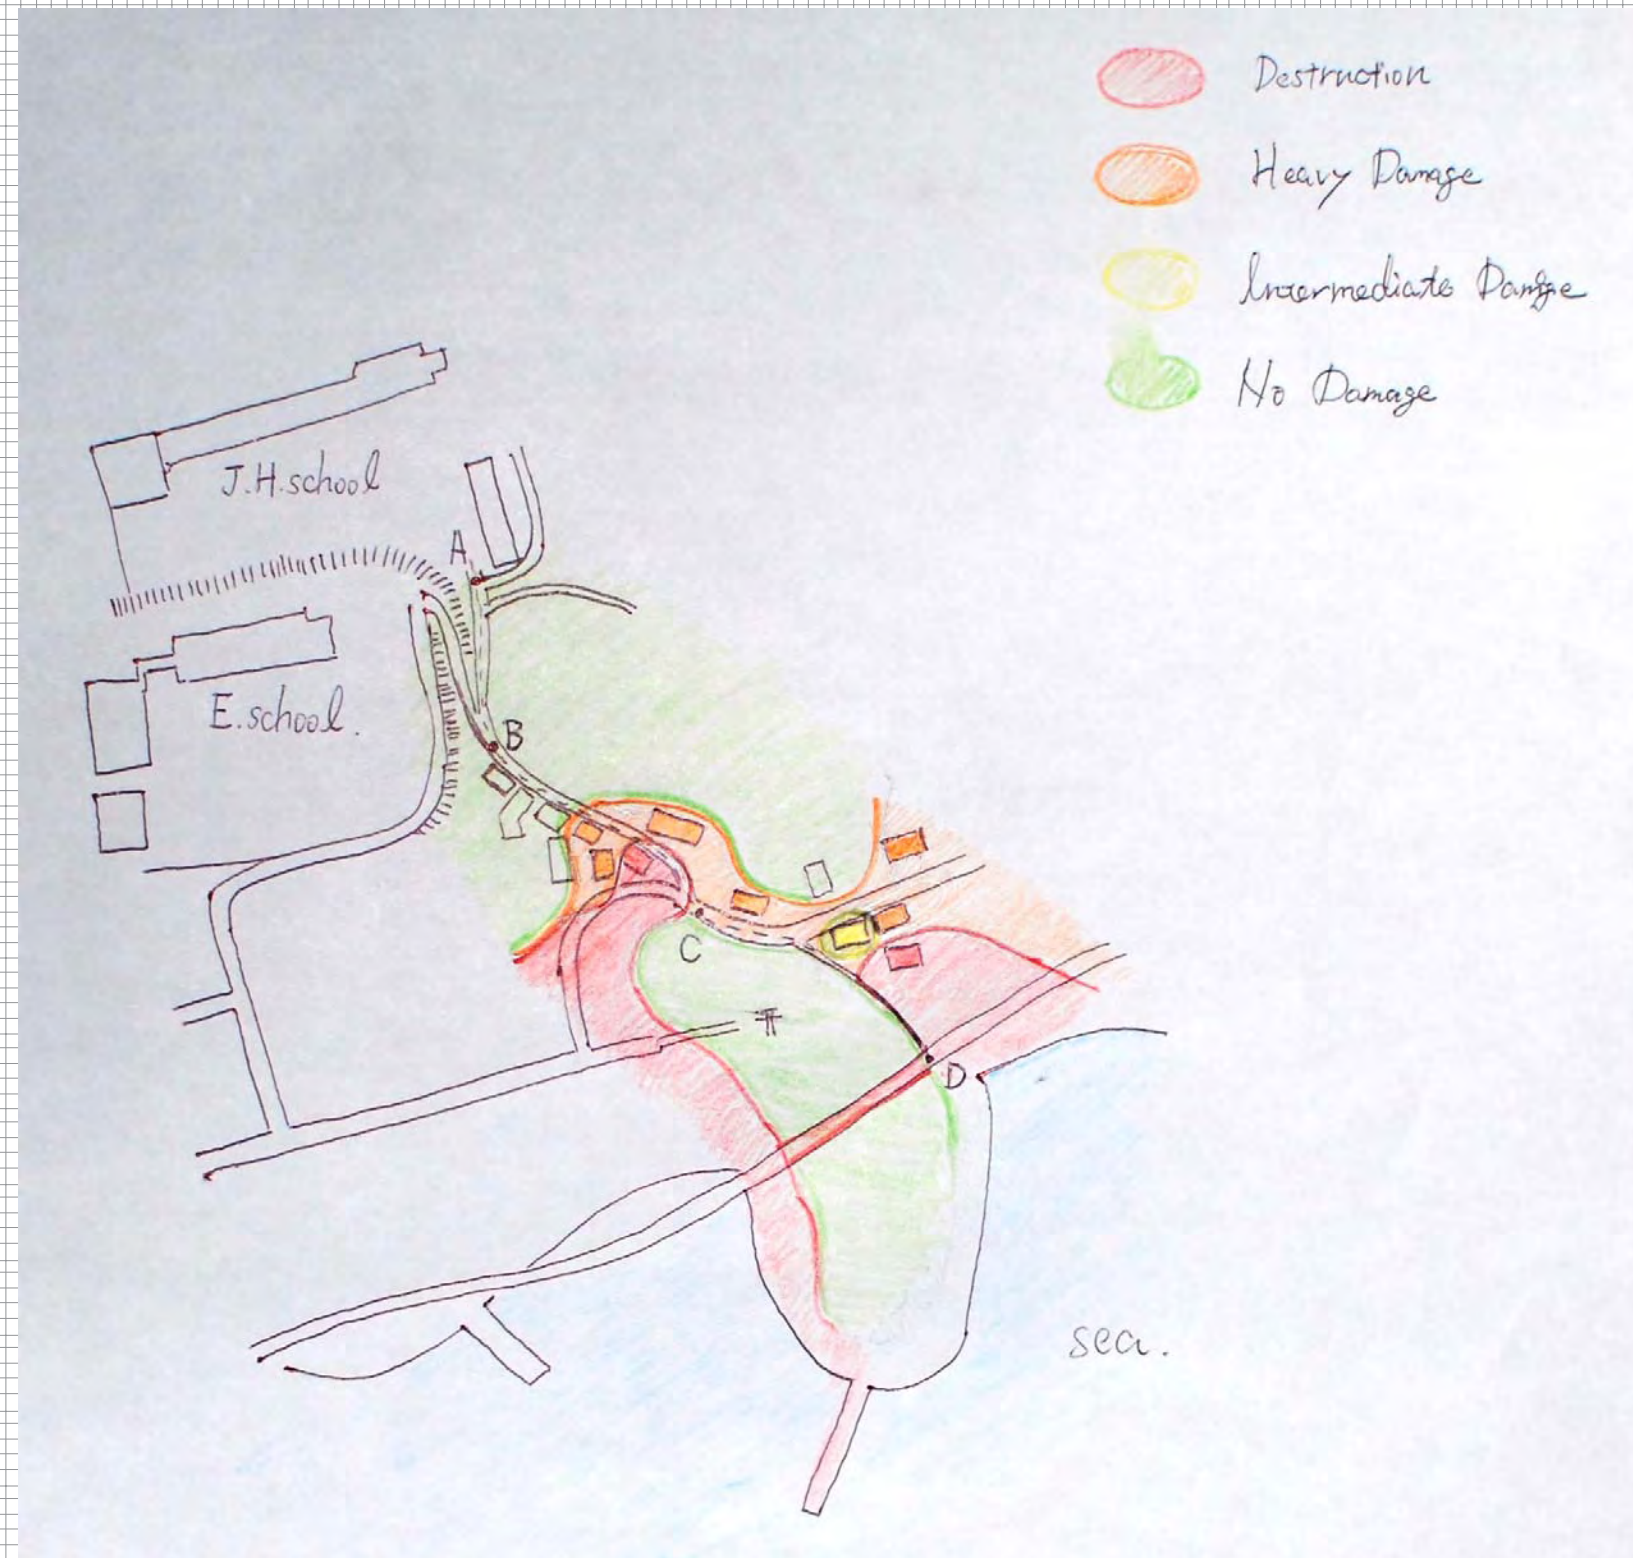
Damage Situation Map

Based on the site analysis, the damage situation map is made. Damage contour is drawn at the center of the site.

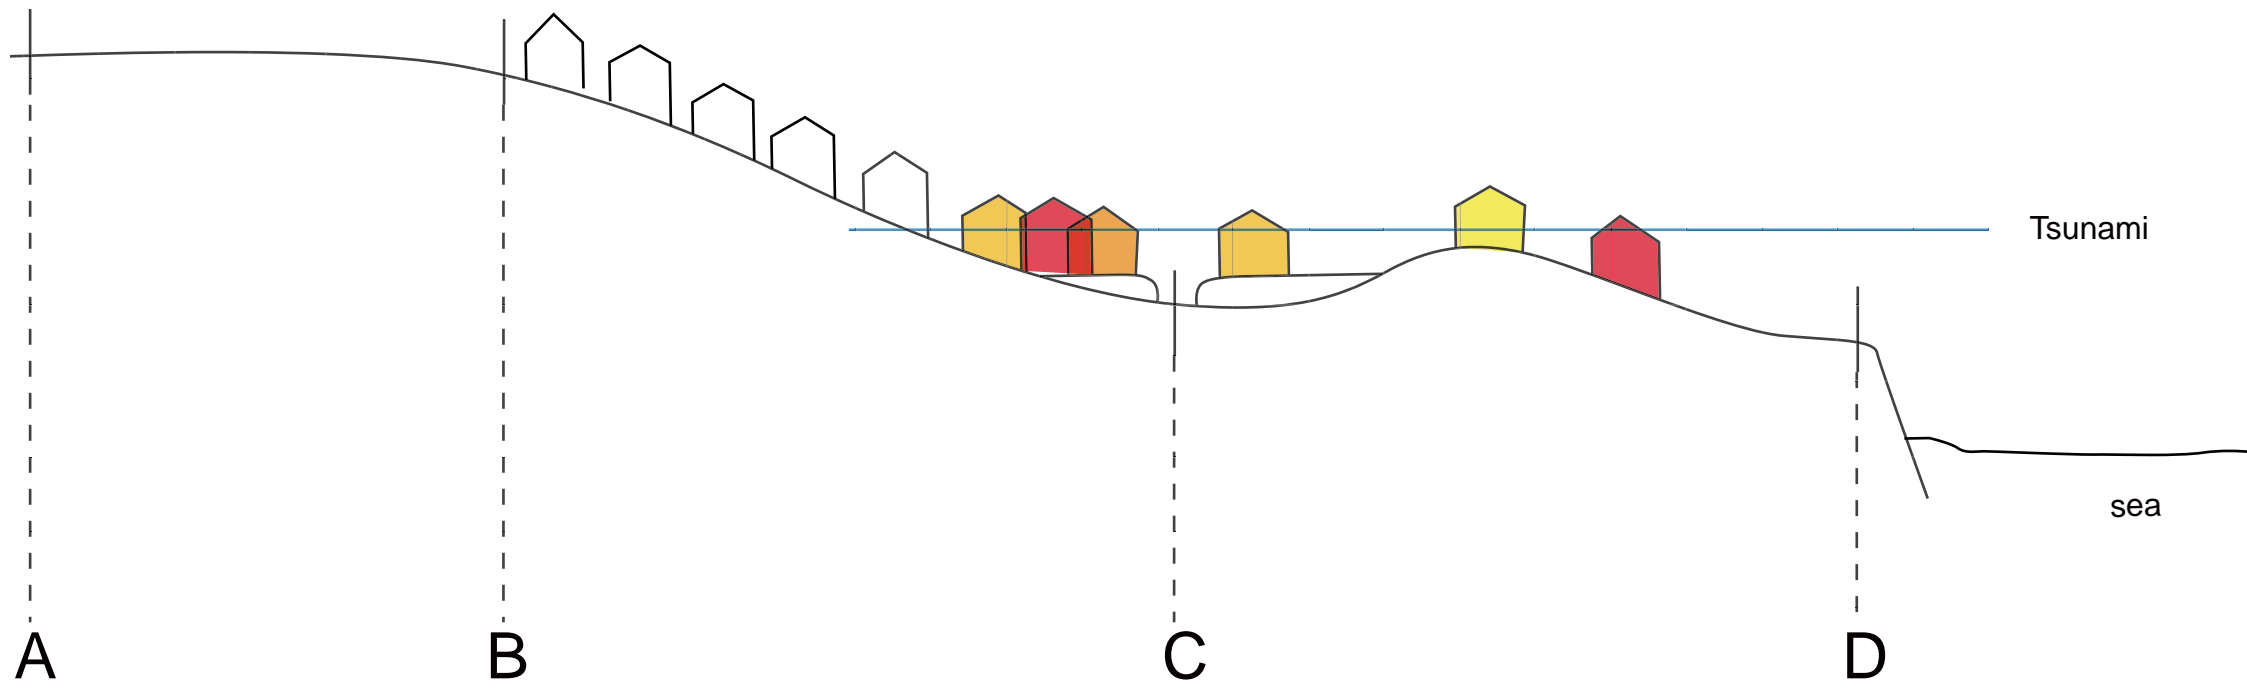
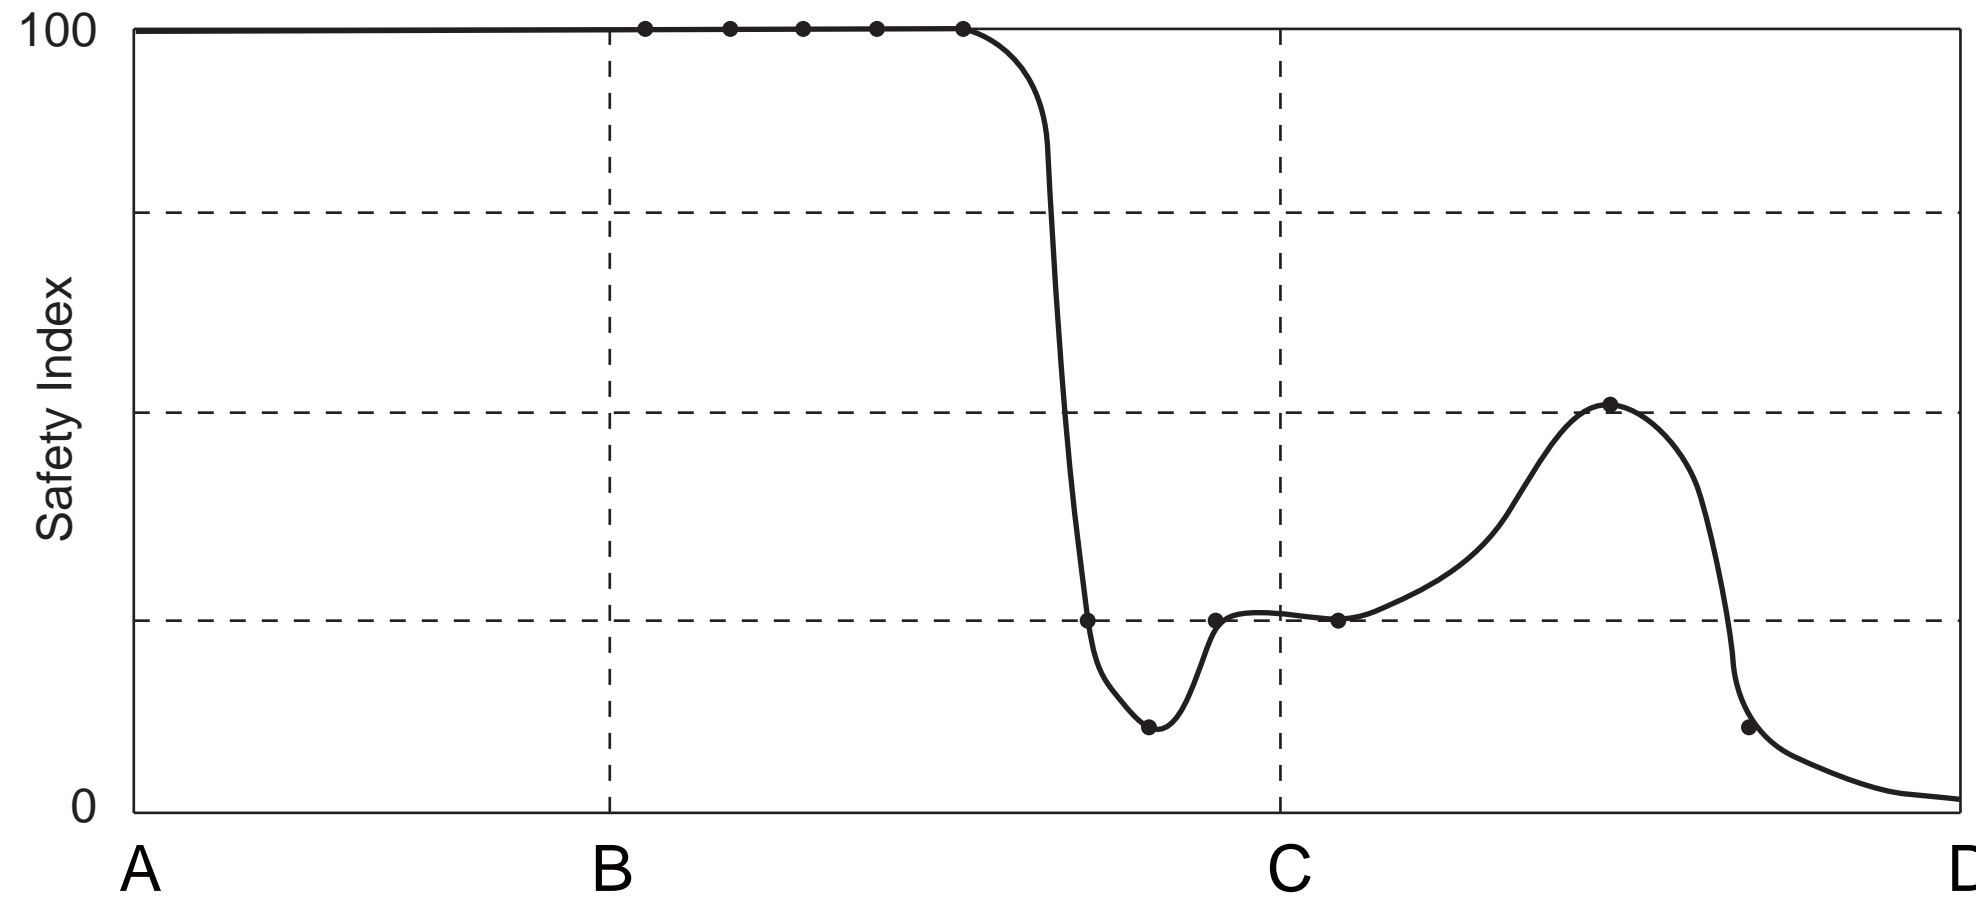
For land use plan for reconstruction, the risk of tsunami should be figured out. From the damage situation, following safety index is set up.

Connecting the plotted dots, the chart of safety index is drawn. Comparing between this chart and section, it is found there is another factor except the ground level and the length from sea. It is possible to be due to geological formation.

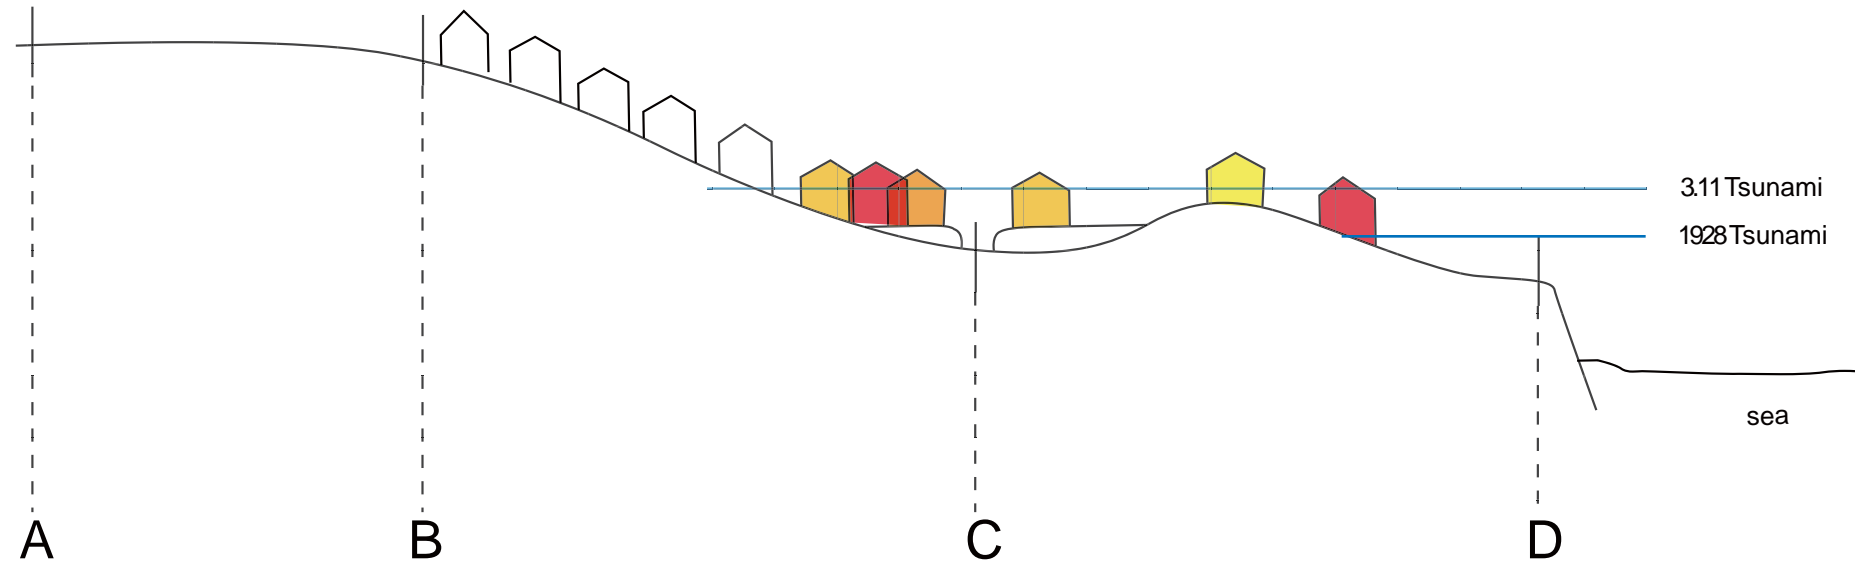
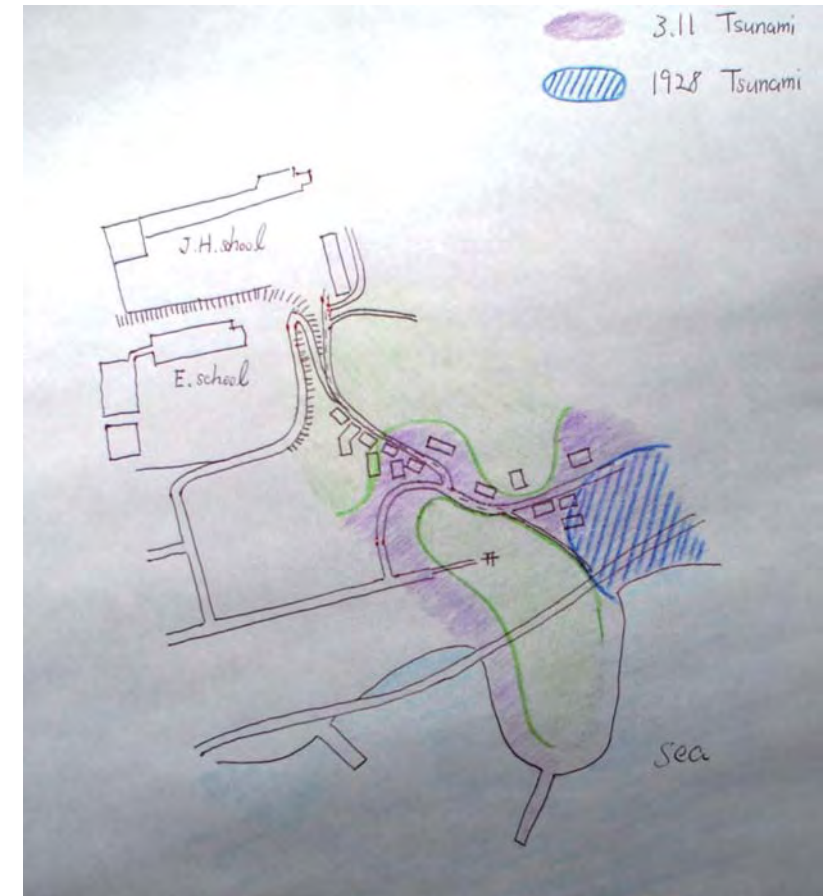
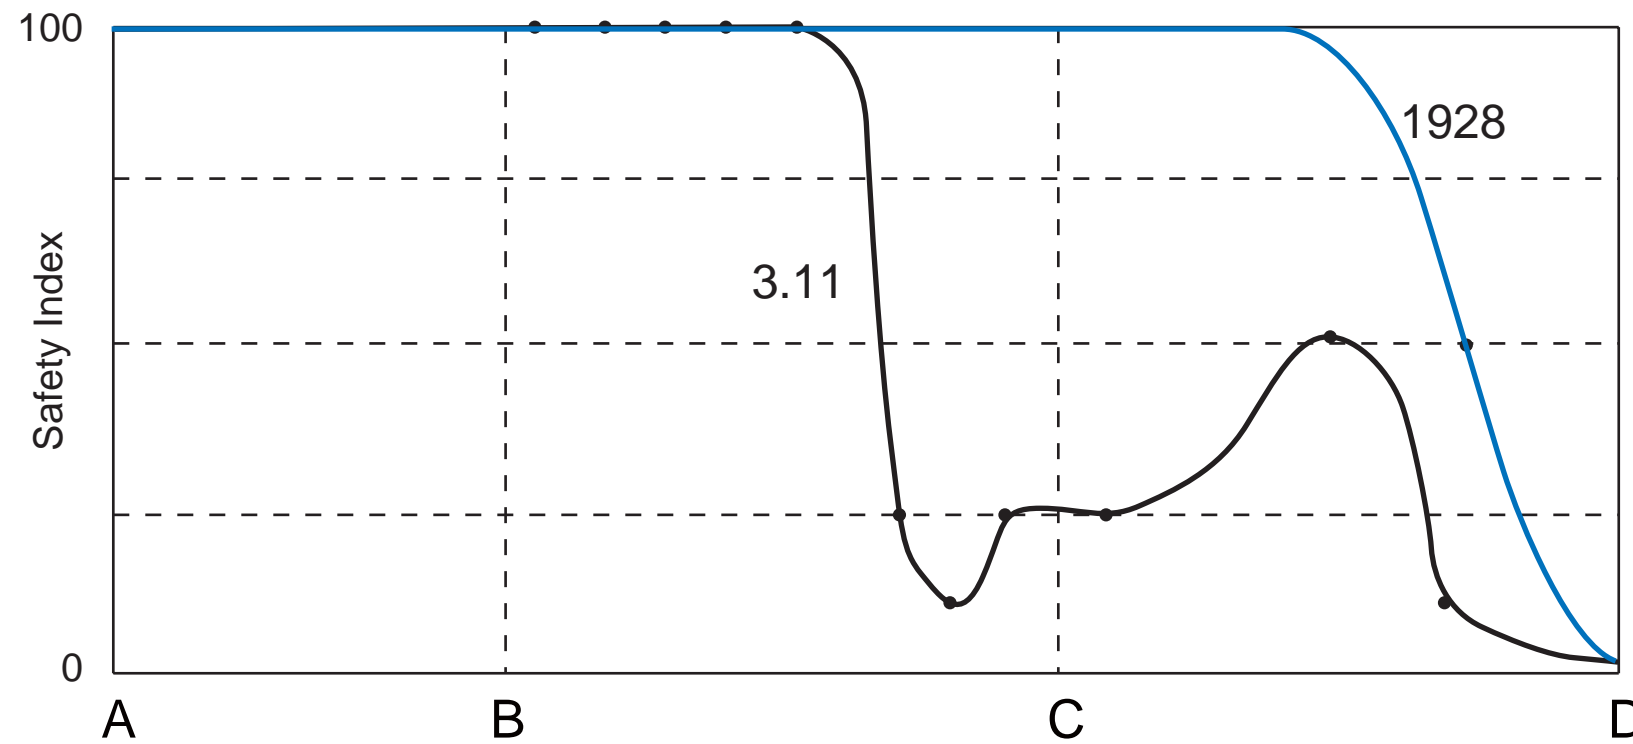
Up to now, the risk of 3.11 tsunami has been mentioned. However, this area has been devastated by tsunami many times. Degrees of tsunamis are different depending on time. The height, area and estimated safety index of tsunami in 1928 are shown in section and figure. From the safety index figure, the risk of the area around C is different between 3.11 and 1928 tsunami. Generally, low-frequent tsunami is estimated to be larger than high-frequent tsunami based on statistics. Considering the uncertainty of statistics, a viewpoint of land characteristics should be carefully observed for deciding land use plan.

Through the site analysis and the observation of previous tsunami data, higher risk area is identified in the site. Considering the uncertainty of statistics, the land use should be decided from the observation of land characteristics.
