SLOPES OF UTATSU

UTATSU IS SURROUNDED BY MOUNDS ON THREE SIDES AND BORDERED BY SEA. WATER CANAL AND ELEVATED HIGHWAY CUTS ACROSS THE SOUTHERN BORDER OF UTATSU. THIS ANALYSIS LOOKS AT THE SLOPES ON THE NORTHERN SIDE, WHICH ACTED AS NATURAL BARRIERS TO THE 3.11 TSUNAMI.

SLOPES OF UTATSU - FINDINGS FROM THE VISIT

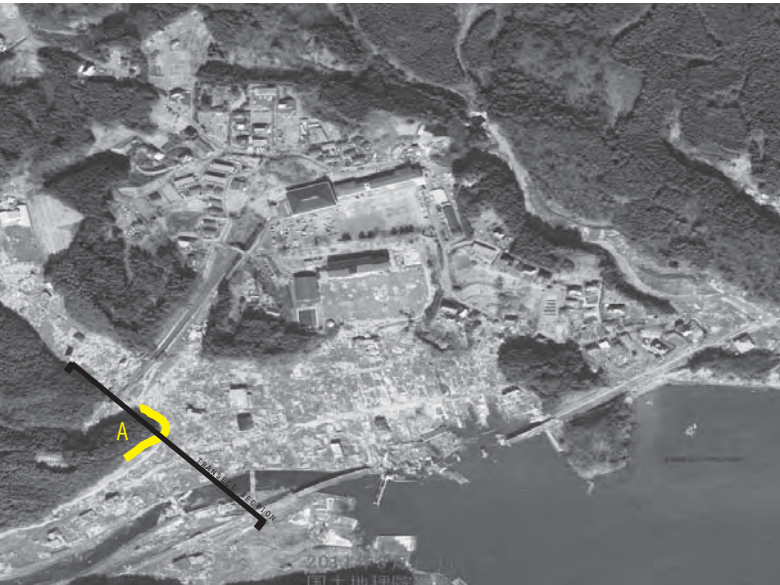
SLOPE A - CEDAR TREE MOUND BY ENTRY ROAD TO UTATSU

SLOPE BY ENTRY ROAD TO UTATSU

TREES DAMAGED BY SALT WATER, UP-ROOTED TREES

CONCRETE REINFORCEMENT, CONCRETE COVERED PATH, PILED STONE AT TOE,

50 DEGREES SLOPE

8-10M

CUT ON ROAD SIDE

SLIGHT EROSION ON SIDES

EXPOSED BEDROCK

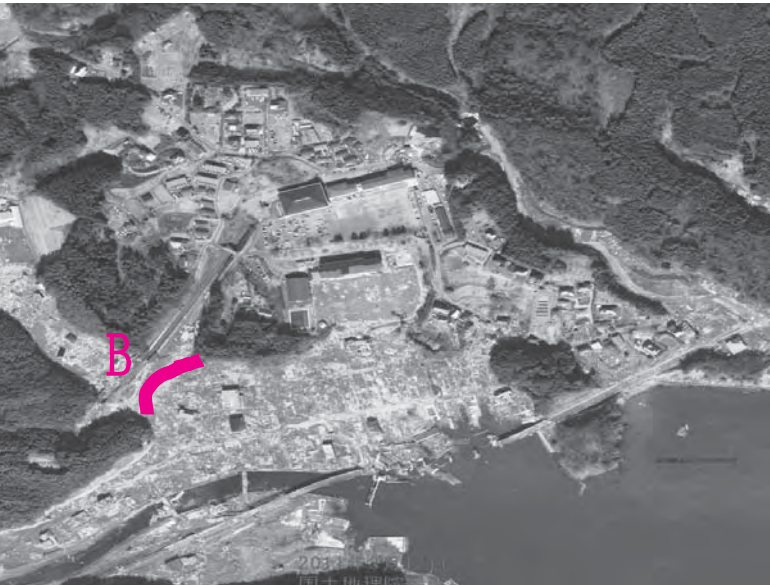
SLOPE B - ARTIFICIAL MOUND / JR LINE TRAIN TRACK

**ENGINEERED SLOPE

- ARTIFICIAL MOUND FOR JR TRAIN. TUNNEL AT GROUND LEVEL
- EXPOSED TOP OUTER SURFACE OF TUNNEL
- PILED UP STONE, GRASS
- 40 DEGREES SLOPE
- 10-12M
- ARTIFICIAL
- RAMP UP TO STATION
- EXPOSED STONE INNER FILL, MISSING GRASS PATCHES
- GRASS

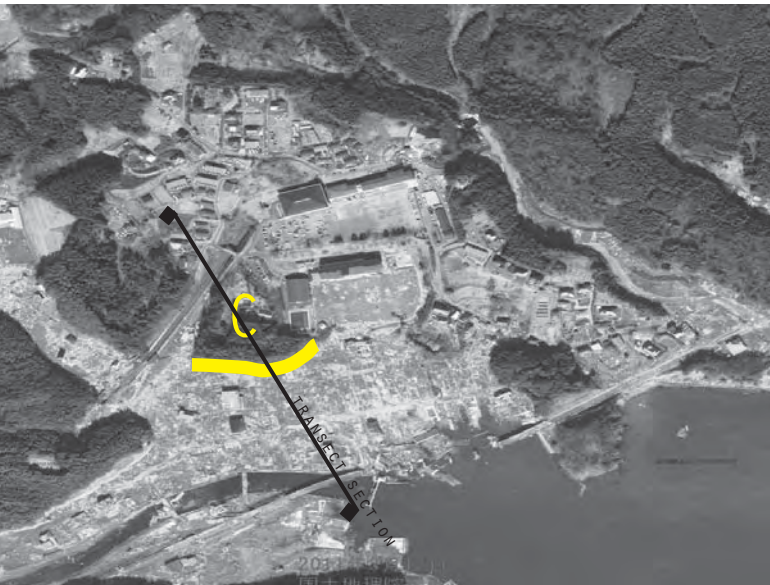
SLOPE C - BEHIND PARKING LOT

WHERE: SLOPE BEHIND PARKING LOT

POST TSUNAMI CONDITION: DEAD BAM-
BOO, UPROOTED TREES

SURFACE: ROCKY SURFACE, STONE CLIFF

50-80 DEGREES SLOPE

18-22M

CUT AT TOE, PILED STONE

EROSION +++
5M UP FROM GROUND ALL ERODED

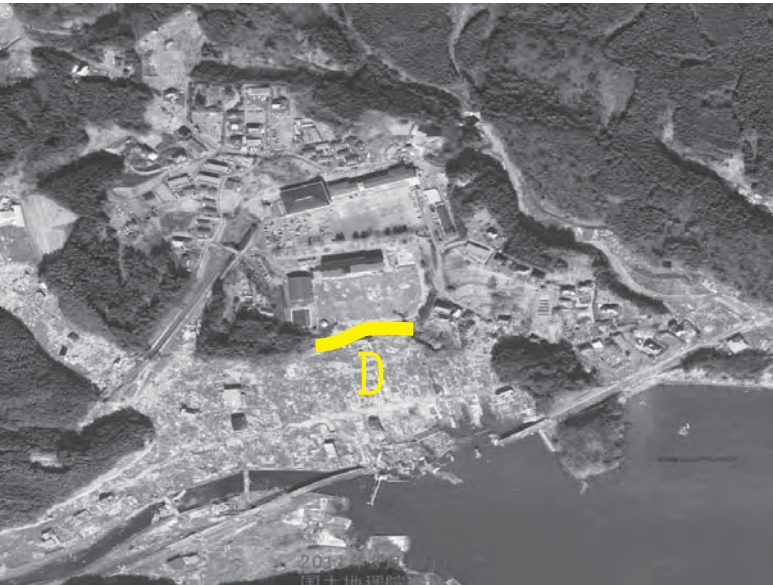
SLOPE D - SCHOOL GROUNDS

CUT AND FILLED SLOPE BY TWO SCHOOLS

NOT MUCH VISIBLE DAMAGE

SURFACE: CONCRETE WALL, GRASS PATHCES

50-90 DEGREES SLOPE

CUT AT TWO LEVELS FOR RAMP, CON-
CRETE WALL

NO VISIBLE EROSION

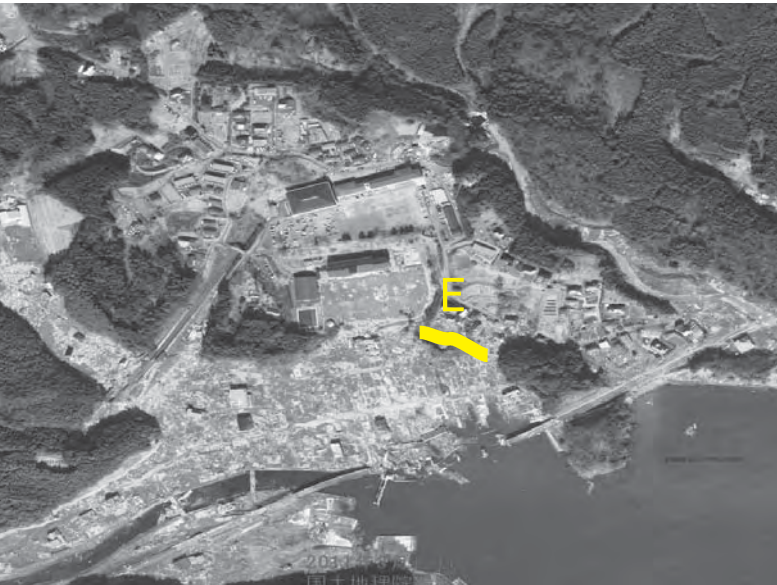
SLOPE E - BEHIND RESIDENCES

SLOPE BEHIND RESIDENCES, DIVIDES
HOUSES ON TOP FROM BELOW

UPROOTED TREES AND BAMBOO,
HANGING ITEMS

TREES, EXPOSED BEDROCK, SOIL
COLOR IS DIFFERENT

60-70 DEGREES SLOPE

15M APPROXIMATE HEIGHT

CUT AT TOE, FILLED WITH CONCRETE
WALL

EROSION NEAR GROUND

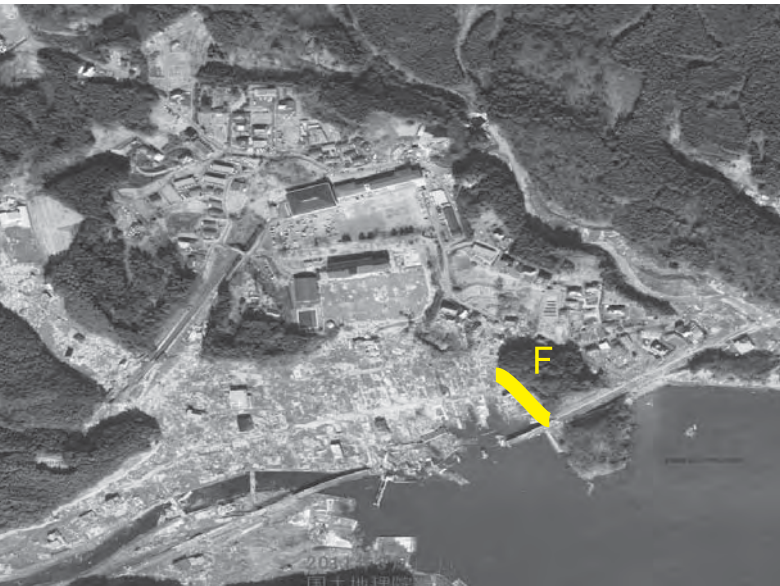
SLOPE F - SHRINE

SLOPE WITH SHRINE AT TOP, ELEVATED HIGHWAY CUTS ACROSS

UPROOTED TREES, HANGING ITEMS (UNREMOVED)

SALT WATER DAMAGE TO CEDAR TREES, DAMAGED HOUSE NEXT TO STAIRS

30 DEGREES (STAIRS)

30M HEIGHT

TOE/MIDDLE CUT AT NW SIDE FOR ROAD, SLICED AT SW SIDE FOR HIGHWAY

EROSION NEAR GROUND

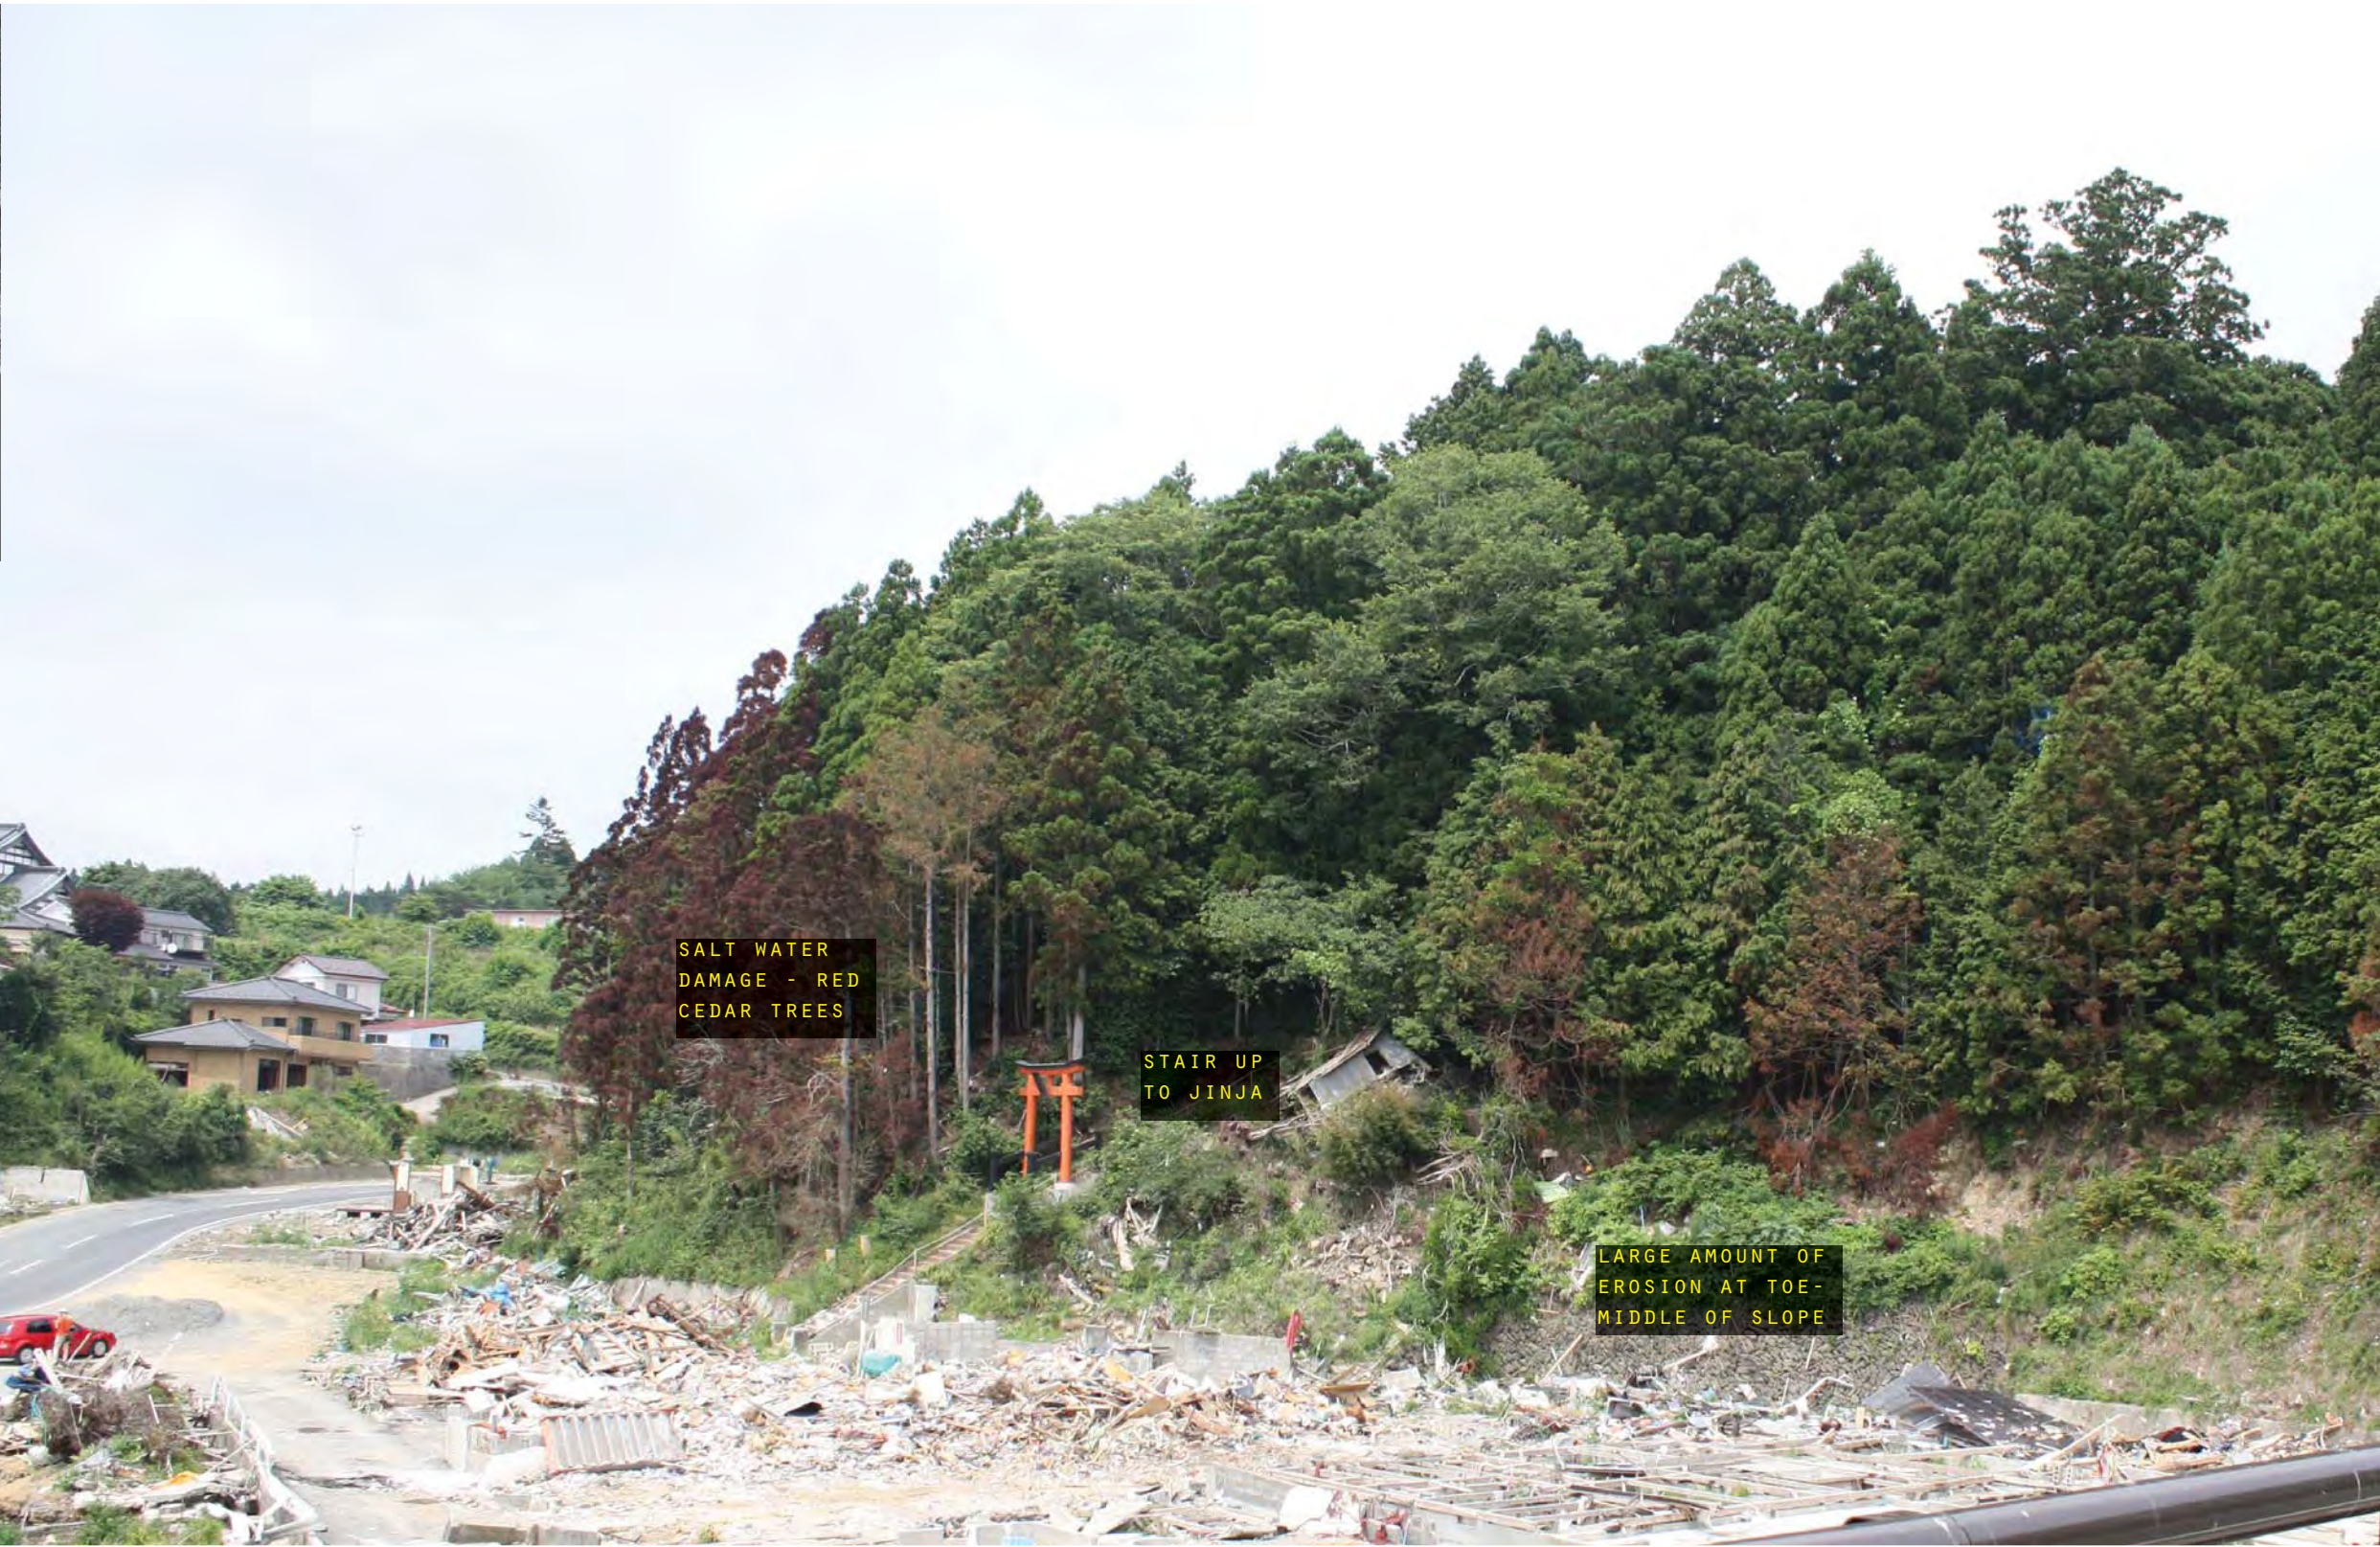
SALT WATER DAMAGE - RED CEDAR TREES

STAIR UP TO JINJA

LARGE AMOUNT OF EROSION AT TOE - MIDDLE OF SLOPE

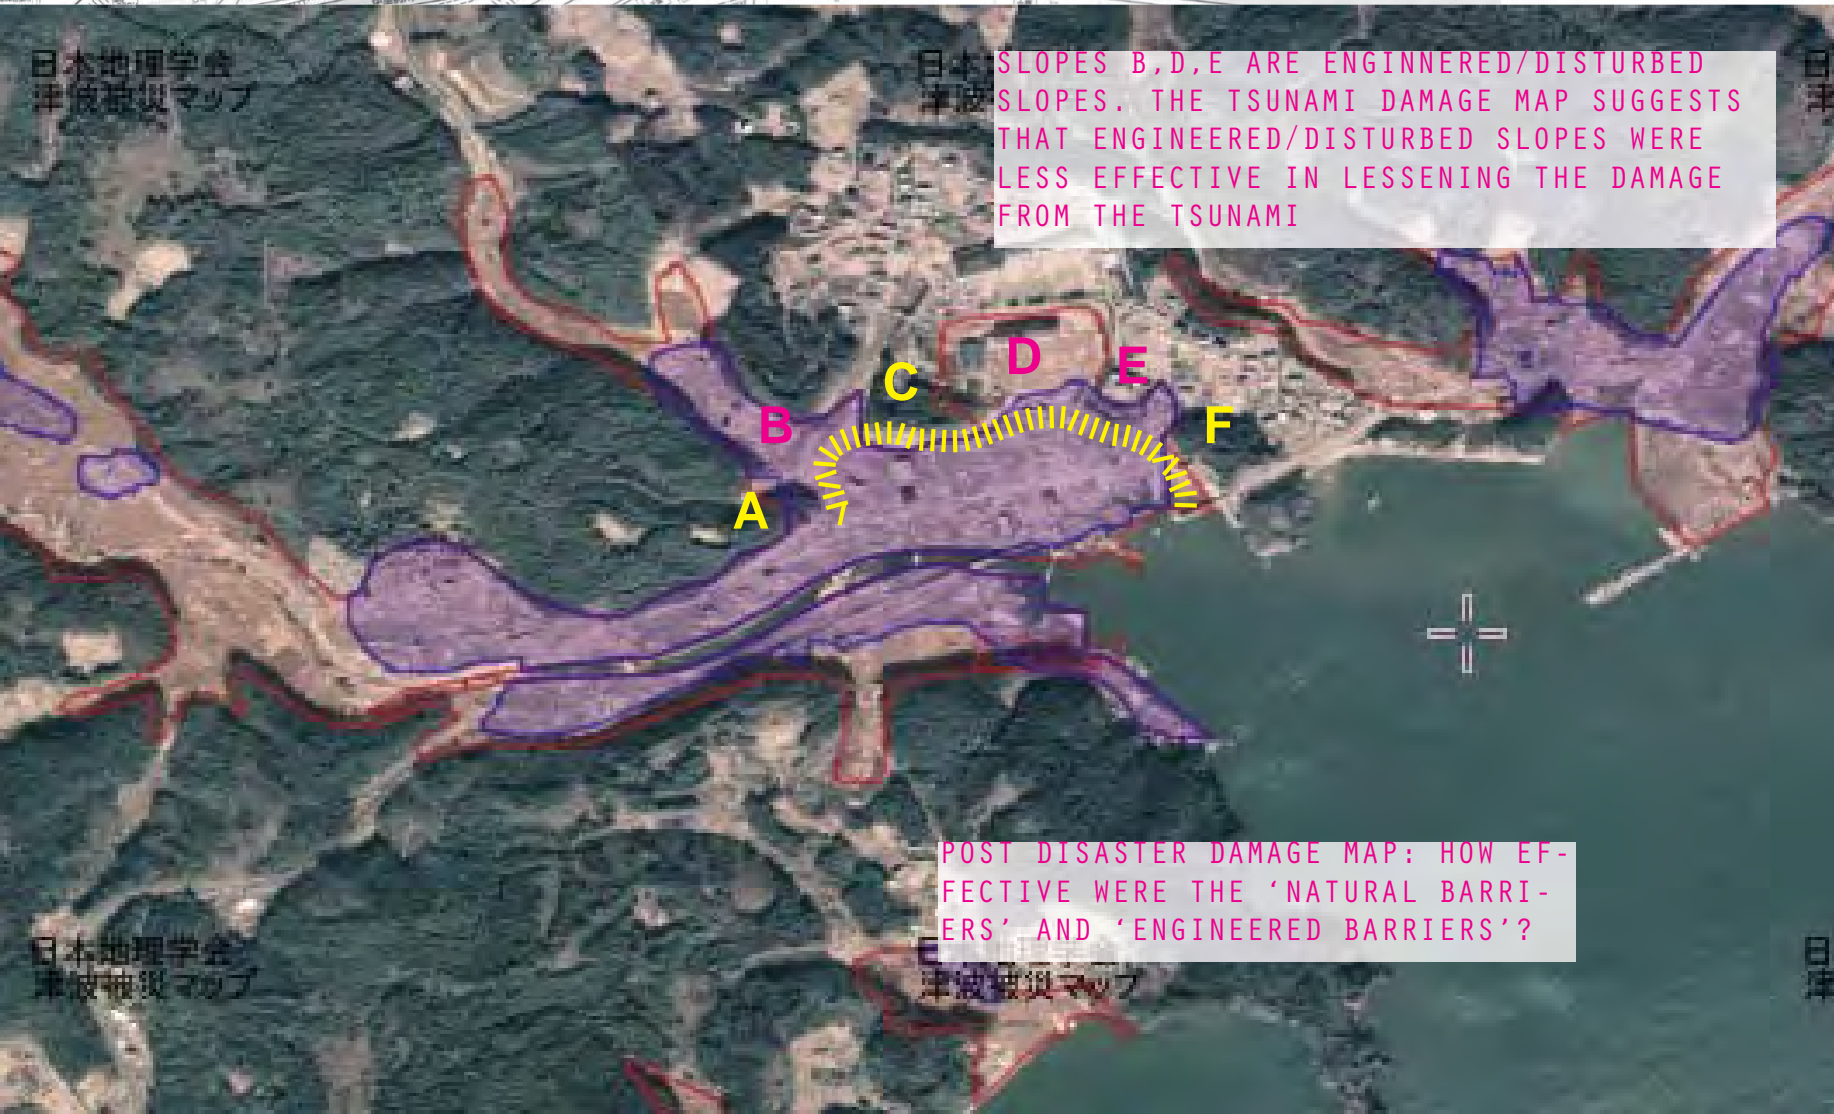
POST DISASTER DAMAGE MAP: HOW EF-
FECTIVE WERE THE 'NATURAL BARRI-
ERS' AND 'ENGINEERED BARRIERS'?

SLOPES B,D,E ARE ENGINEERED/DISTURBED
SLOPES. THE TSUNAMI DAMAGE MAP SUGGESTS
THAT ENGINEERED/DISTURBED SLOPES WERE
LESS EFFECTIVE IN LESSENING THE DAMAGE
FROM THE TSUNAMI

HOWEVER THESE SLOPES CREATED A **FORTRESS** FOR THE UPPER
GROUNDS FROM TSUNAMI INUNDATION. INTERESTING FINDING FROM
THE SITE VISIT WAS THAT DISTURBED SLOPES WERE RELATIVELY
LESS EFFECTIVE IN LESSENING THE DAMAGE FROM THE TSUNAMI.
THE DAMAGE MAP SHOWS THAT THE AREAS BEYOND SLOPES B,D,AND
E WERE ALSO EFFECTED BY TSUNAMI. THESE WERE SLOPES THAT
WERE EITHER ENTIRELY ENGINEERED (SLOPE B- TRAIN STATION
SLOPE), OR DISTURBED (SLOPE D - CUT AND FILLED TO CREATE
RAMPED ACCESS, SLOPE E- SLICED TO CREATE ROAD)

ACTUAL VISIT TO THE SITE SHOWED DIFFERENT READING OF
THE SLOPES. ALMOST ALL SLOPES WERE CUT AT TOE UP TO MID
LEVEL, AND FILLED WITH LAYERED STONE OR CONCRETE. THUS,
SLOPES **WERE NOT ACCESSIBLE** TO BE USED AS EVACUATION
ROUTES. AN ALTERNATIVE USE OF THE ENGINEERED PORTION OF
THE SLOPES (CONCRETE EMBANKMENTS) COULD BE TO USE THE
THICKNESS OF THE WALLS AND OCCUPY THE THICKNESS BY CREAT-
ING RAMPED ACCESS, ETC.
