WEST VALLEY | Utatsu (Minami-Sanriku, Miyagi)

+ TRANSECT | WEST VALLEY

3B / Transects
through the Site

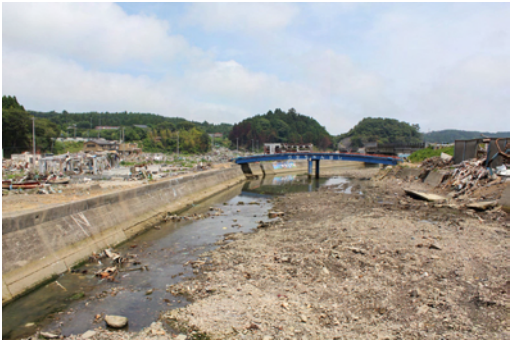
Concrete surface performs badly in keeping water. Comprehensive drainage system is required .

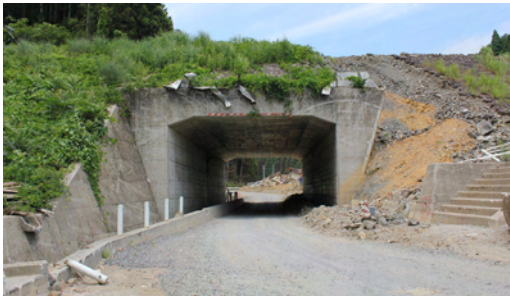
Masonry surface with soil infill reduces the water holding capacity.

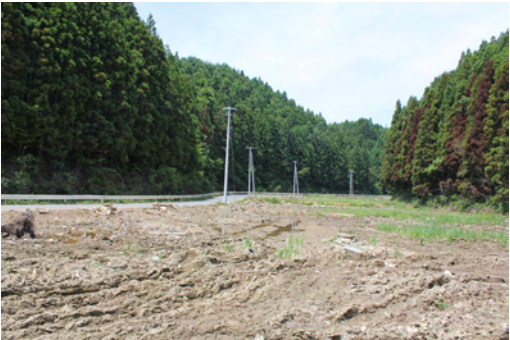
Soil surface has strong water holding capacity.

Due to different in landform and water system, the transect has dramatic difference in term of damages and post-disaster conditions. The area with engineered concrete land surface suffered from most serious damage, However, the cultivated farmlands with soil land in the valley has least damages. One of the reason is the soil surface has better water holding capacity.

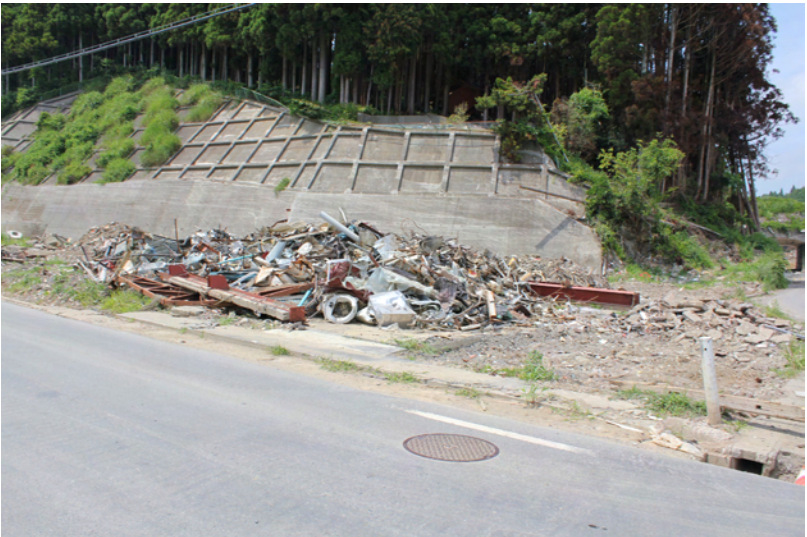
Concrete Retaining : Provides protection to prevent slopes from erosion , but its low wall porosity requires intensive drainage for rain

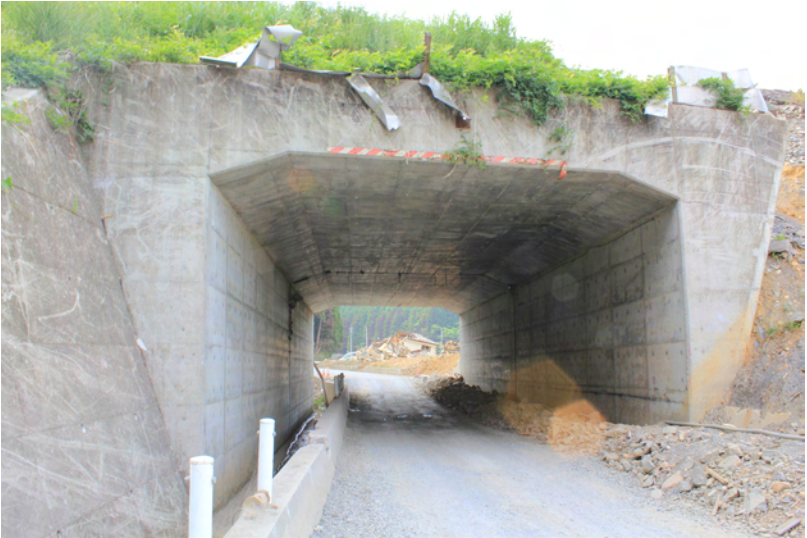
JR underpass: Becomes a by-pass for water when tsuinami came. It created a severe flush with high water velocity.

A catchwater system, about 2 m wide and 1.8 m deep is used to collect rain water from the valley and slope. Due to its materiality of concrete and engineered strength, the damage is minimal. The concrete JR underpass also was preserved well after tsunami.

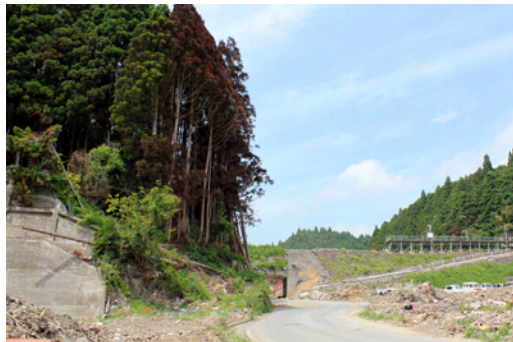
Concrete retainment only protects parts of uphill vegetations

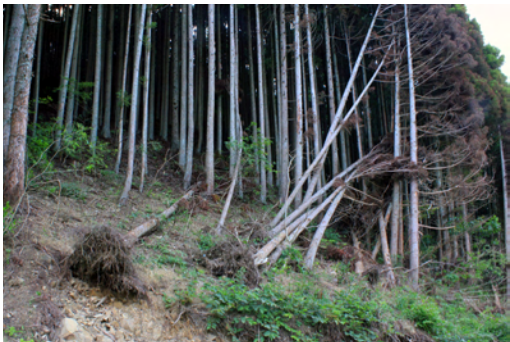
The concrete underpass, below JR, became the weakest point during tsunami, vegetation and trees are seriously damaged by severe flush passing through

The damages and salinations of tress was most seri-
ous nearby the JR embarkment underpass during
the 3.11 tsunami. These damages indicate a direct
connection between the JR embarkment and its
context

Originally, the JR embarkment is engineered strongly as
an infrastructure to support the JR railway. In addition,
it could function as a dike to protect the inland valley.
However, th tide of tsunami came over the JR embark-
ment very much, so proverties behind the embarkment
were totally damaged. Moreover, from the damges
tresses, they reflect the JR underpass was the weakest
point, which suffer strongest impact during tsunami.

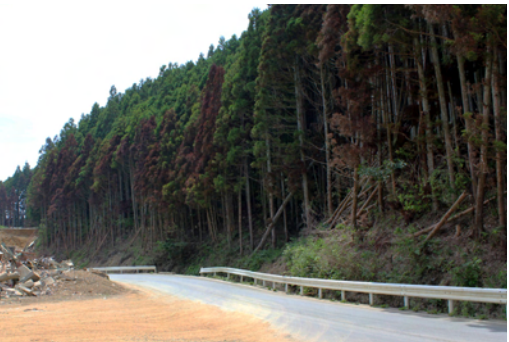
Tree by salinated by seawater

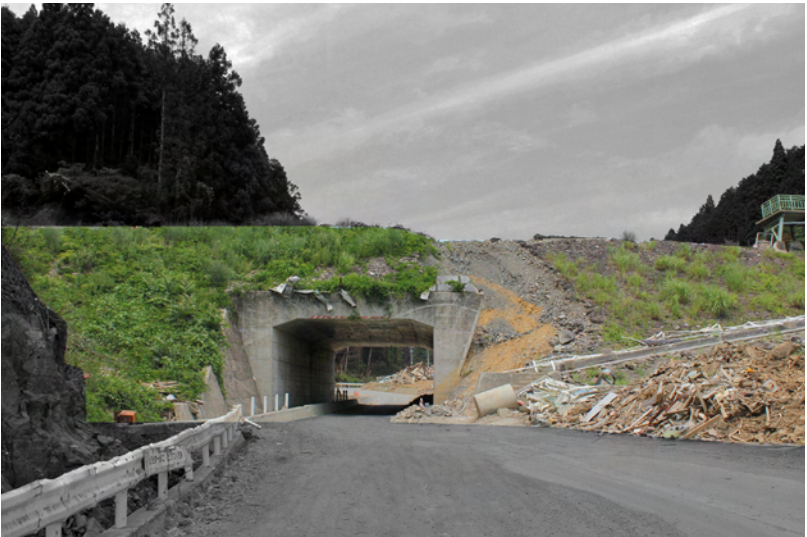
FRONT: Minor erosion happened, the gravel surface is slightly washed out.

The JR embarkment has different extend in term of damages. At the front, the surface was slightly washed out. At the back, serious soil erosion is happened to the embarkment.

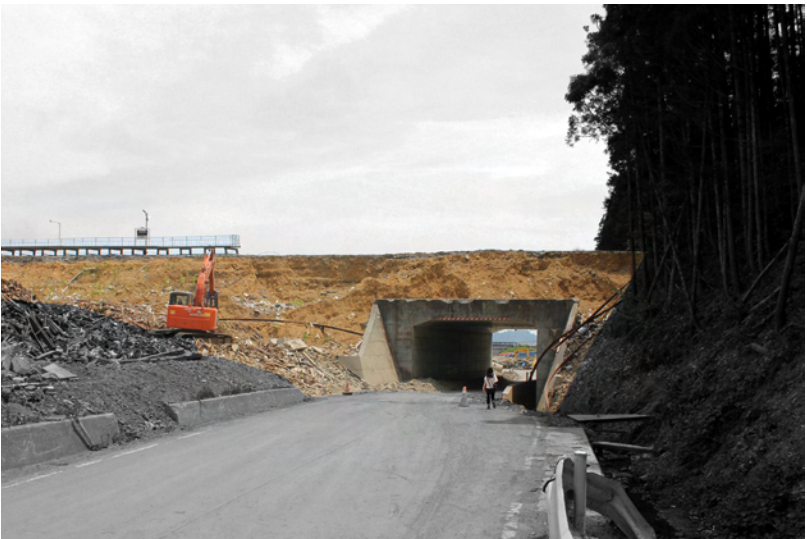
BACK: Serious erosion happened, the embankment surface is totally washed out, the soil infill is exposed.

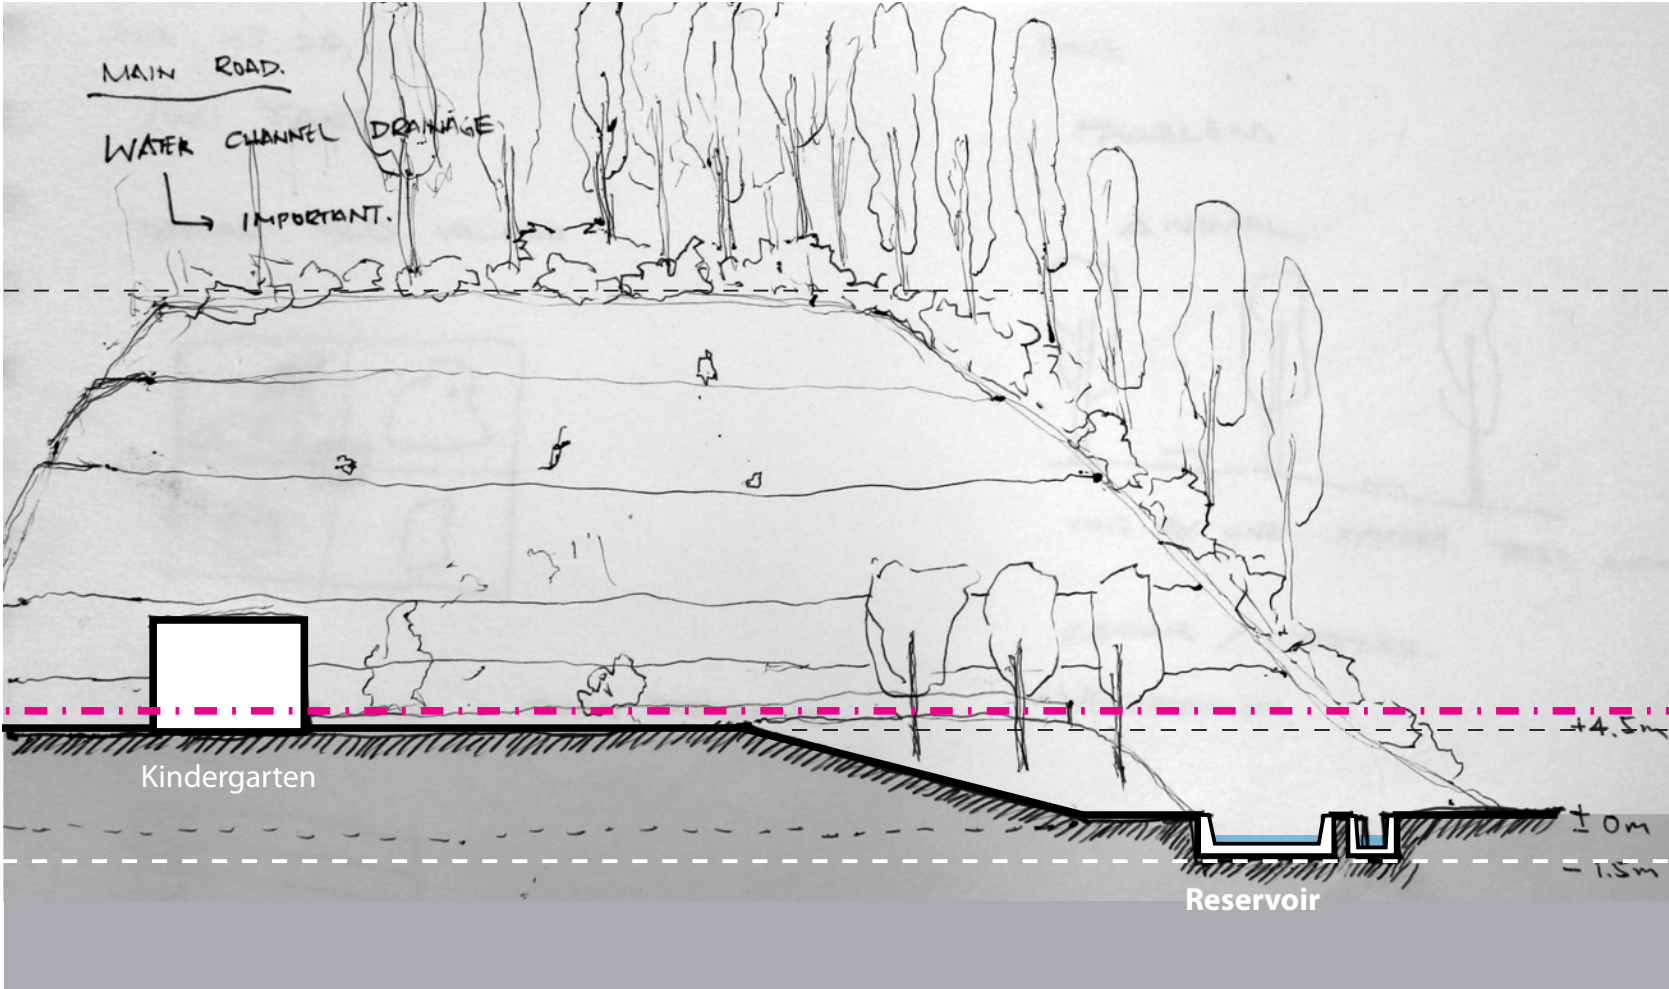
TRANSECT [B] | Kindergarten

Although the kindergarten is located at relatively low altitude place, but due to its geographical condition of its context, it has minimal damage during 3.11 tsunami.

From observation, the kindergarten is located in a small valley, which joins to the major west valley. And the kindergarten is built on top of a podium about four and half meters higher, it became potential protection during the tsunami.
