SITE TRANSECT : **EAST VALLEY ROAD**

3B / Transects through the Site

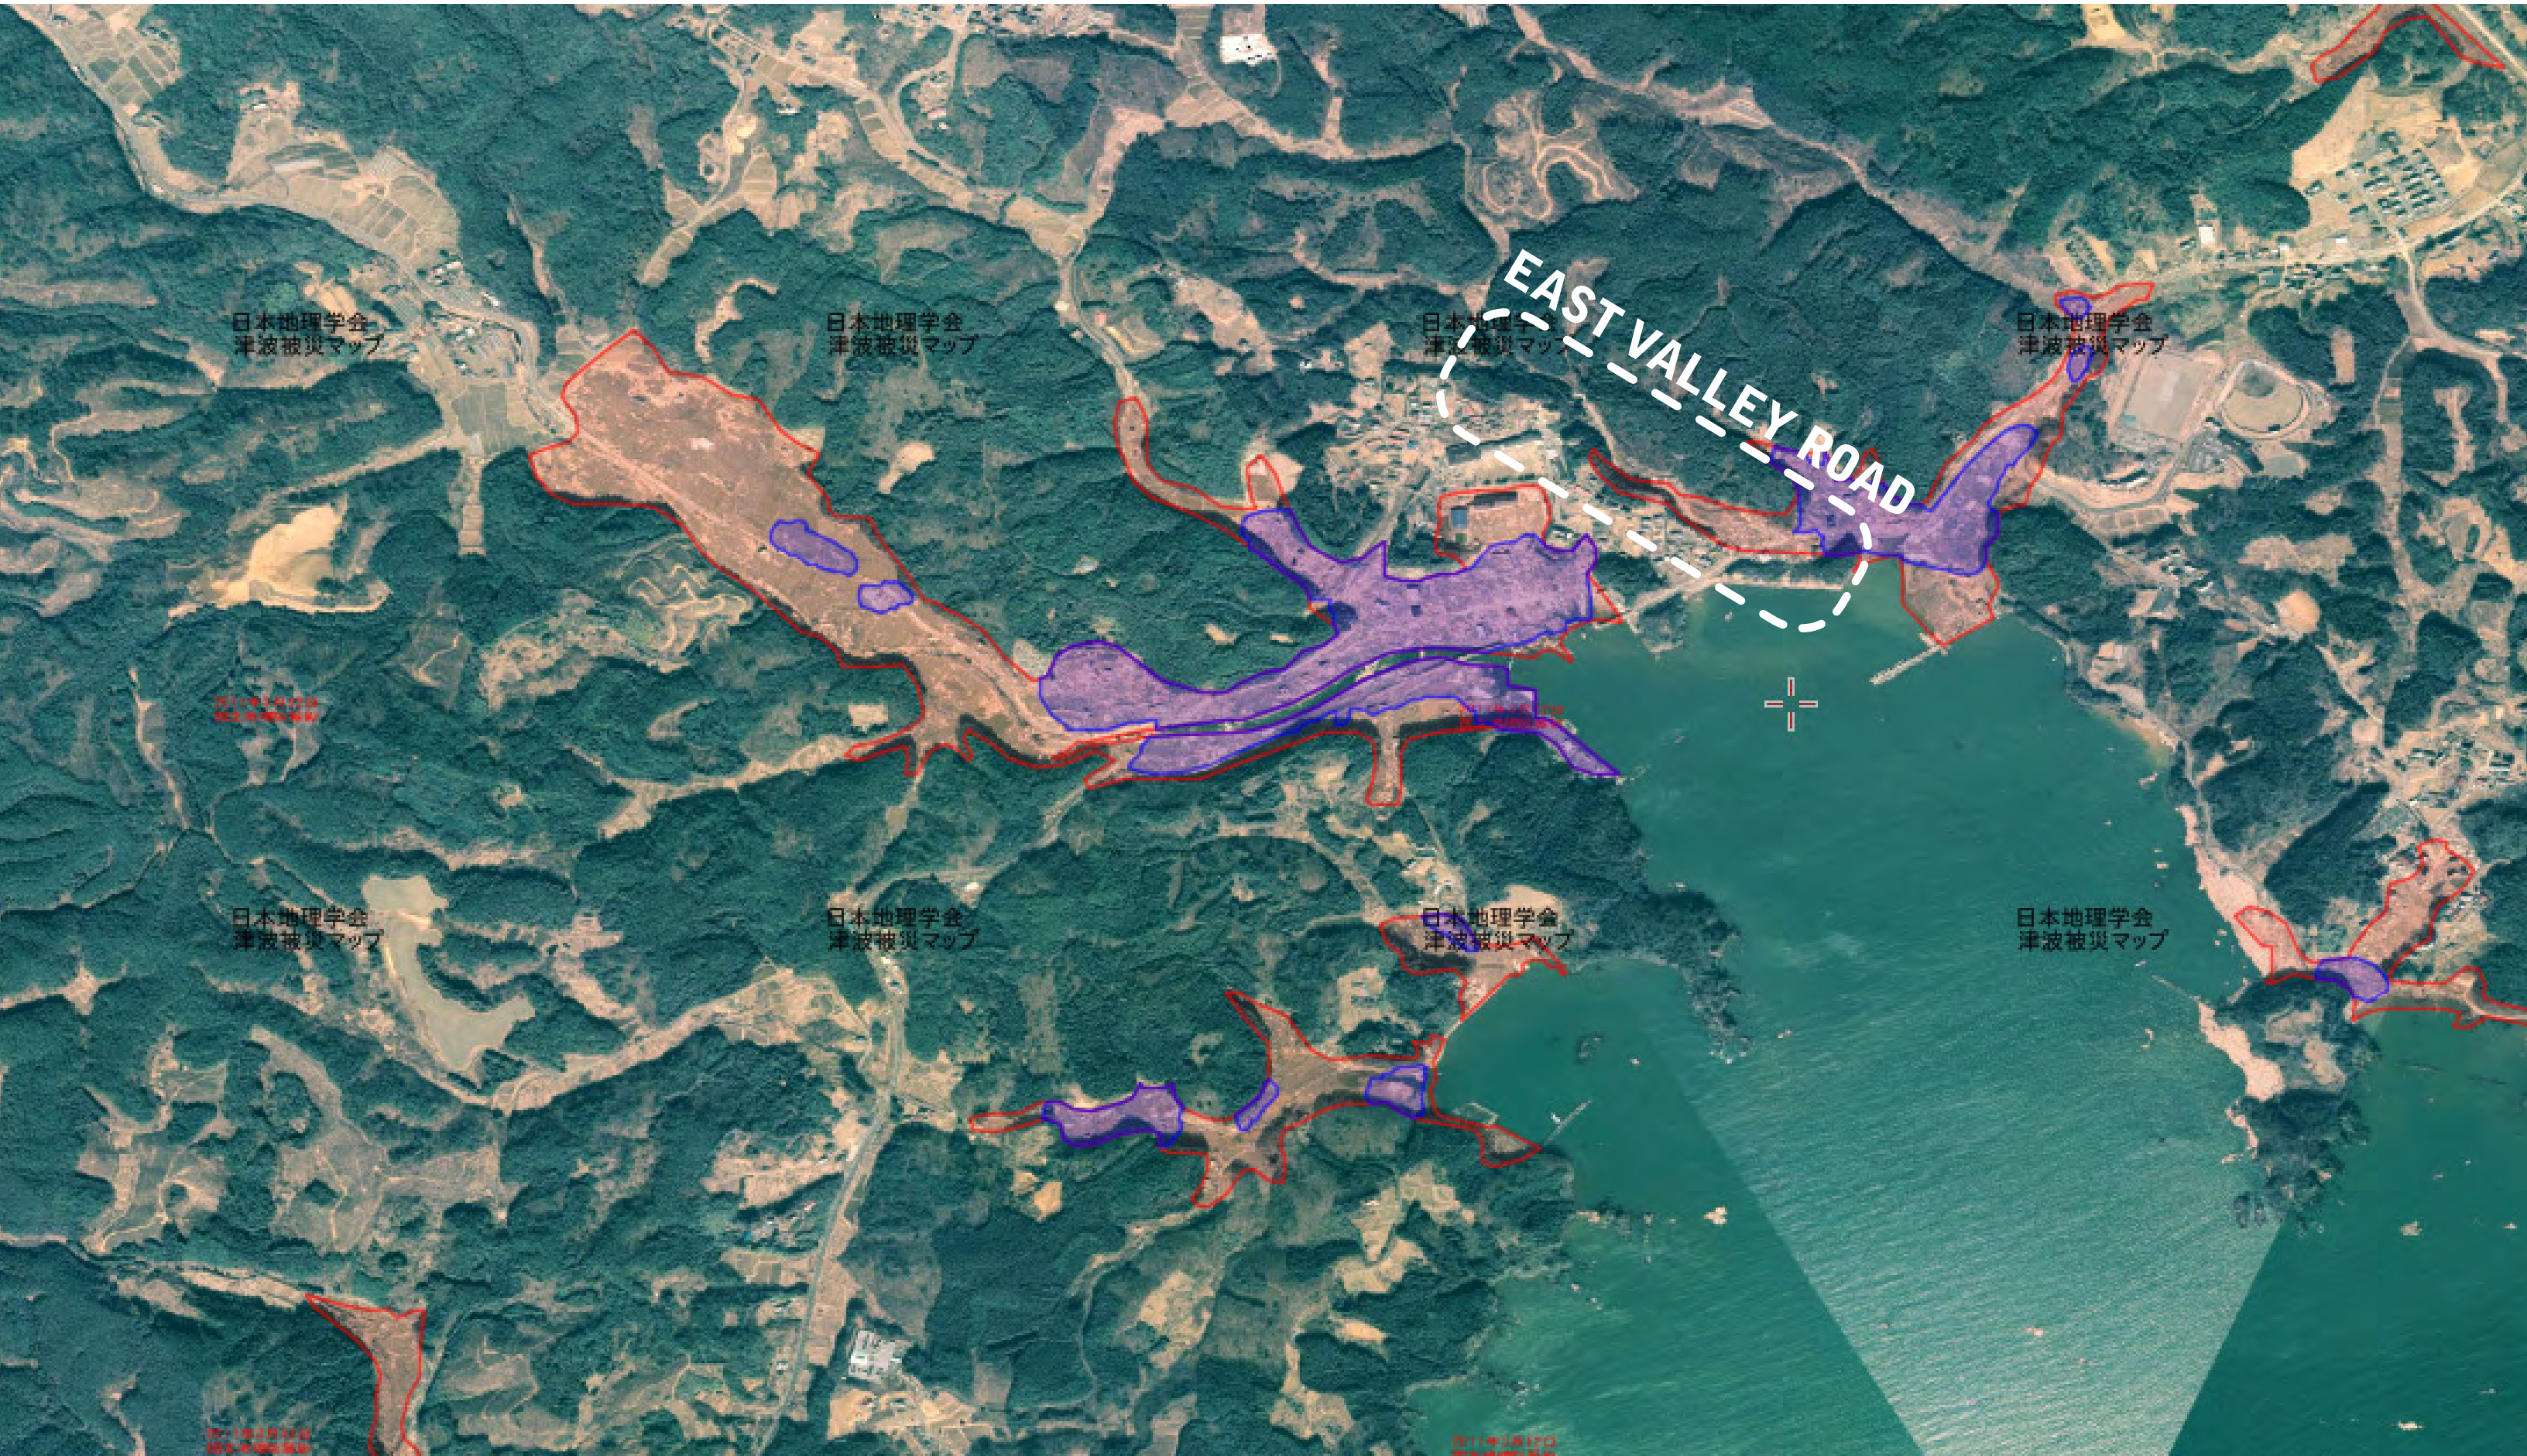
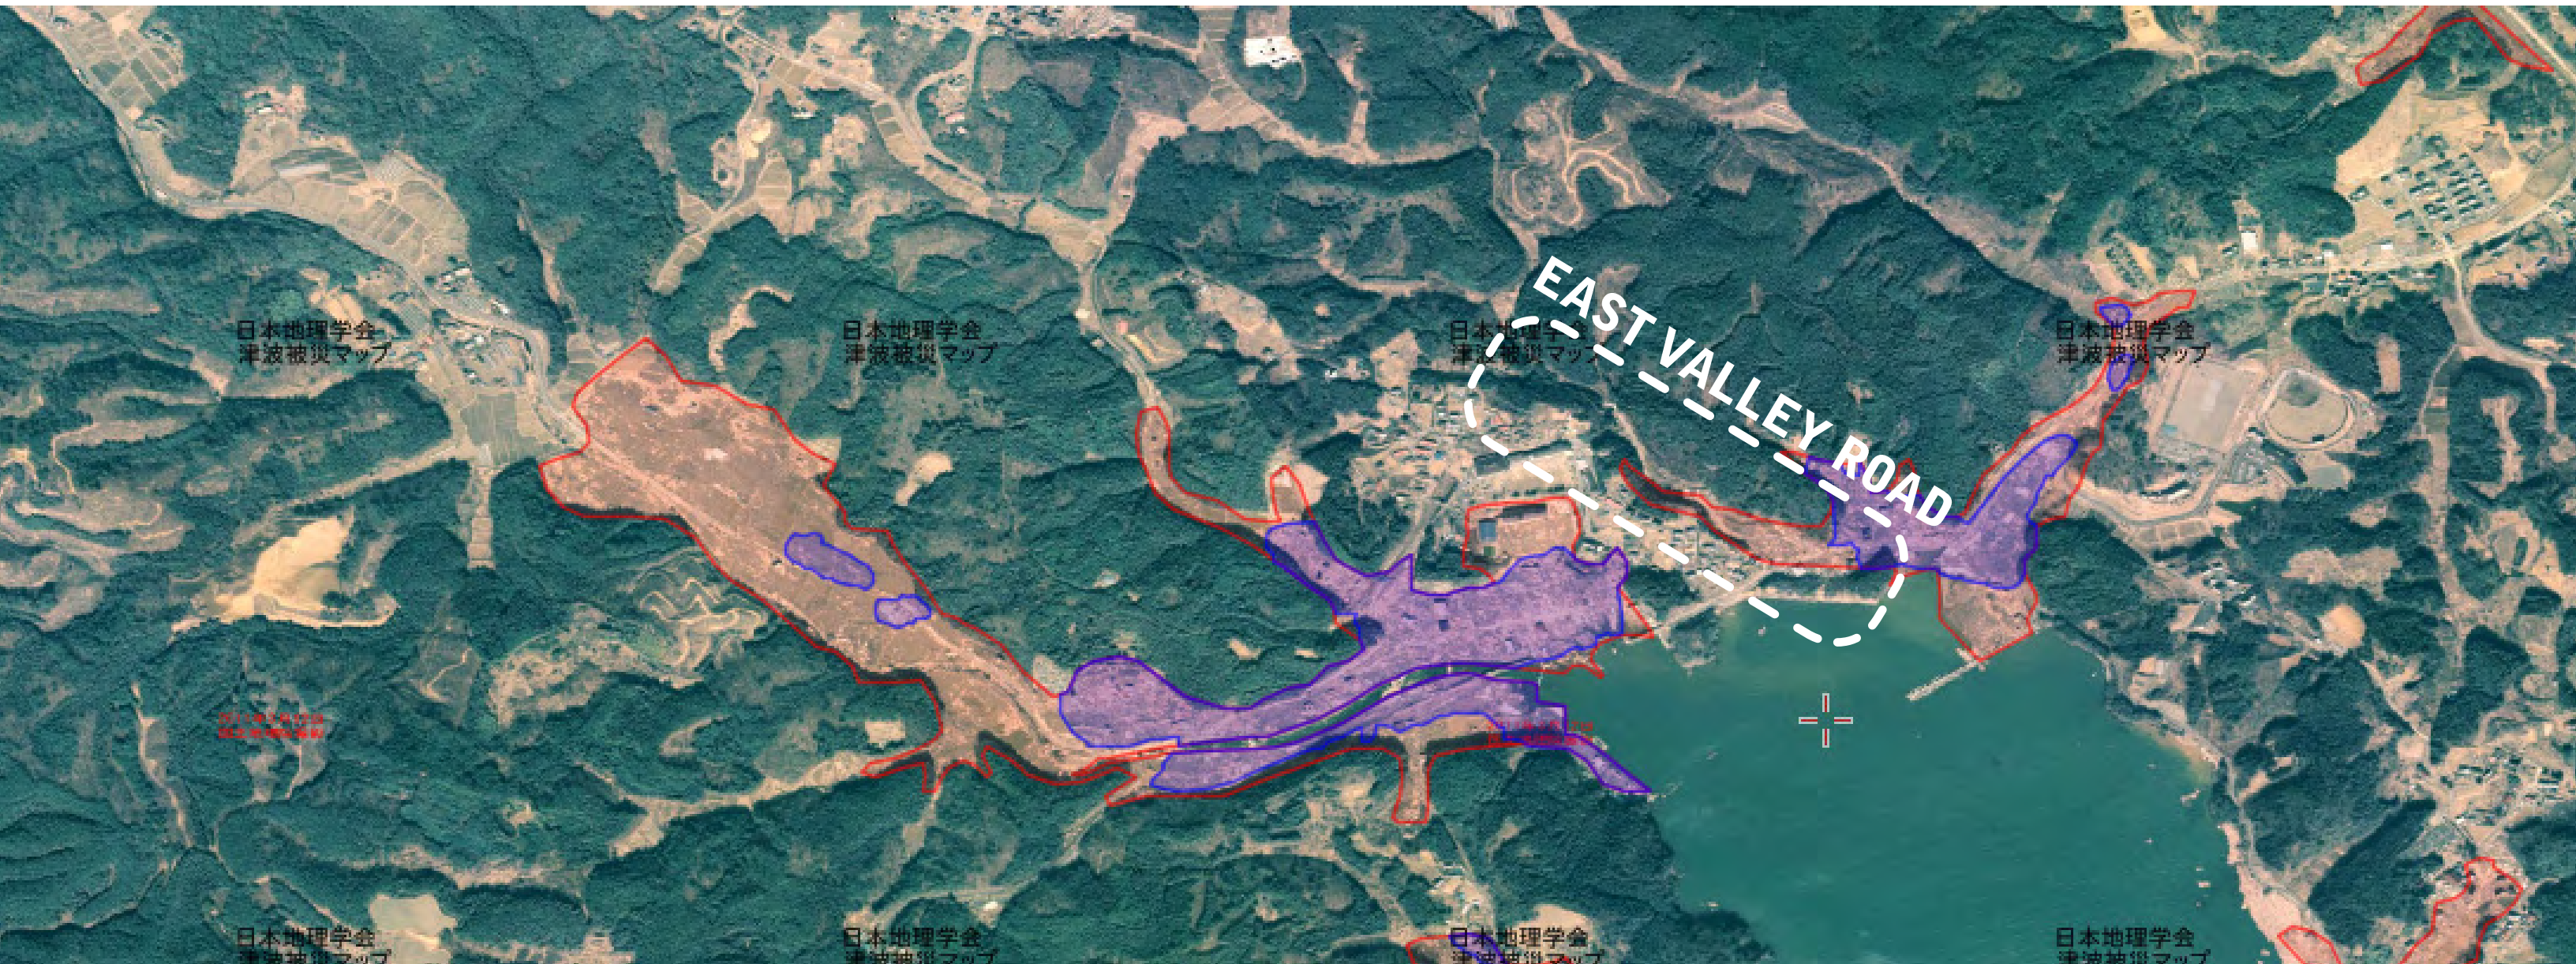
The East Valley Road transect runs SE to NW on the East Side of the Ishotomae Area of the town of Utatsu, Japan. About 600m long (though the entire length is ~2000m) and fluctuating between ~40-60m wide, the road is essentially a shallow valley (with a ~1-5 degree incline) flanked by ~30-45 degree slopes with scalable walls of ~40m on either side, heavily forested with ~20m tall Cedar and other various deciduous trees, and small scale underbrush.

Eight single/double storey residential (?) building foundations remain on this transect. All structures above foundations have been completely destroyed. Two single/double storey commercial (?) building foundations remain. All structures above foundations have been completely destroyed.

Man-made concrete drainage infrastructure. ~3m tall x 2m wide cross section, with smaller tributaries from hills above. Drainage is all intact.

Above-ground power lines remain with minimal damage.

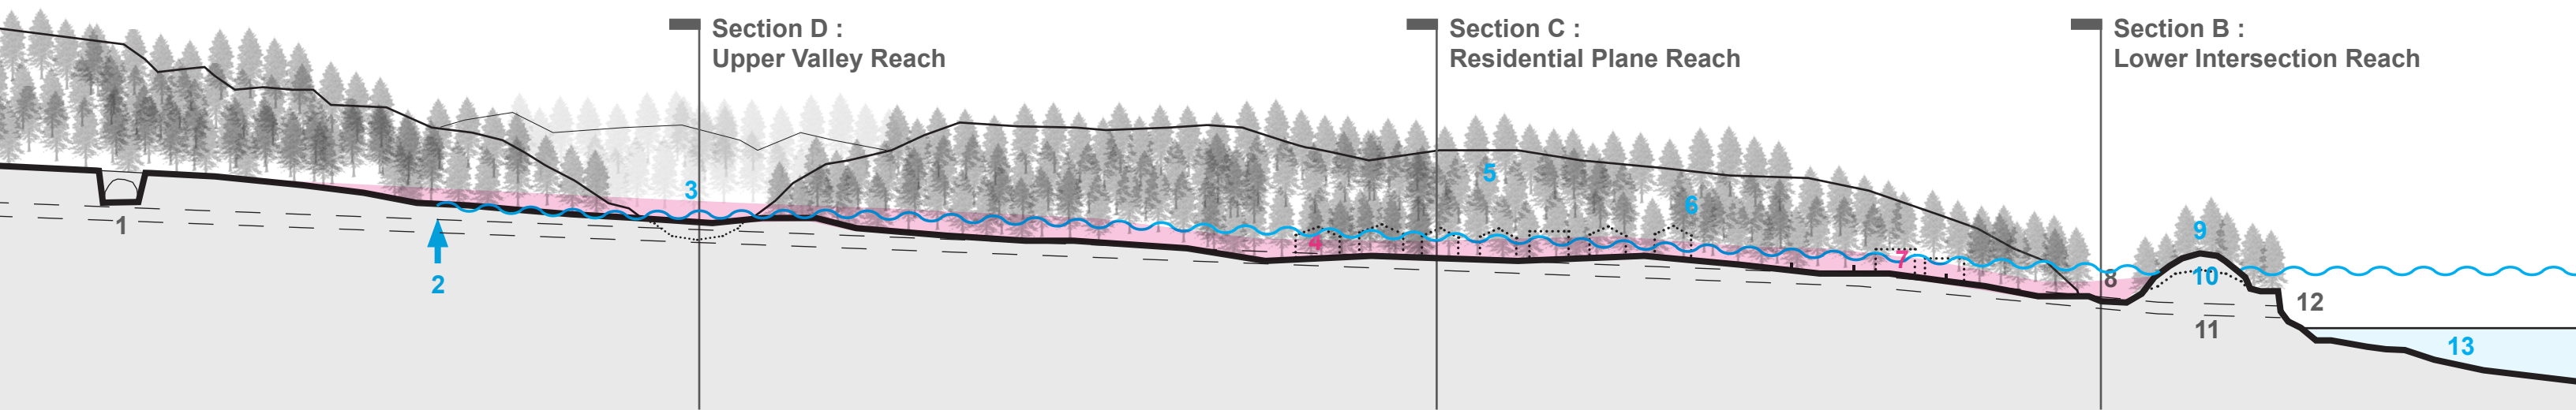
SECTION A : LONGITUDINAL EAST VALLEY
LOOKING NORTHEAST

- 1 Japan-Rail Tunnel
- 2 Tsunami High Water / Debris Mark
- 3 Connecting Valley / Ravine (Beyond)
- 4 Demolished Residential Buildings
- 5 Slopes with Planted Cedar Forests
- 6 Scalable 30-45° Slopes
- 7 Demolished Commercial
- 8 Highway Bypass
- 9 Natural Embankment / Tsunami Barrier

- 10 Partial Failure of Natural Barrier (Dashed)
- 11 Concrete Drainage
- 12 Concrete Tsunami Barrier (6m)
- 13 Pacific Ocean

The East Valley Road transect runs SE to NW on the East Side of the Ishotomae Area of the town of Utatsu, Japan. About 600m long (though the entire length is ~2000m) and fluctuating between ~40-60m wide, the road is essentially a shallow valley (with a ~1-5 degree incline) flanked by ~30-45 degree slopes with scalable walls of ~40m on either side, heavily forested with ~20m tall Cedar and other various deciduous trees, and small scale underbrush.

Eight single/double storey residential (?) building foundations remain on this transect. All structures above foundations have been completely destroyed. Two single/double storey commercial (?) building foundations remain. All structures above foundations have been completely destroyed.

Man-made concrete drainage infrastructure. ~3m tall x 2m wide cross section, with smaller tributaries from hills above. Drainage is all intact.

Above-ground power lines remain with minimal damage.

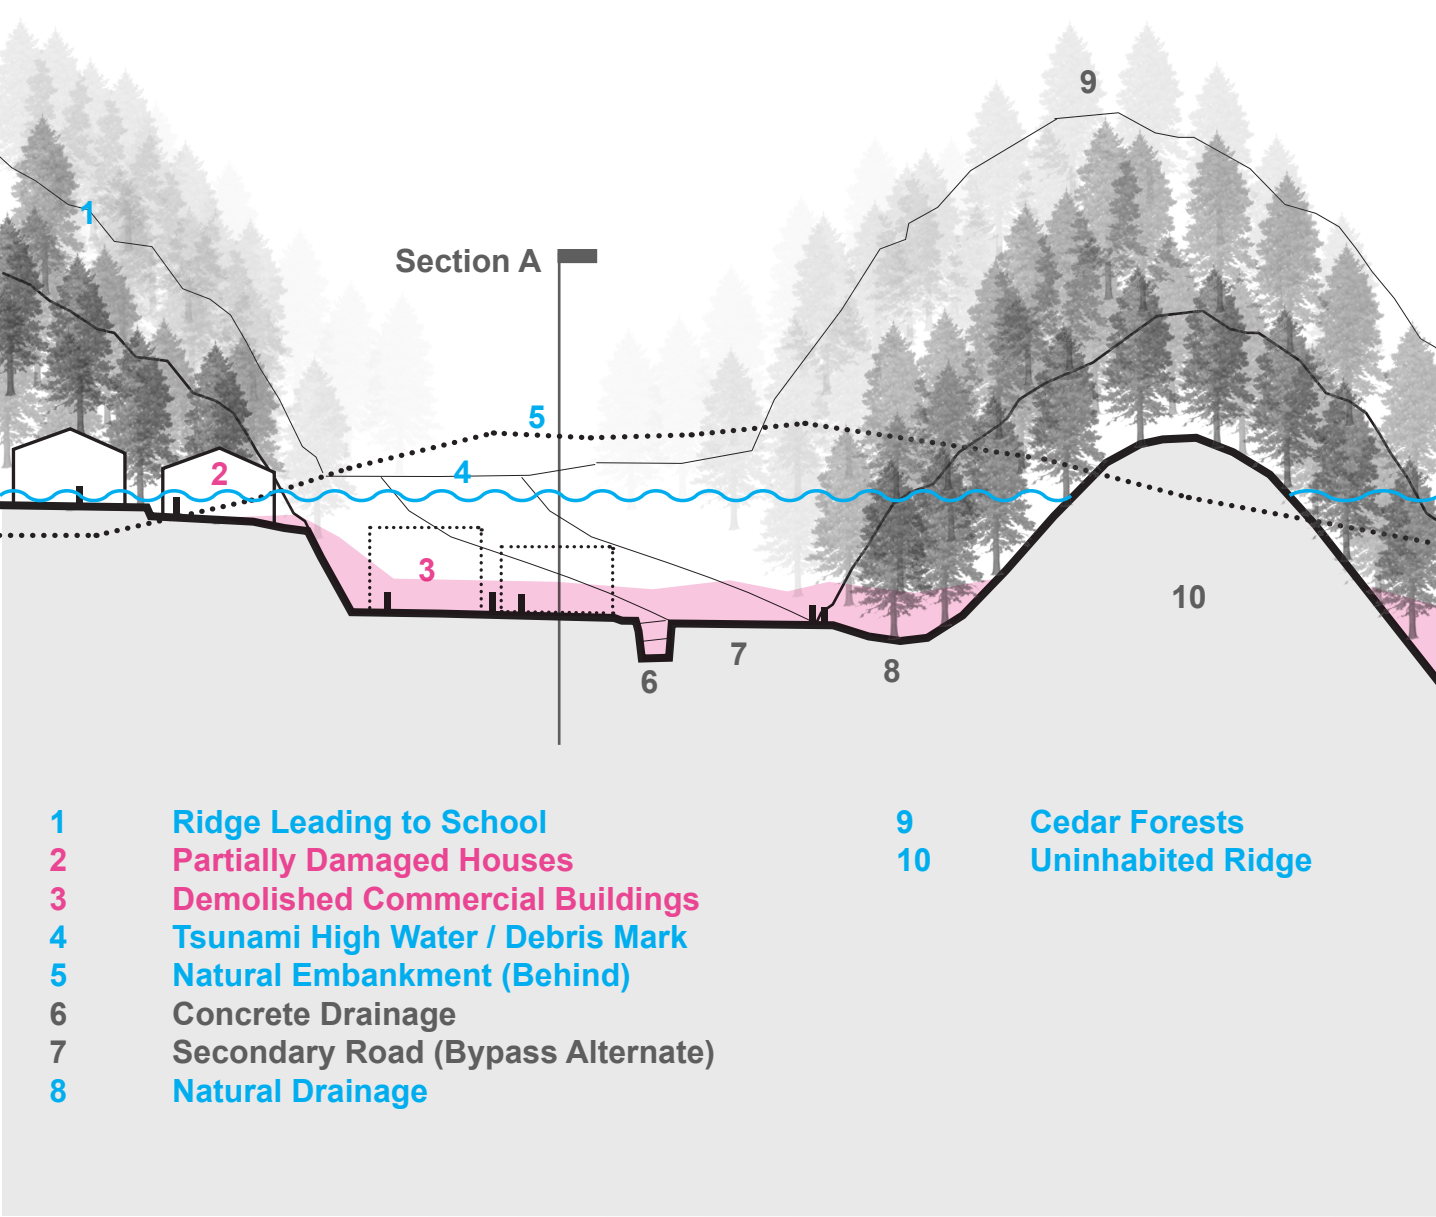
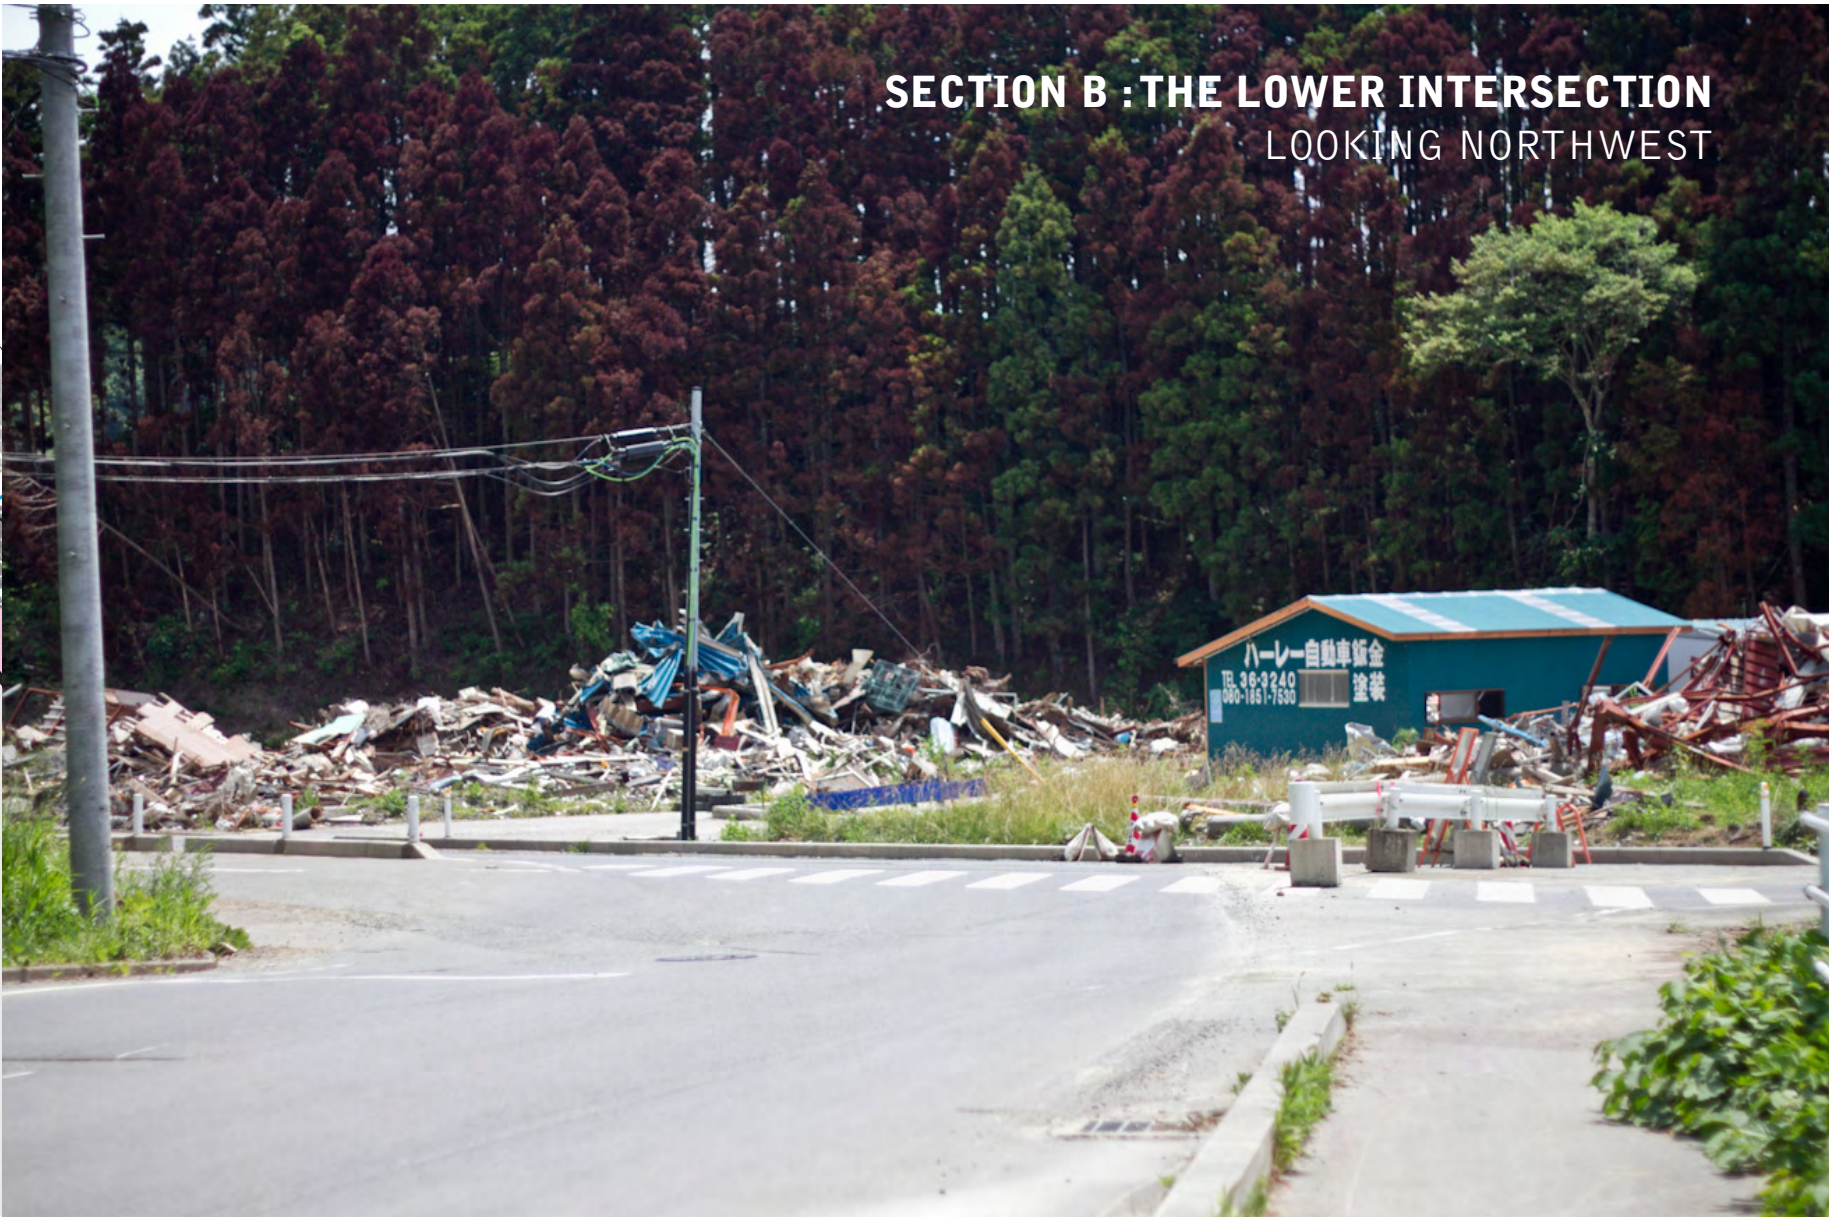
SECTION B : THE LOWER INTERSECTION
LOOKING NORTHWEST

The East Valley Road transect runs SE to NW on the East Side of the Ishotomae Area of the town of Utatsu, Japan. About 600m long (though the entire length is ~2000m) and fluctuating between ~40-60m wide, the road is essentially a shallow valley (with a ~1-5 degree incline) flanked by ~30-45 degree slopes with scalable walls of ~40m on either side, heavily forested with ~20m tall Cedar and other various deciduous trees, and small scale underbrush.

Eight single/double storey residential (?) building foundations remain on this transect. All structures above foundations have been completely destroyed. Two single/double storey commercial (?) building foundations remain. All structures above foundations have been completely destroyed.

Man-made concrete drainage infrastructure. ~3m tall x 2m wide cross section, with smaller tributaries from hills above. Drainage is all intact.

Above-ground power lines remain with minimal damage.

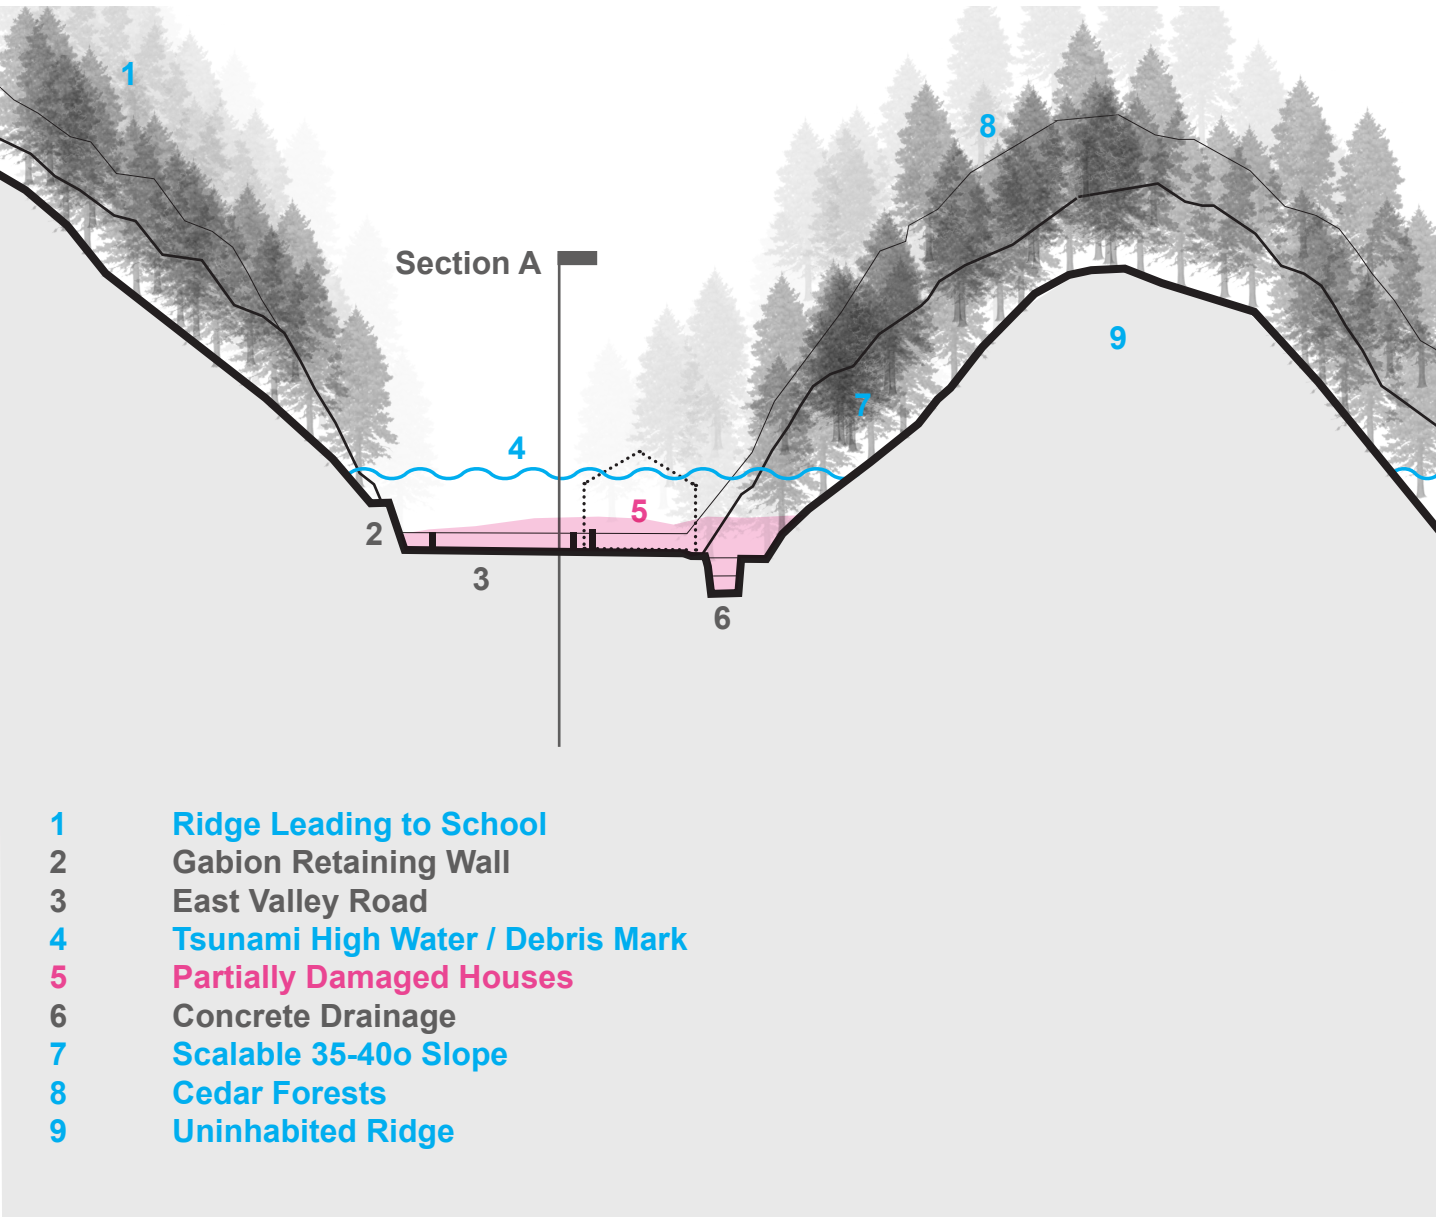
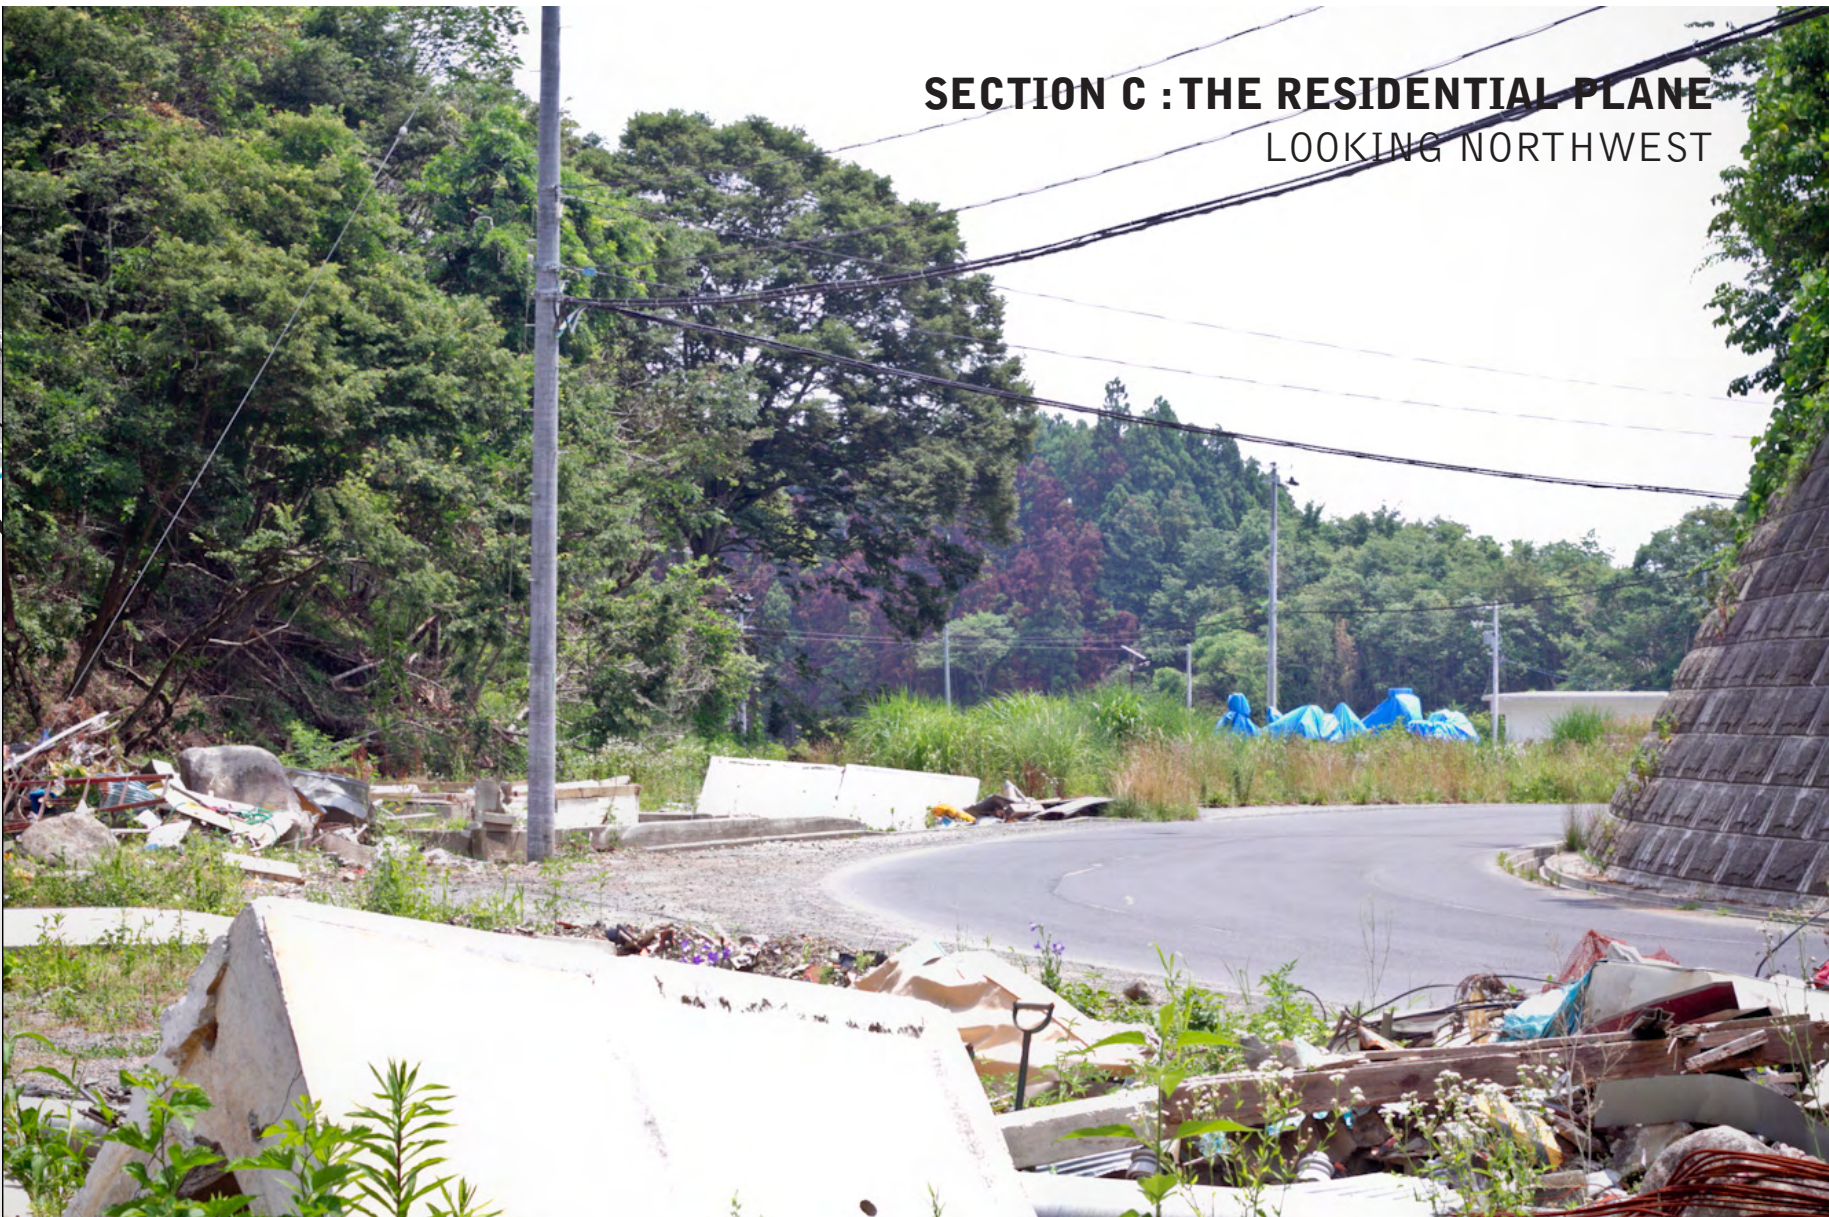
SECTION C : THE RESIDENTIAL PLANE
LOOKING NORTHWEST

The East Valley Road transect runs SE to NW on the East Side of the Ishotomae Area of the town of Utatsu, Japan. About 600m long (though the entire length is ~2000m) and fluctuating between ~40-60m wide, the road is essentially a shallow valley (with a ~1-5 degree incline) flanked by ~30-45 degree slopes with scalable walls of ~40m on either side, heavily forested with ~20m tall Cedar and other various deciduous trees, and small scale underbrush.

Eight single/double storey residential (?) building foundations remain on this transect. All structures above foundations have been completely destroyed. Two single/double storey commercial (?) building foundations remain. All structures above foundations have been completely destroyed.

Man-made concrete drainage infrastructure. ~3m tall x 2m wide cross section, with smaller tributaries from hills above. Drainage is all intact.

Above-ground power lines remain with minimal damage.
