This site is the street from the gate of junior high school to coast. It is gradually declining from north-west to south-east.

Walking down the slope, I found a clear boundary of tsunami damage. In higher area, building has no damage and people can live as usual. On the other hand, in lower area, the most of houses are heavily damaged and they are not available without repair.

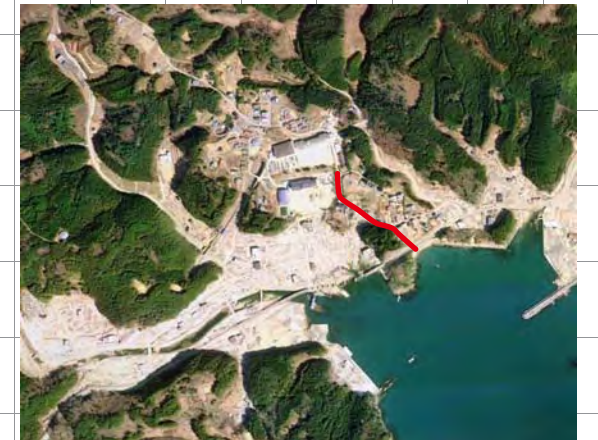
(A to B)
From the gate of junior high school to the entrance of slope. The street is almost flat. Traces of tsunami damages are not found.

(B to C)
From the entrance to the bottom of slope. Ground level is declining. 5 or 6 houses are built along the street. Firstly, traces of tsunami damages are not found and people living here. However, stepping across a line, heavily damaged houses are shown up. The insides of damaged houses are completely destroyed and they are not available anymore.

(C to D)
From the bottom of slope to coast. Ground level is climbing a little and declining again. At the end this street meets coast. There are some houses facing to sea. The 1st floor parts of buildings are heavily damaged. One of them has been already repaired.
