SLOPES OF UTATSU

UTATSU IS SURROUNDED BY MOUNDS ON THREE SIDES AND BORDERED BY SEA. WATER CANAL AND ELEVATED HIGHWAY CUTS ACROSS THE SOUTHERN BORDER OF UTATSU. THIS ANALYSIS LOOKS AT THE SLOPES ON THE NORTHERN SIDE, WHICH ACTED AS NATURAL BARRIERS TO THE 3.11 TSUNAMI.

SLOPES OF UTATSU - FINDINGS FROM THE VISIT

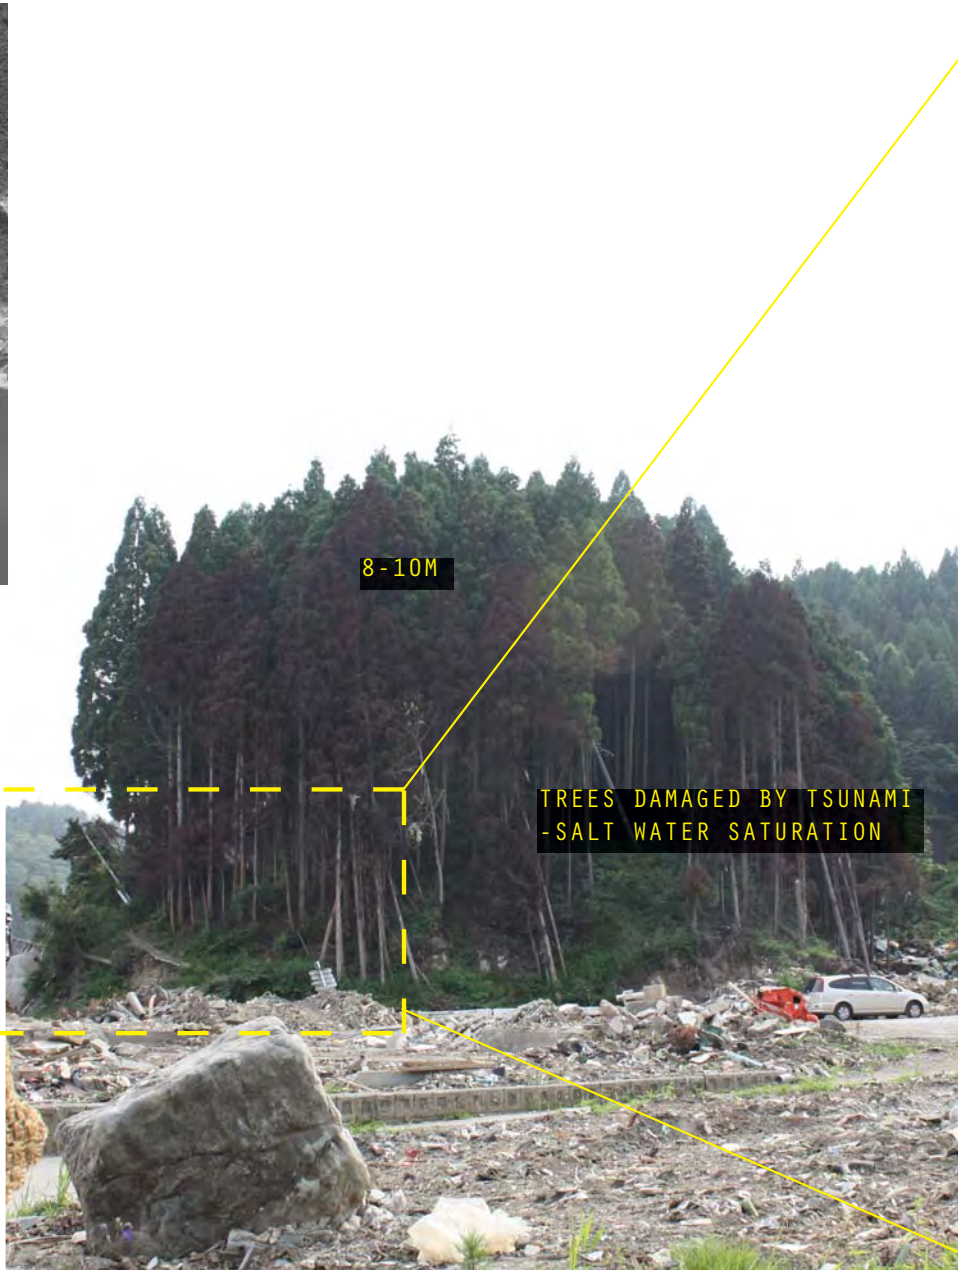
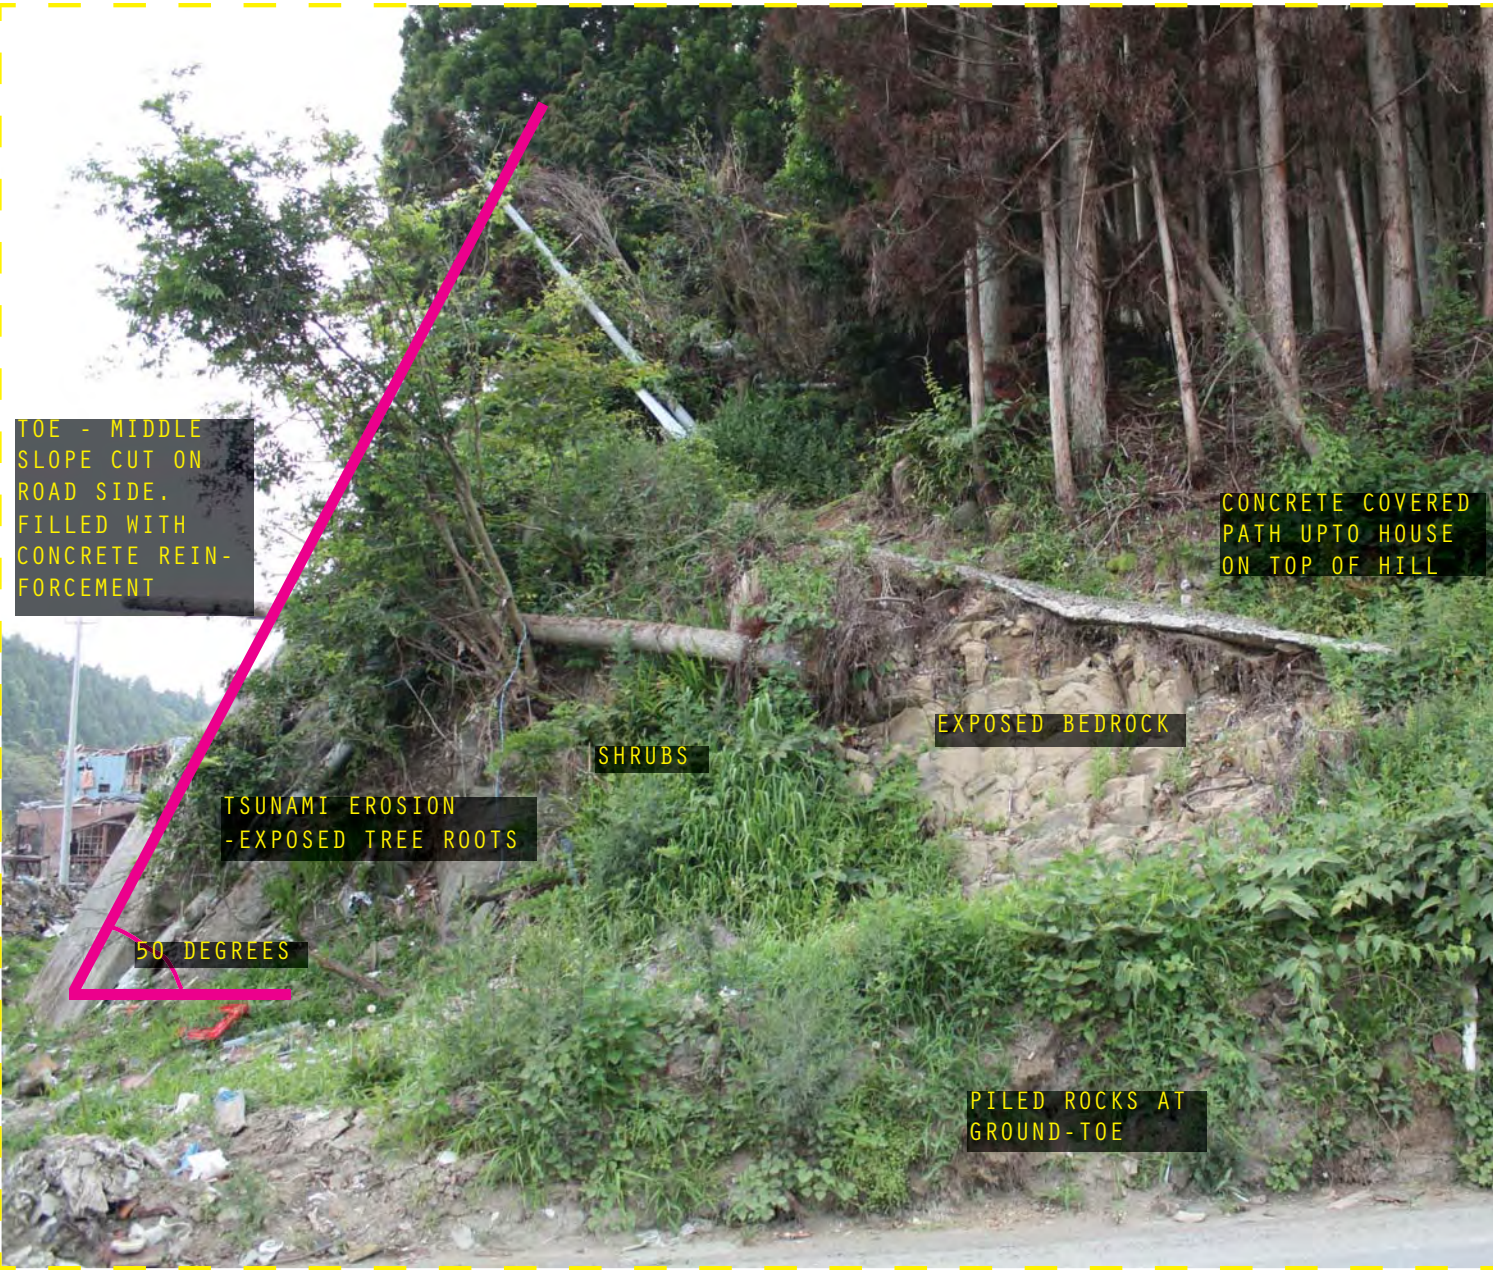
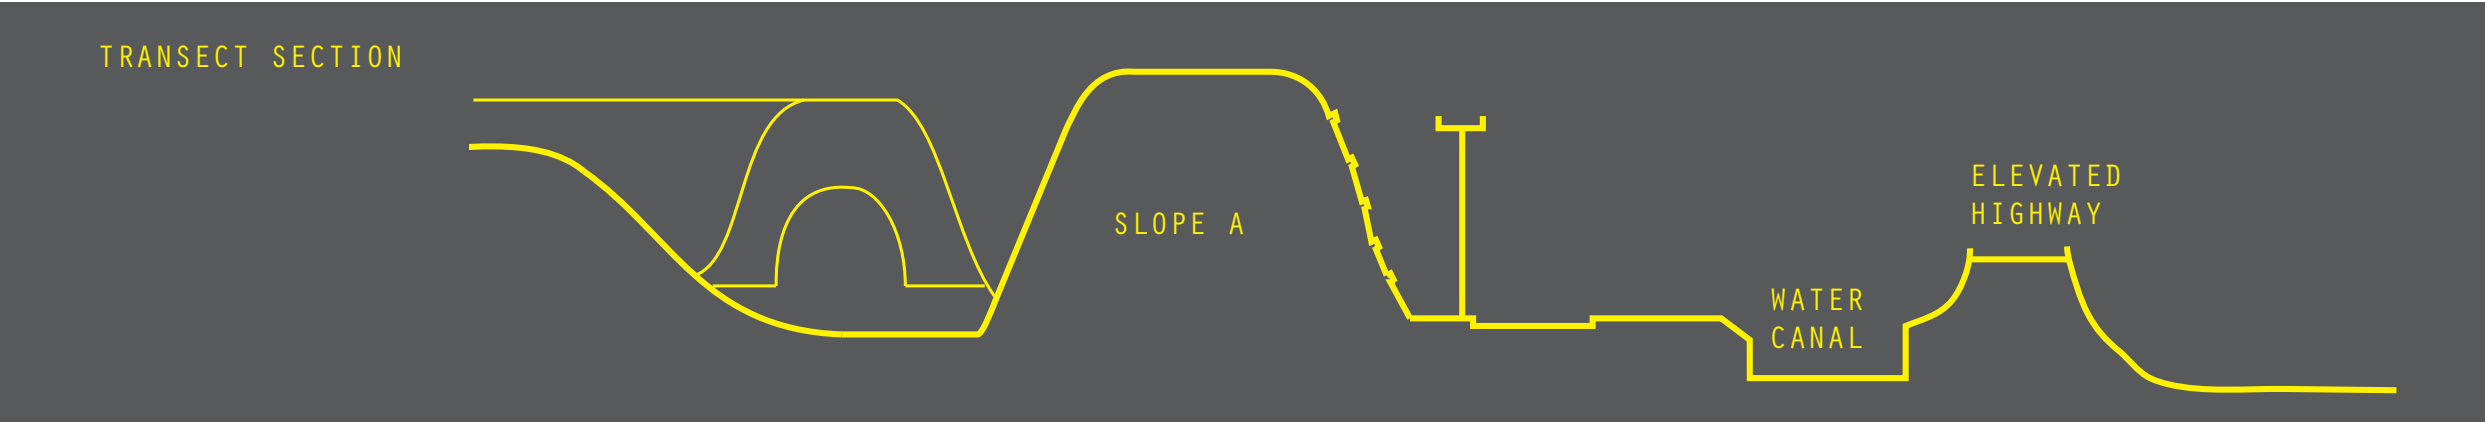
SLOPE A - CEDAR TREE MOUND BY ENTRY ROAD TO UTATSU

TREES DAMAGED BY SALT WATER, UP-ROOTED TREES

CONCRETE REINFORCEMENT, CONCRETE COVERED PATH, PILED STONE AT TOE,

50 DEGREES SLOPE

8-10M

CUT ON ROAD SIDE

SLIGHT EROSION ON SIDES

EXPOSED BEDROCK

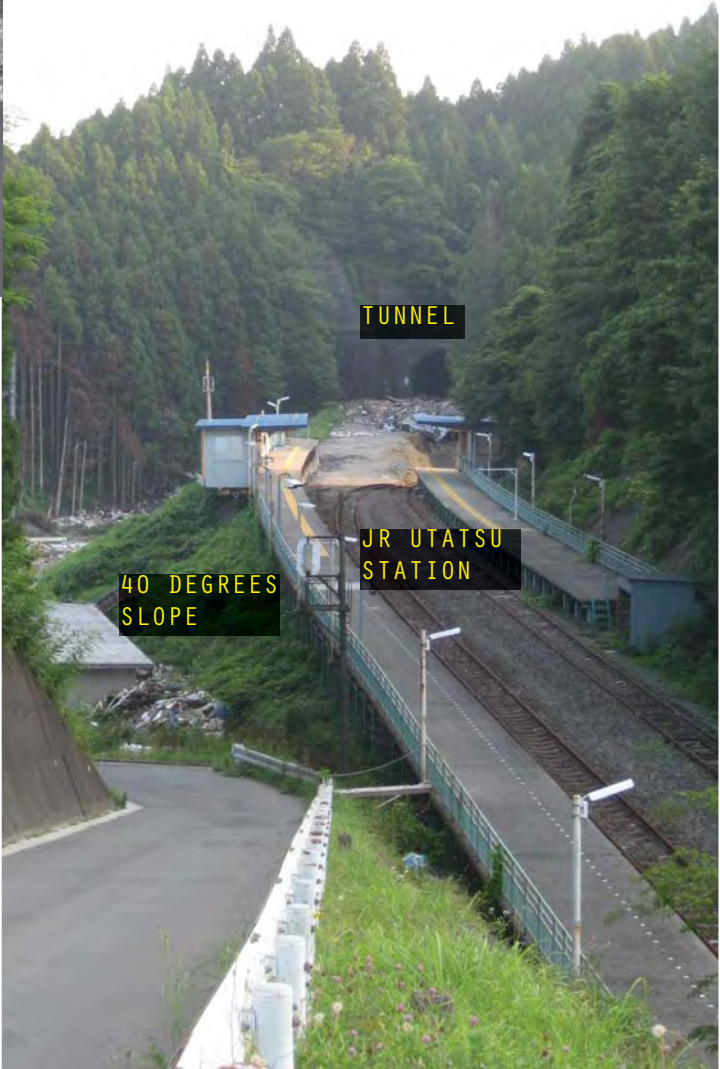
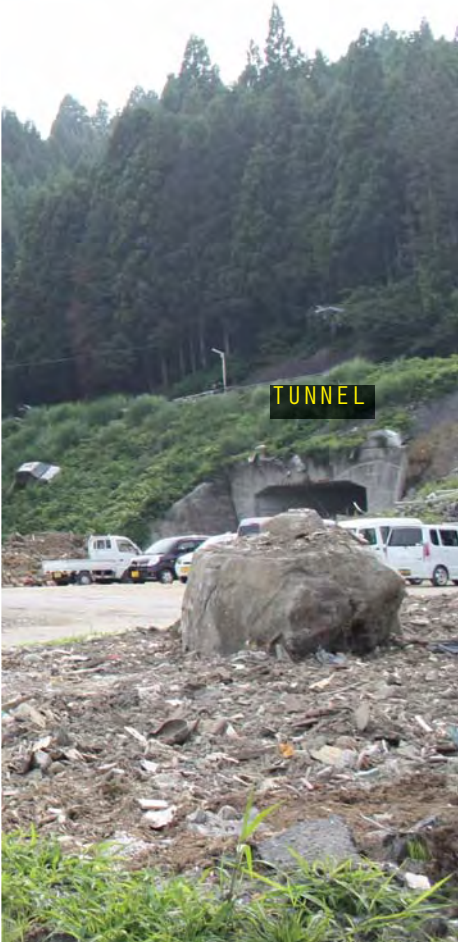
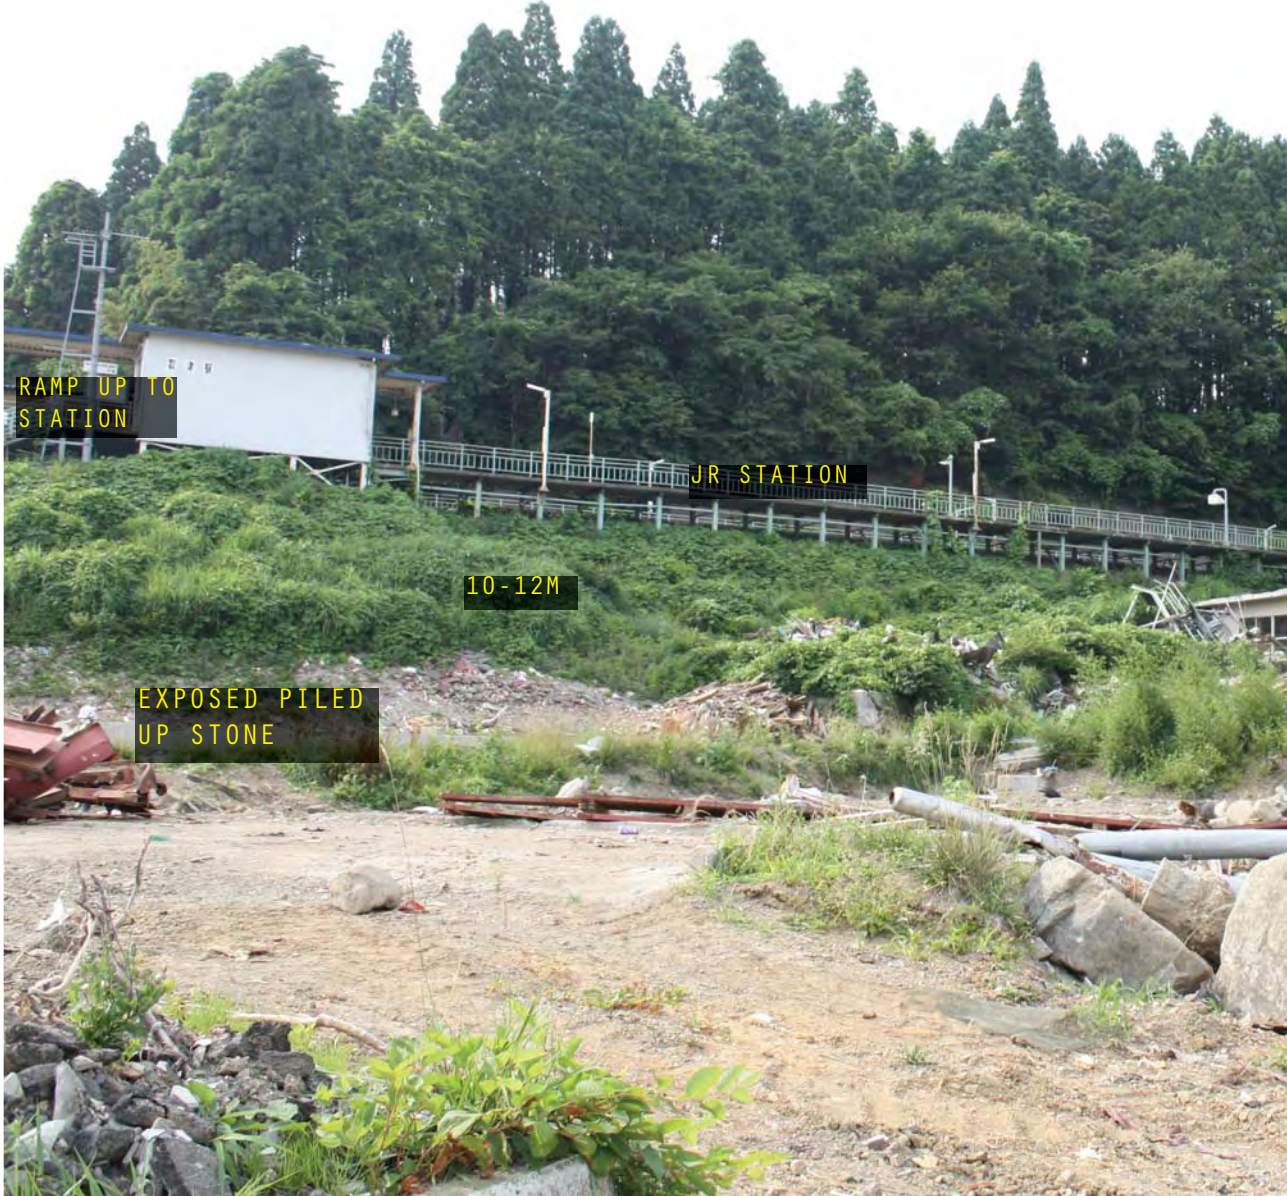
SLOPE B - ARTIFICIAL MOUND / JR LINE TRAIN TRACK

- ARTIFICIAL MOUND FOR JR TRAIN. TUNNEL AT GROUND LEVEL
- EXPOSED TOP OUTER SURFACE OF TUNNEL
- PILED UP STONE, GRASS
- 40 DEGREES SLOPE
- 10-12M
- ARTIFICIAL
- RAMP UP TO STATION
- EXPOSED STONE INNER FILL, MISSING GRASS PATCHES
- GRASS

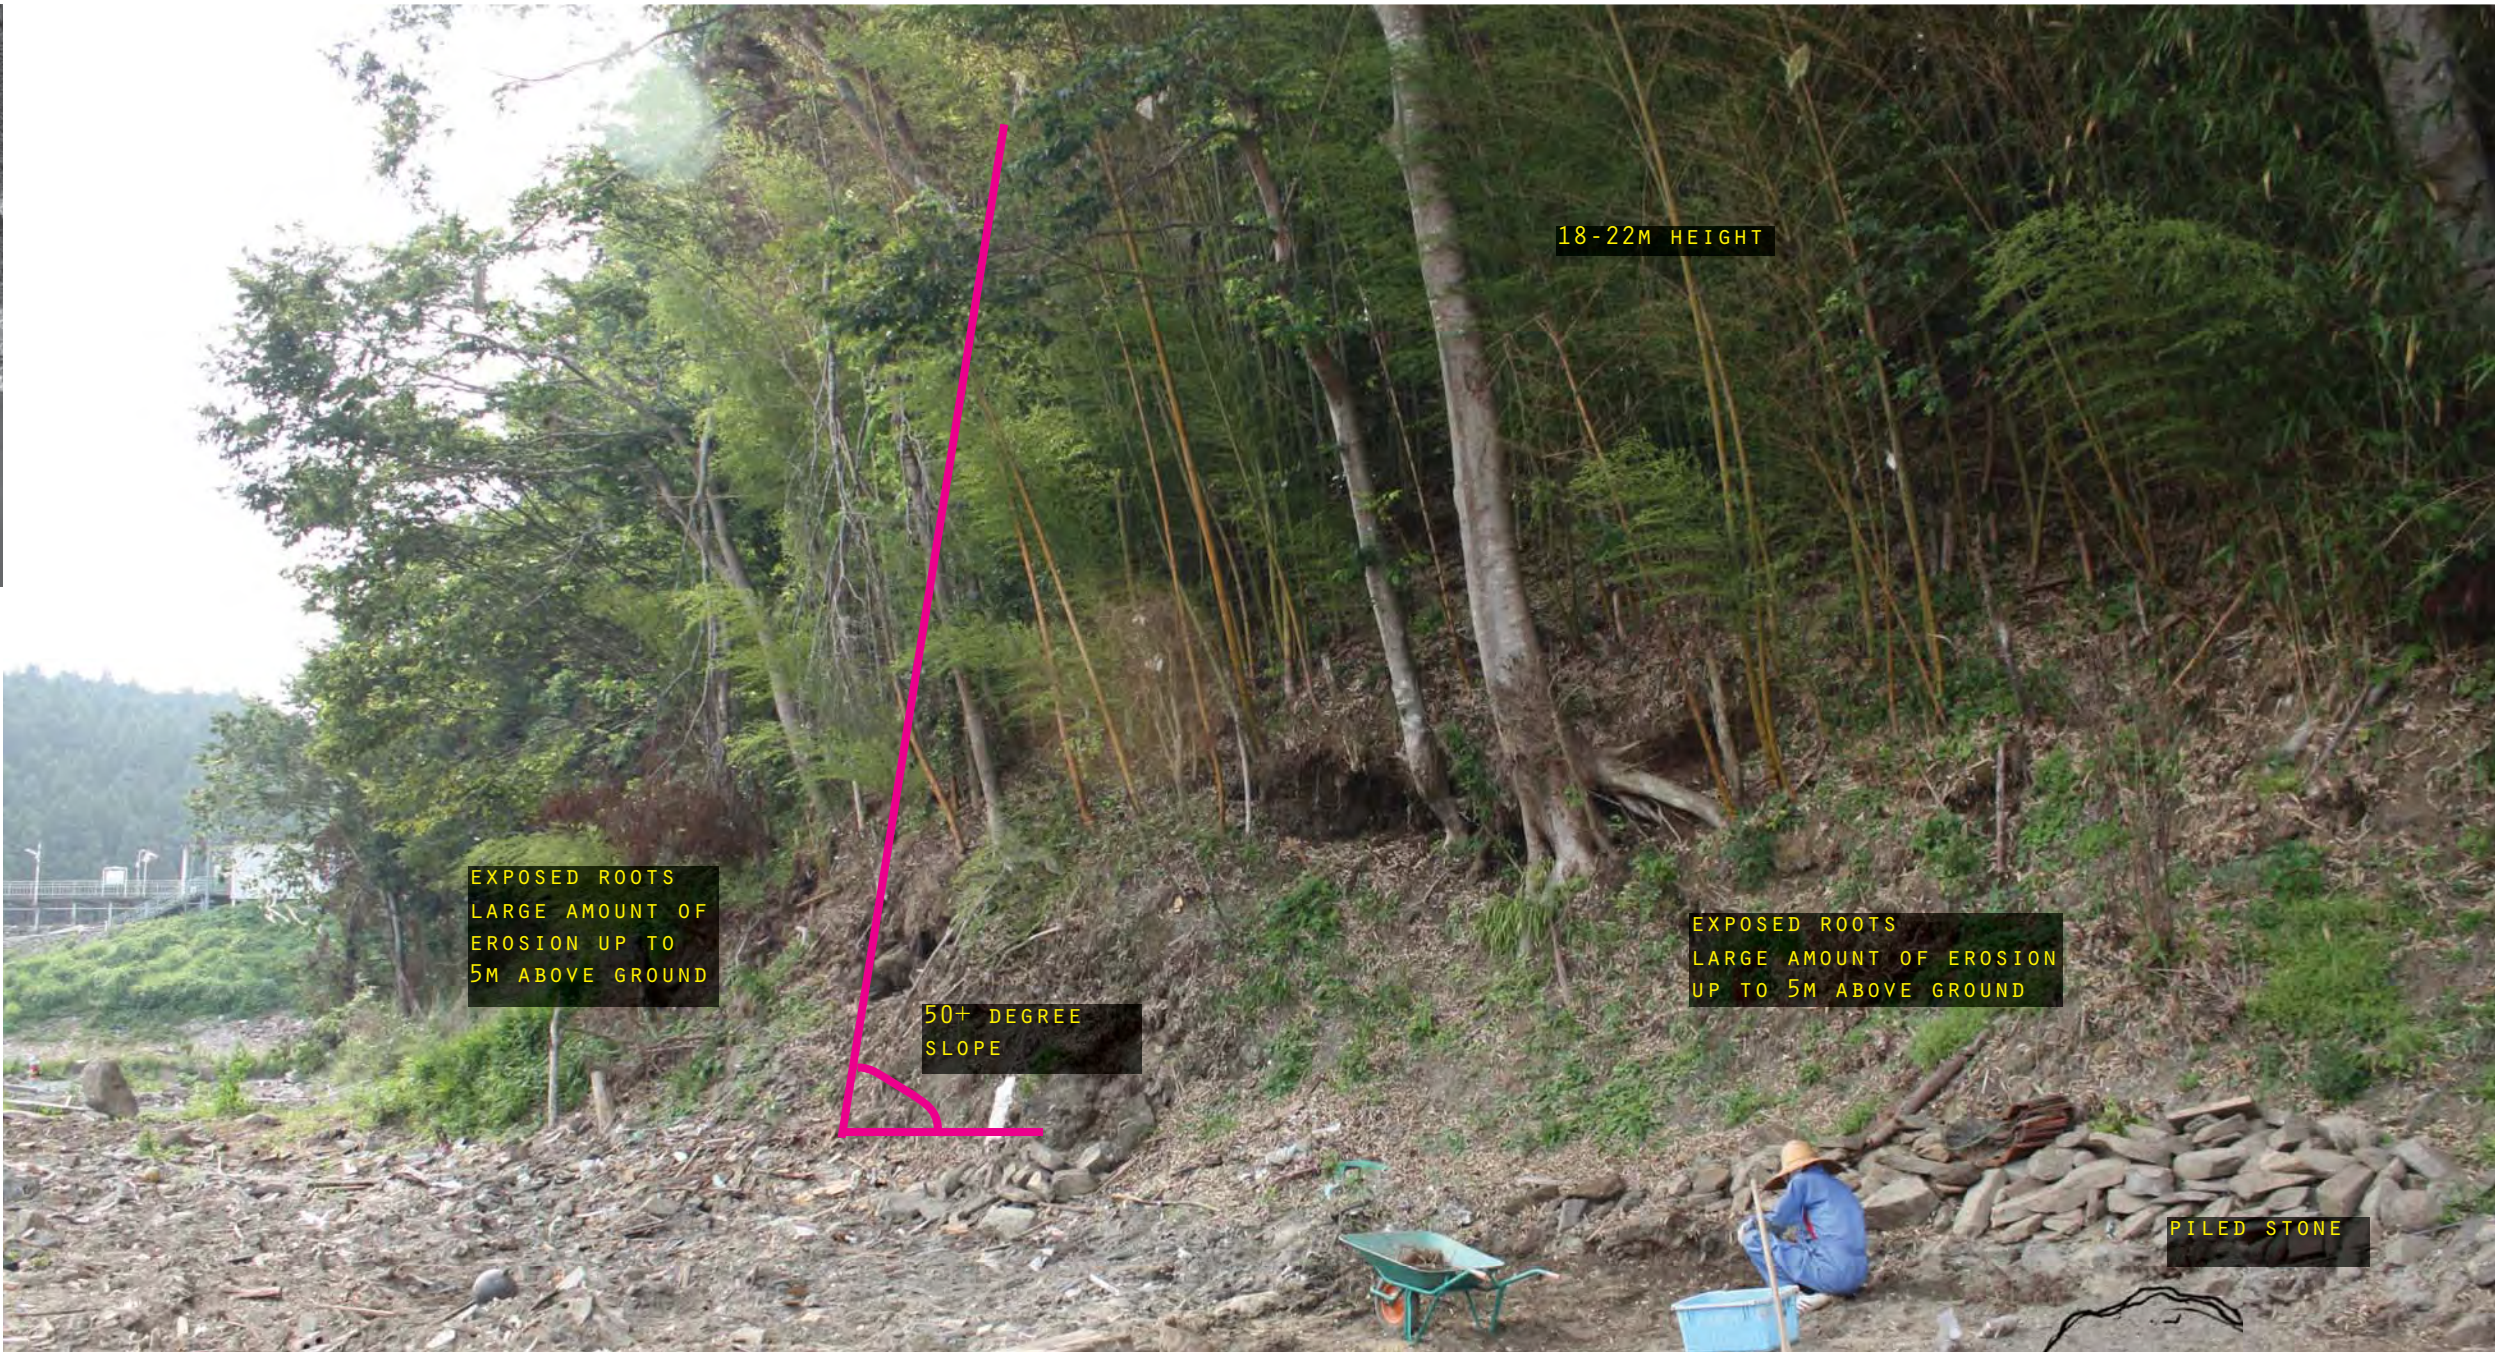
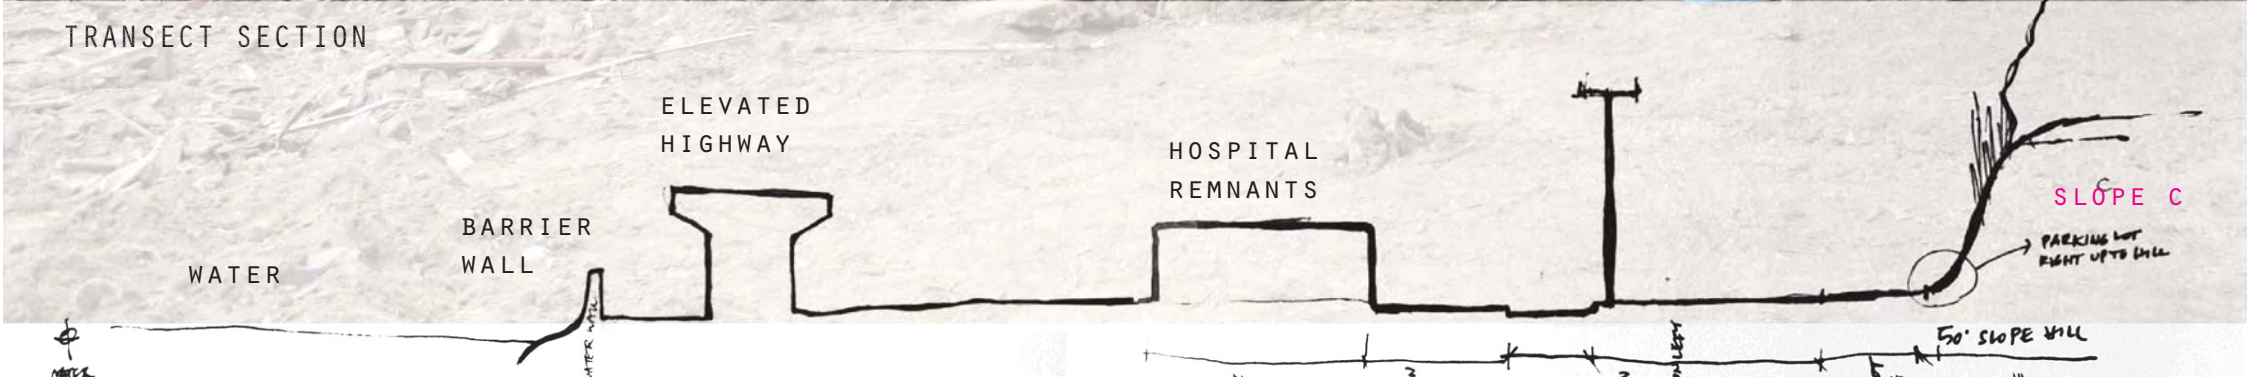
SLOPE C - BEHIND PARKING LOT

POST TSUNAMI CONDITION: DEAD BAM-
BOO, UPROOTED TREES

SURFACE: ROCKY SURFACE, STONE CLIFF

50-80 DEGREES SLOPE

18-22M

CUT AT TOE, PILED STONE

EROSION +++
5M UP FROM GROUND ALL ERODED

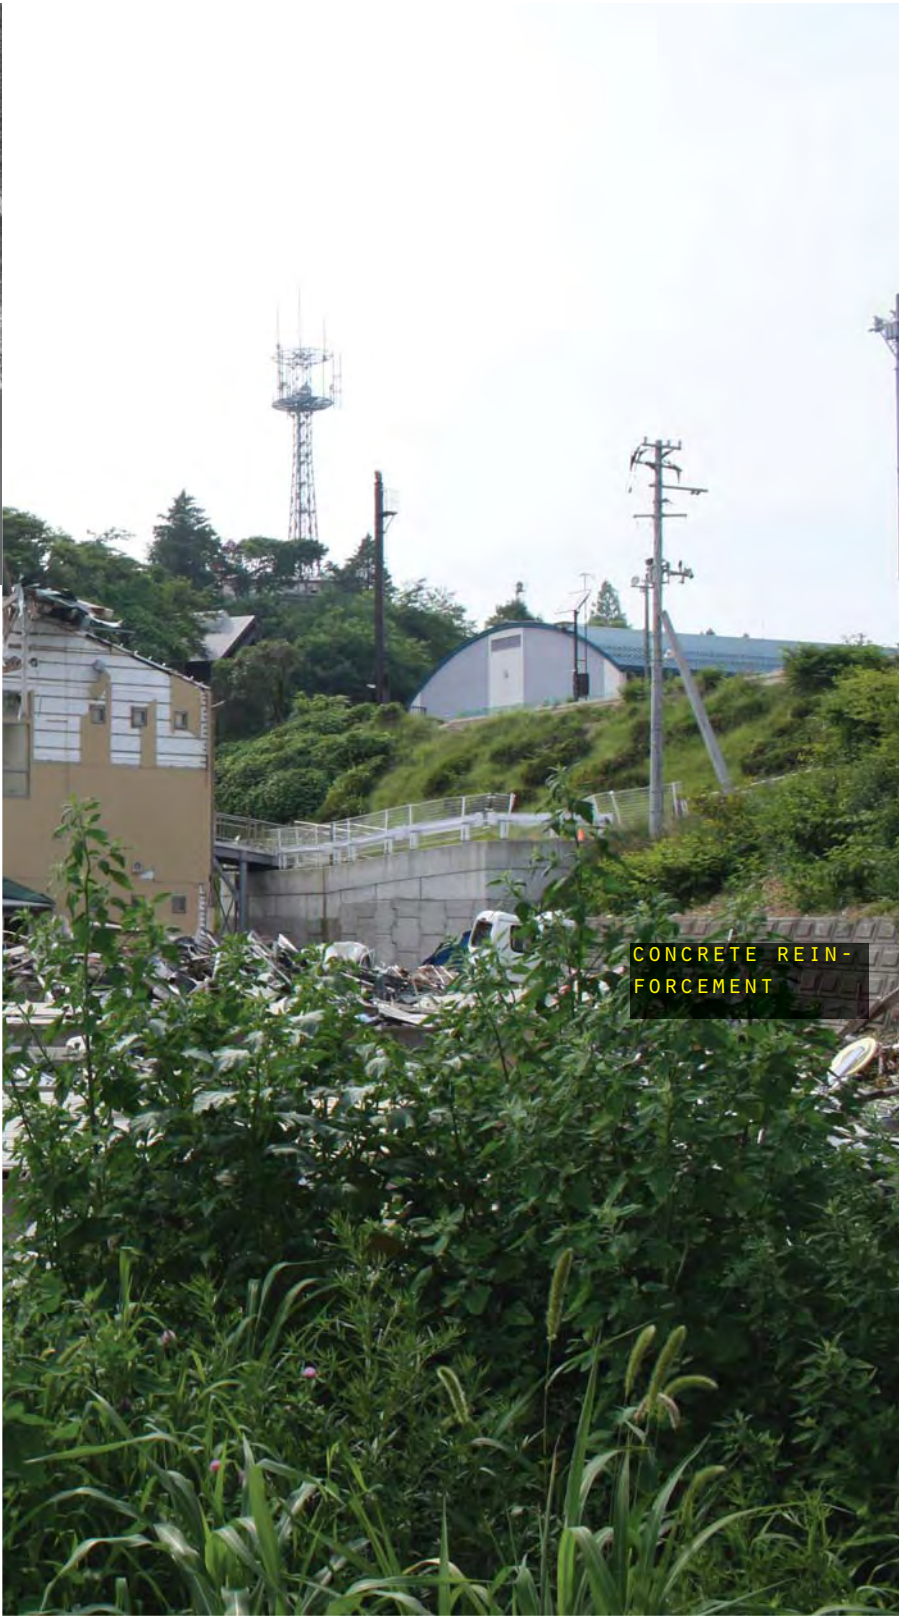
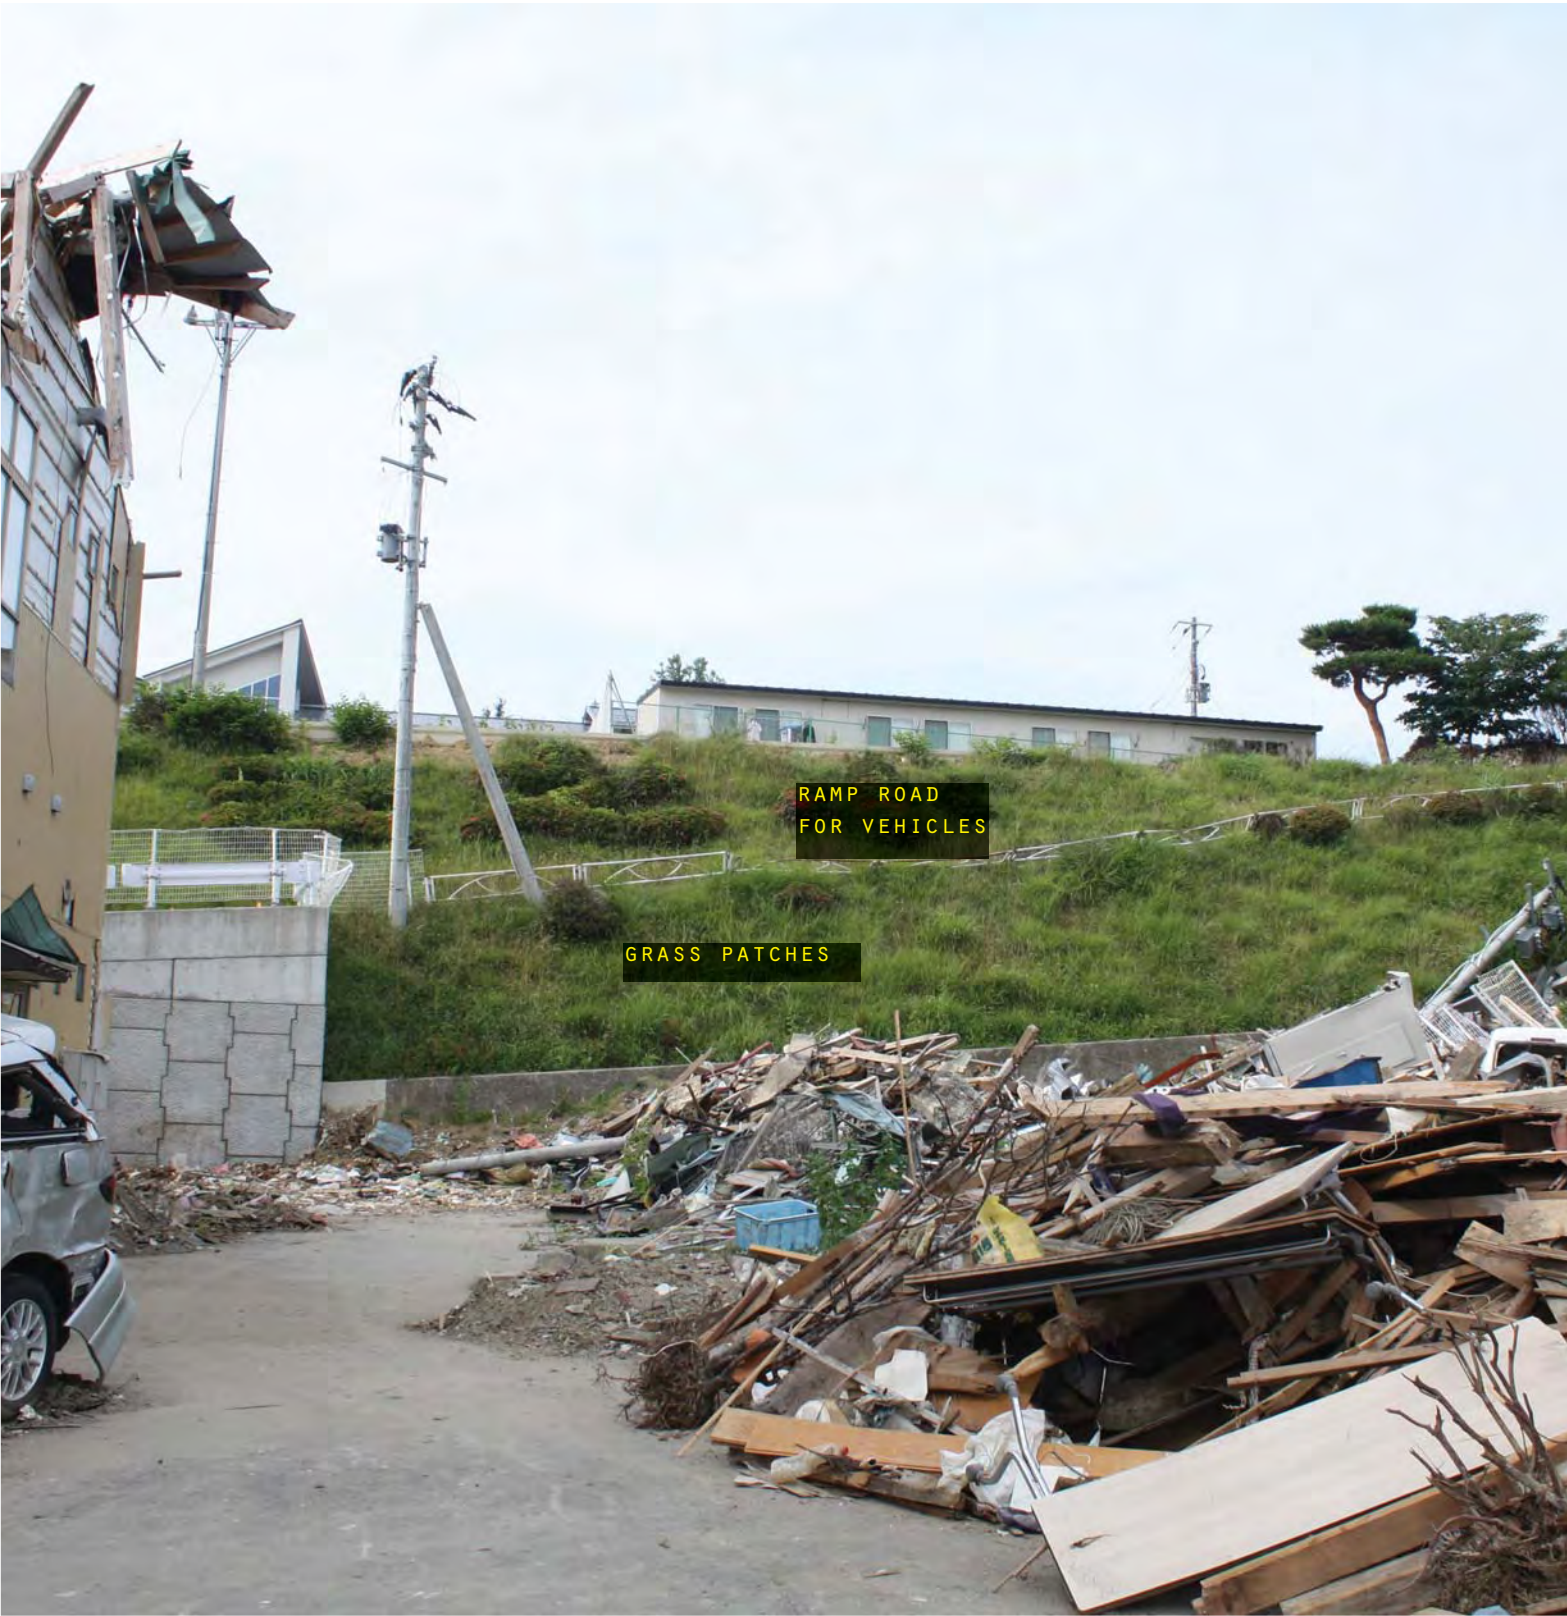
SLOPE D - SCHOOL GROUNDS

CUT AND FILLED SLOPE BY TWO SCHOOLS

NOT MUCH VISIBLE DAMAGE

SURFACE: CONCRETE WALL, GRASS PATHCES

CUT AT TWO LEVELS FOR RAMP, CON-
CRETE WALL

NO VISIBLE EROSION

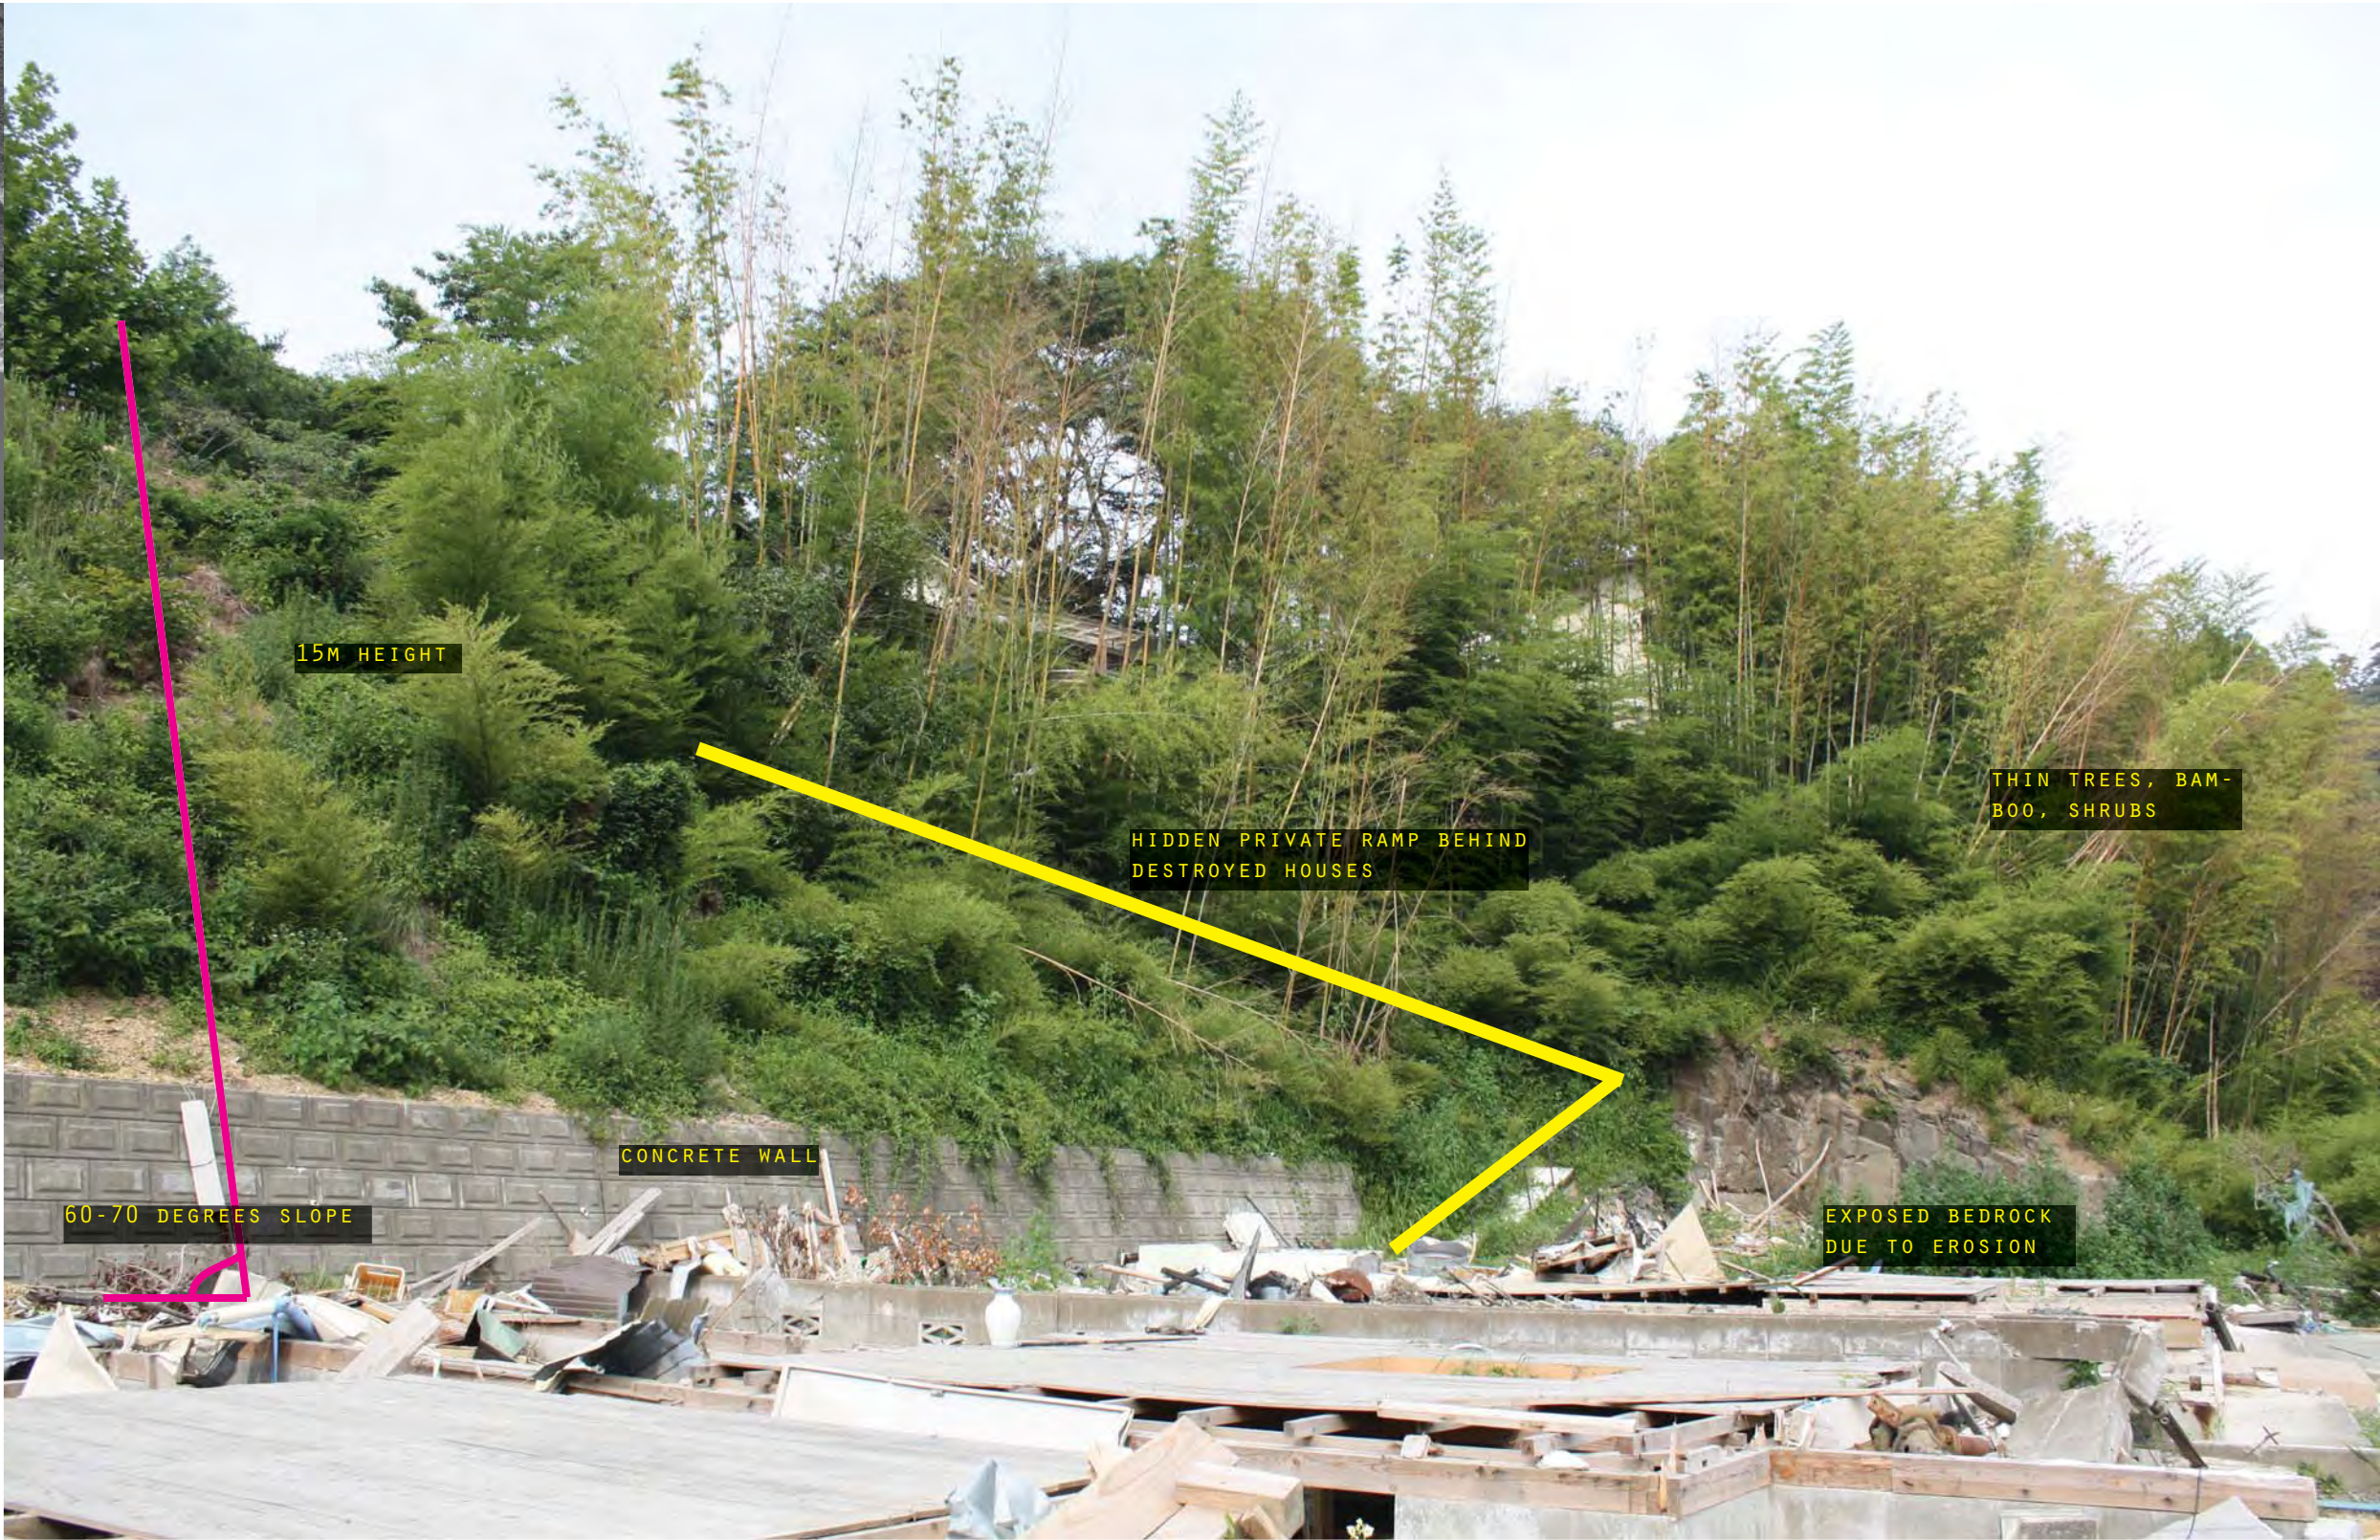
SLOPE E - BEHIND RESIDENCES

SLOPE BEHIND RESIDENCES, DIVIDES
HOUSES ON TOP FROM BELOW

UPROOTED TREES AND BAMBOO,
HANGING ITEMS

TREES, EXPOSED BEDROCK, SOIL
COLOR IS DIFFERENT

CUT AT TOE, FILLED WITH CONCRETE
WALL

EROSION NEAR GROUND
