WEST VALLEY | Utatsu (Minami-Sanriku, Miyagi)

+ TRANSECT | WEST VALLEY

3B / Transects
through the Site

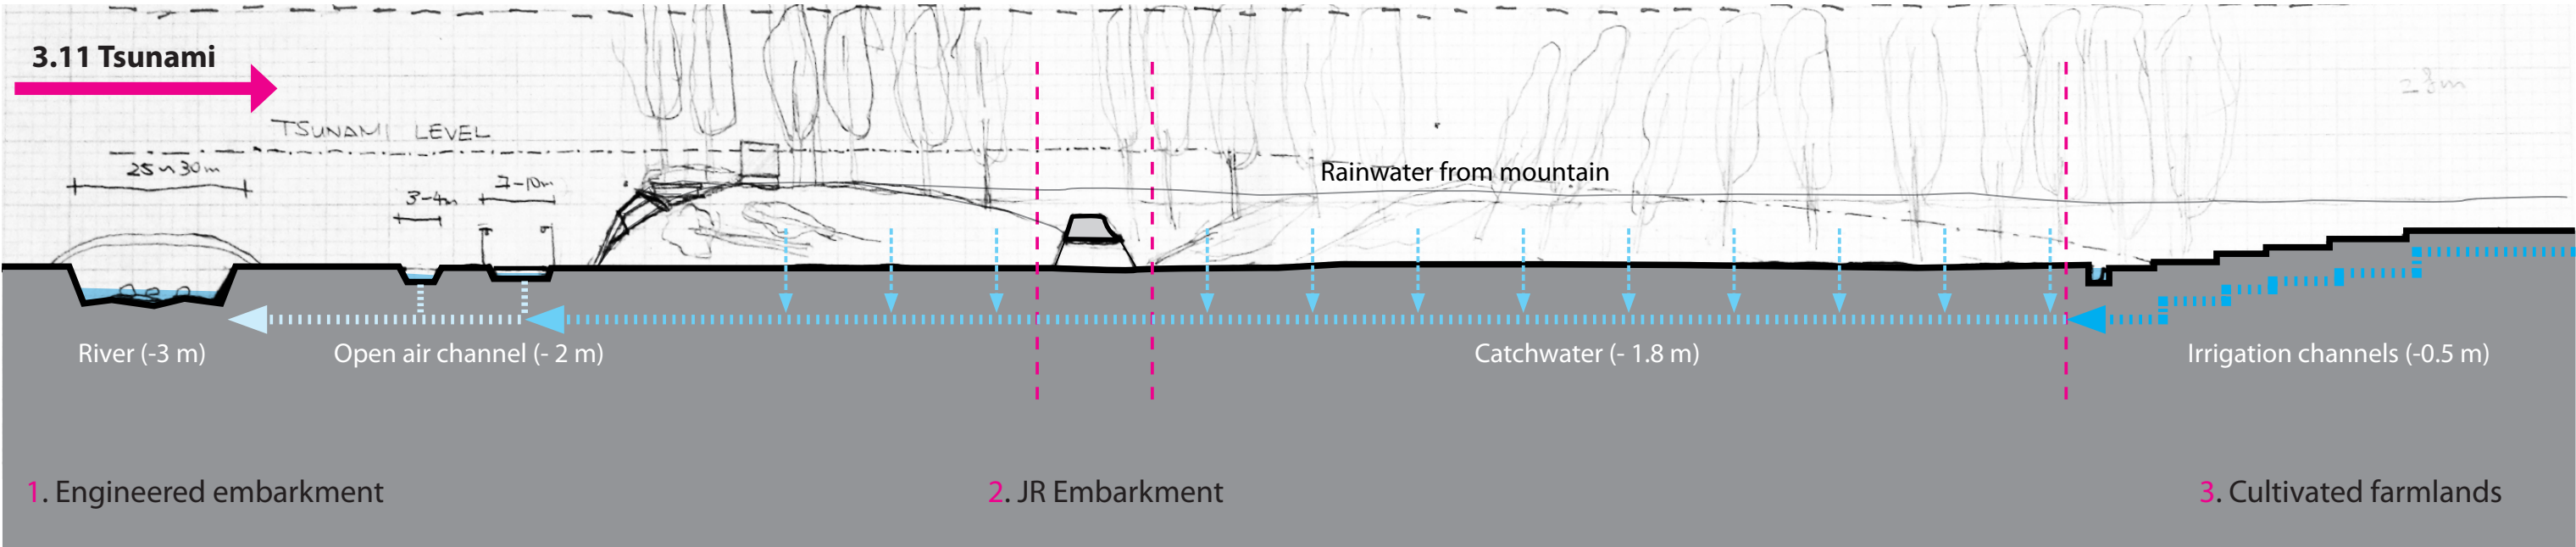
Along the transect A of west valley, the land form changes from the engineered embarkment at river end to farming soil on the other end inside the valley. In between there is a JR embarkment, which interrupts the transect continuity. In addition, the water system is also changed from engineered concrete channel, catchwater and traditional irrigation channels.

Due to different in landform and water system, the transect has dramatic difference in term of damages and post-disaster conditions. The area with engineered concrete land surface suffered from most serious damage, However, the cultivated farmlands with soil land in the valley has least damages. One of the reason is the soil surface has better water holding capacity.

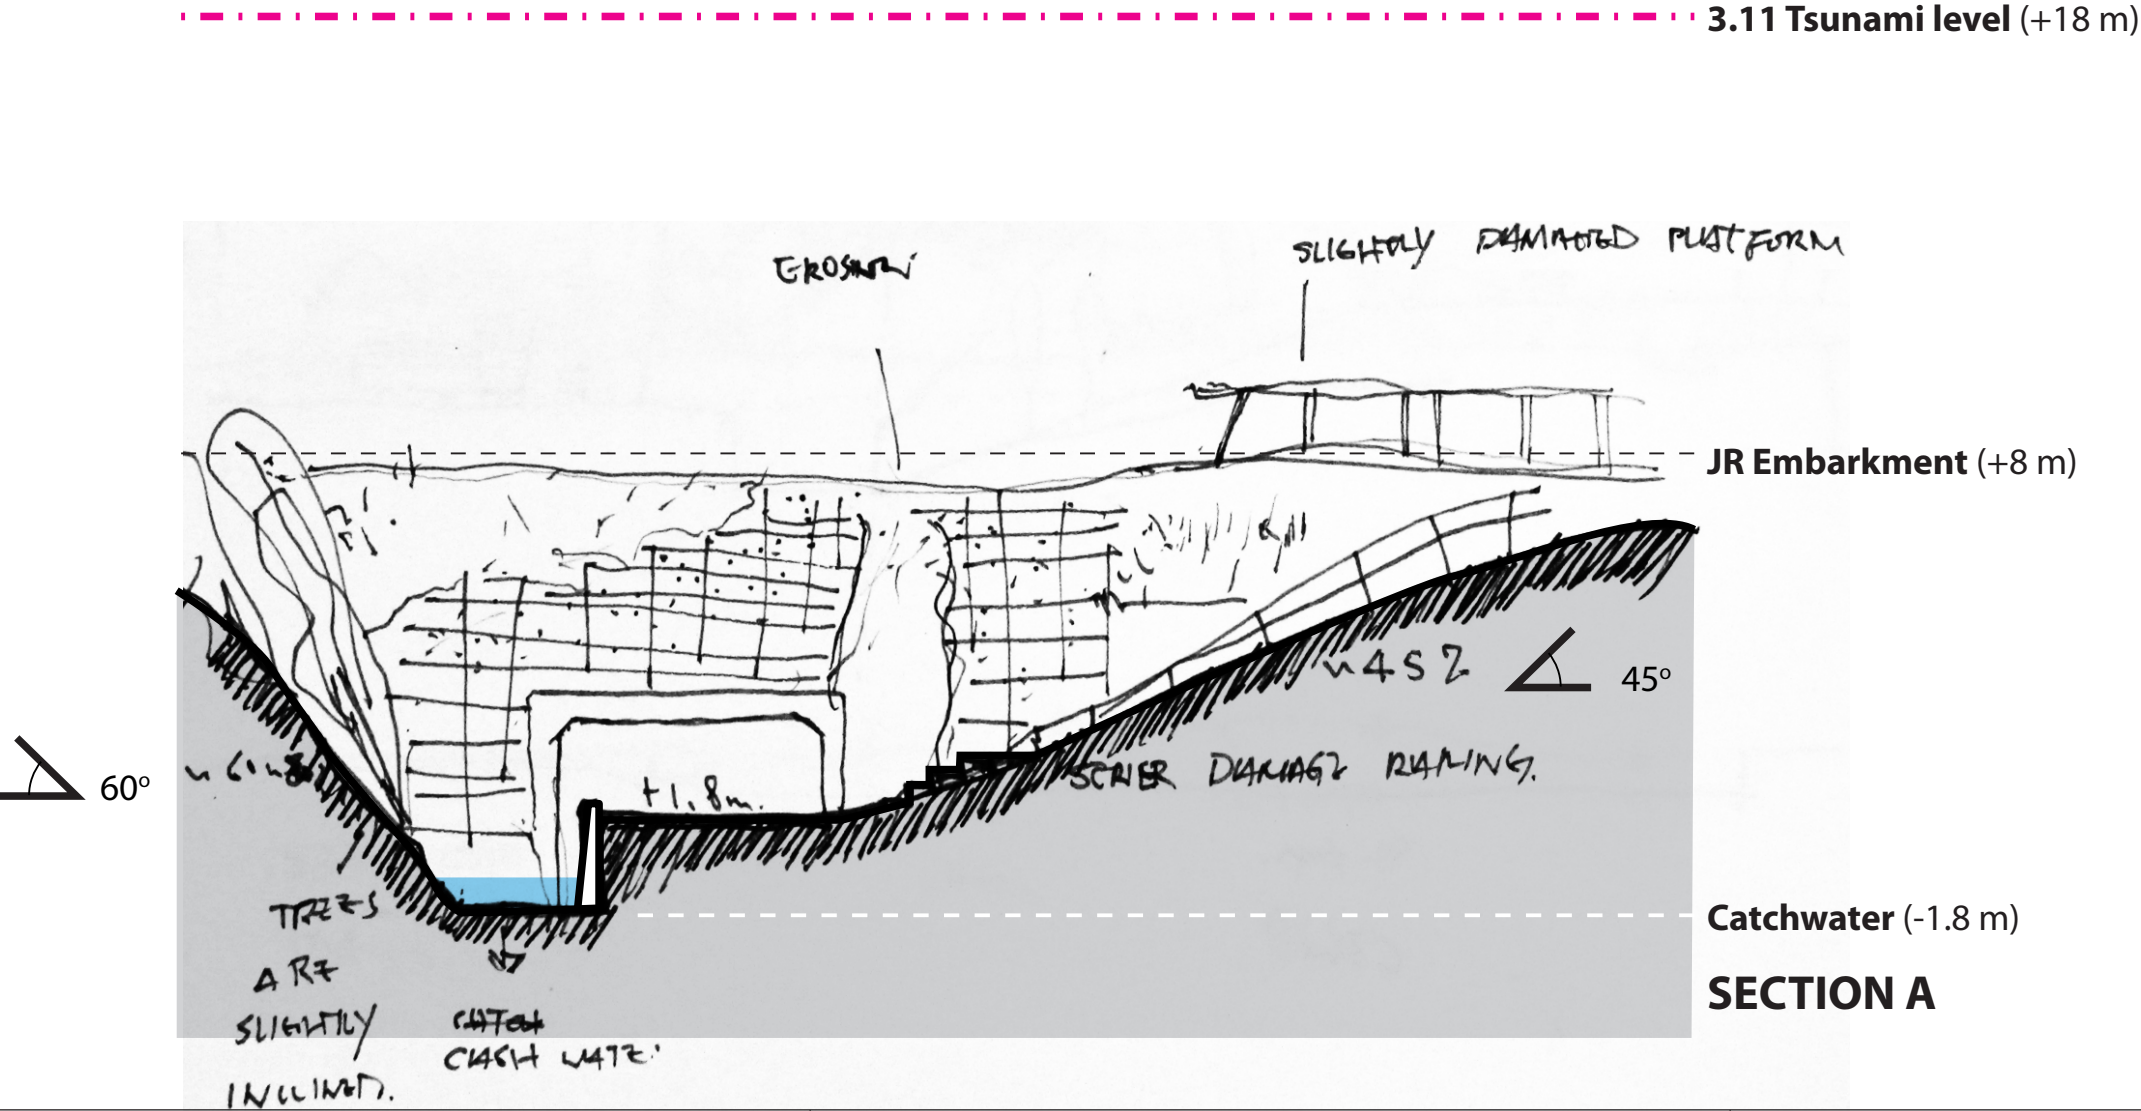
A catchwater system, about 2 m wide and 1.8 m deep is used to collect rain water from the valley and slope. Due to its materiality of concrete and engineered strength, the damage is minimal. The concrete JR underpass also was preserved well after tsunami.

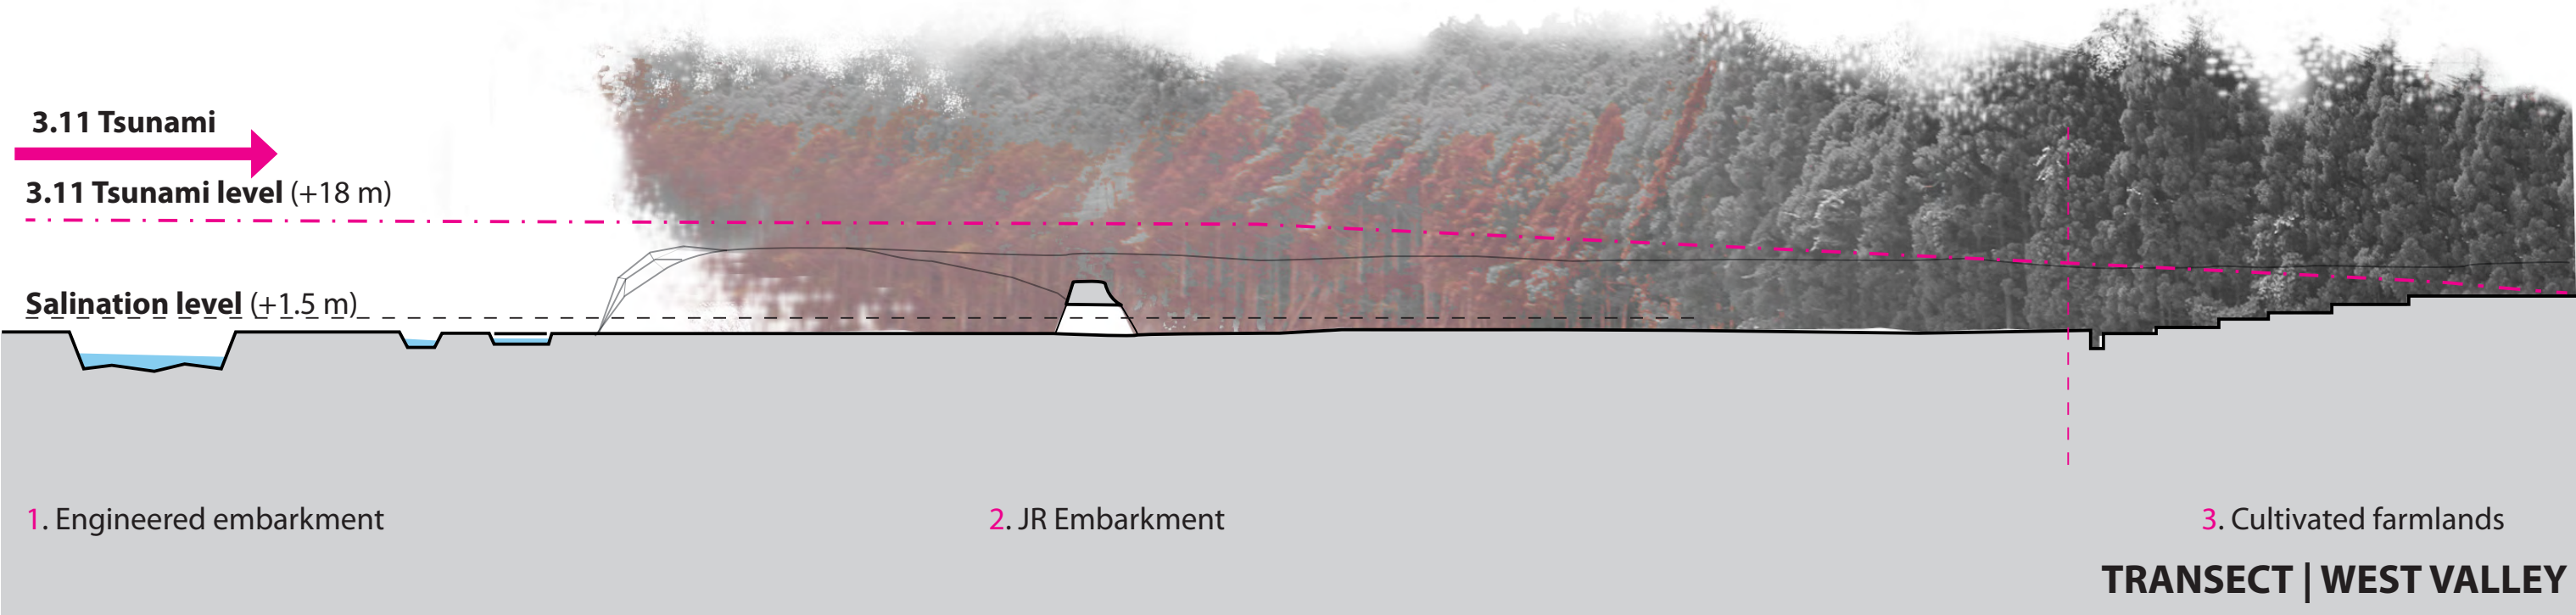
The damages and salinations of tress was most seri-
ous nearby the JR embarkment underpass during
the 3.11 tsunami. These damages indicate a direct
connection between the JR embarkment and its
context

Originally, the JR embarkment is engineered strongly as
an infrastructure to support the JR railway. In addition,
it could function as a dike to protect the inland valley.
However, th tide of tsunami came over the JR embark-
ment very much, so proverties behind the embarkment
were totally damaged. Moreover, from the damges
tresses, they reflect the JR underpass was the weakest
point, which suffer strongest impact during tsunami.

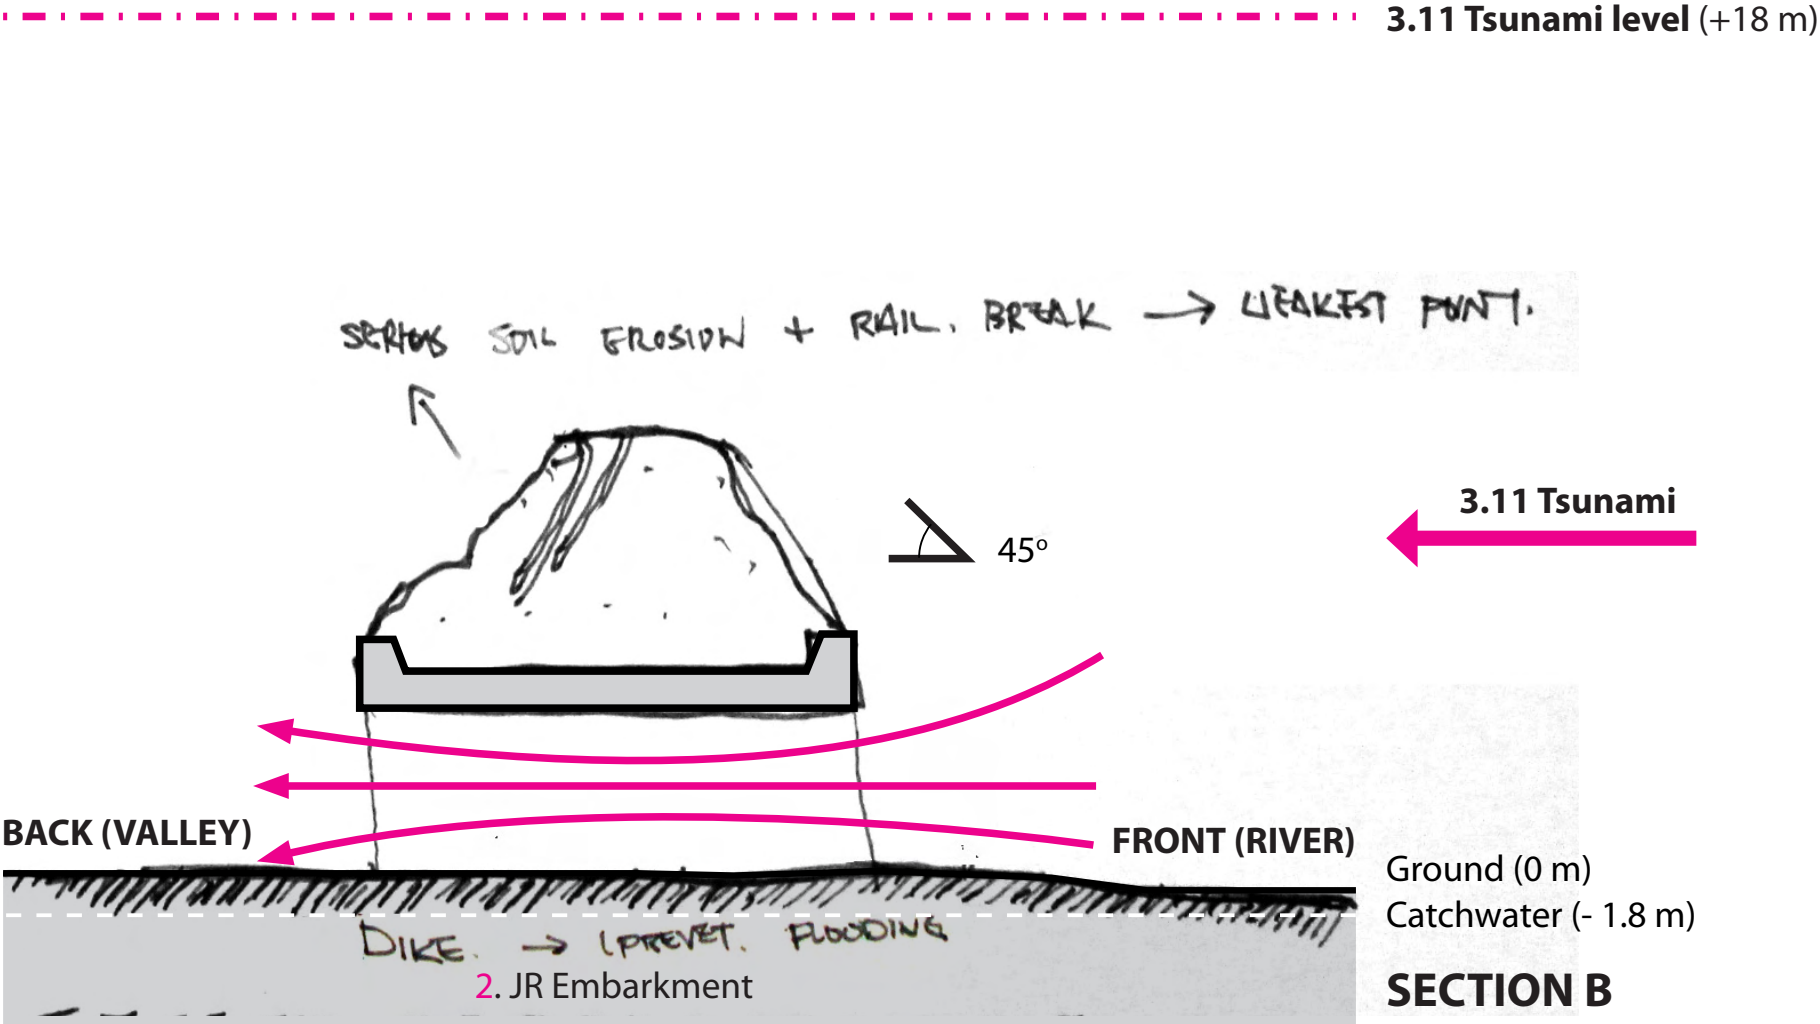
The JR embarkment has different extend in term of damages. At the front, the surface was slightly washed out. At the back, serious soil erosion is happened to the embarkment.
